# Slope stability analysis applied to the 5th section of the Northern Marmara Motorway, İzmit, Türkiye

## Abstract

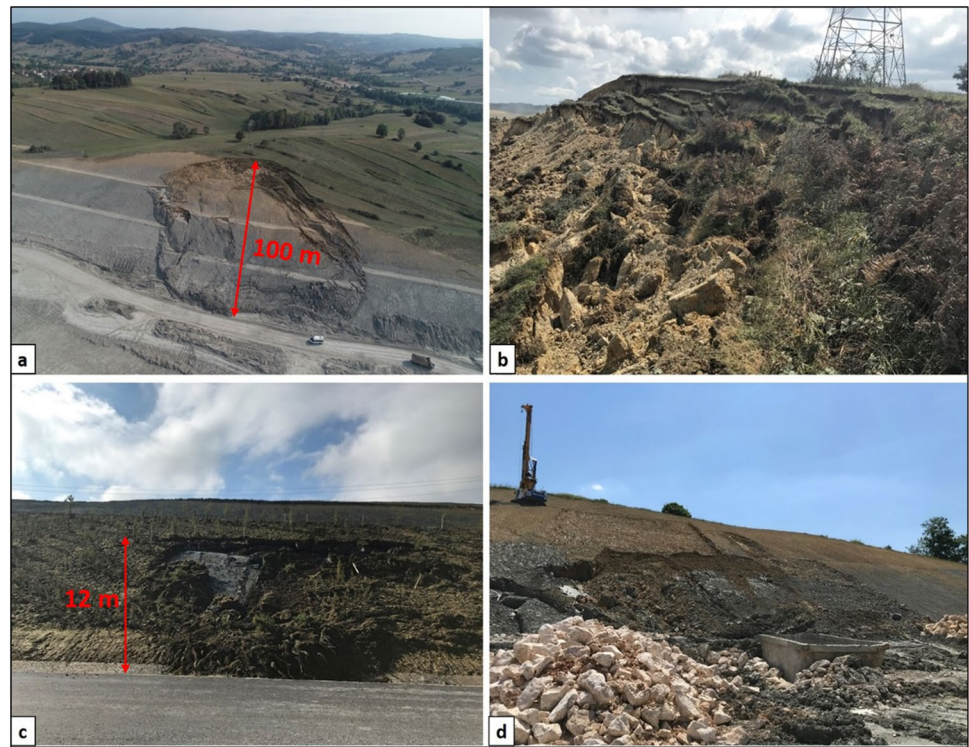
The slope movement, which took place in the YSK 170 + 212 cut slope and is called mass movement 1 (Y1) in this study, occurred between km: 170 + 300–170 + 400 (Fig. 9a, b). At the termination zone, the refuge and right side of the carriageway were elevated by 80 cm and formed the toe. Cracks had formed in a section of about 3 m due to slipping at the top of the landslide (Fig. 9a). The investigations conducted on the mass movement, revealed its impact across a horizontal span of 100 m. The observed characteristics identified the mass movement as a rotational slip (landslide) type (Wicander and Monroe 2005). The study area is within a zone of active tectonic activity. As a result of the tectonic activity in the region, the sedimentary units are frequently fractured and cracked. The development of discontinuity planes through the formation of cracks and fractures in sedimentary rocks is attributed to tectonic activity.

**Fig. 9** **a, b** Front and side view of the rotational slip (landslide) type mass movement occurring in the km: 170 + 300–170 + 400, **c** Front view of translational slide-type mass movement at km: 170 + 640, **d** Side view of flow-type mass movement occurring between km: 175 + 297–175 + 463 kms

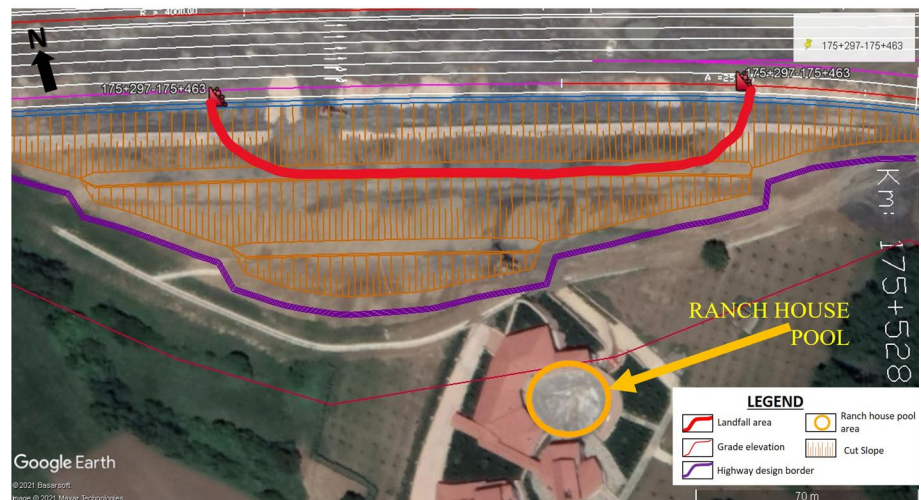
**Fig. 10** Image of the location of the mass movement and the water recharge point that caused the mass movement in kilometers between 175 + 297 and 175 + 463 (Google Earth 2020)

water leaks were prevented, and the water originating from the building was prevented from reaching the slope. An artificial nature design (surface protection with greening, afforestation, etc.) was made on the slope surface and water infiltration from the slope surface into the ground was tried to be kept at a minimum level. Suggested stability improvements for Y1 and Y3 mass movements are given in Table 6.

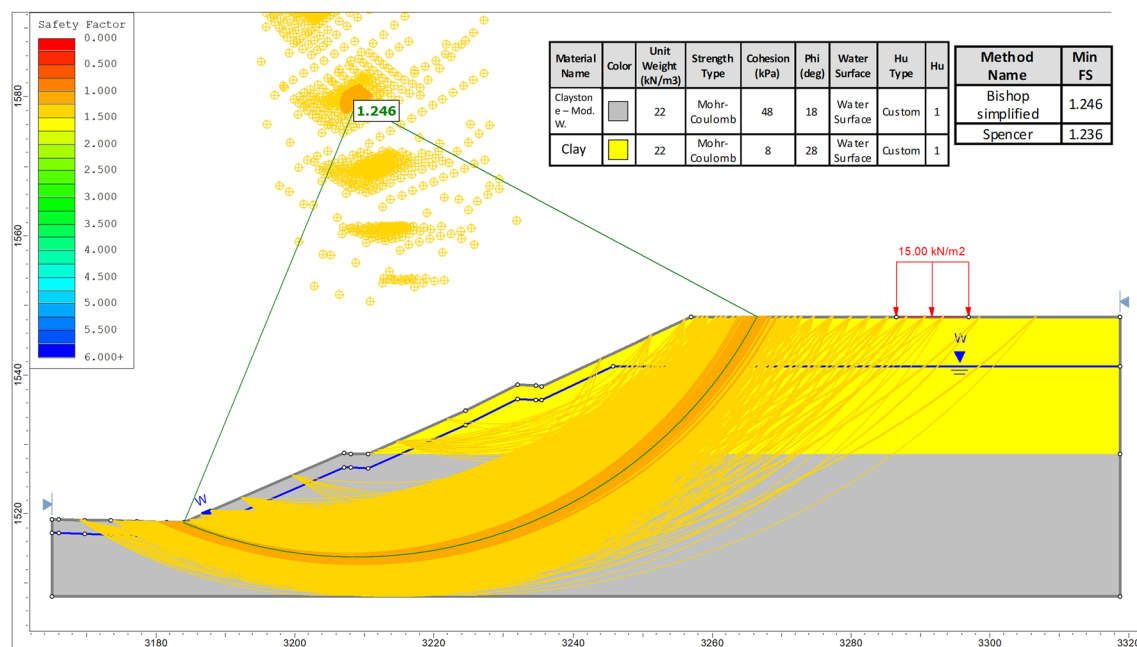
A transmission tower exists at the top of the slope where Y1 mass movement occurred. Therefore, while performing the slope stability improvement analysis, surcharge load is added to the cross-section in the Slide2 software for the transmission tower (Fig. 11). When the laboratory test results are associated with empirical correlations and the slope is evaluated, it is observed that the factor of safety of the slope is  $FS = 1.25$  in the first design situation (Fig. 11). The determined value of the safety factor ( $FS = 1.25$ ) is

**Fig. 11** Slope stability analysis of km: 170+300–170+400 (Y1) mass movement before slipping (Static Condition)

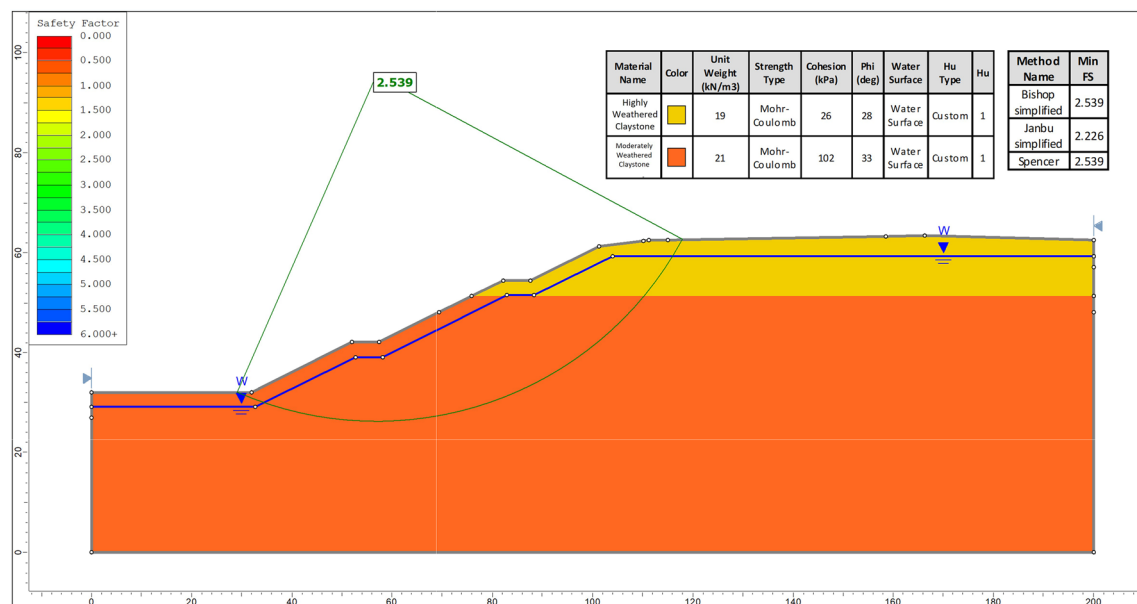
When the area was evaluated and correlated with the empirical correlations, the laboratory test results for the Y3 mass movement showed that the factor of safety value ( $FS = 2.539$ ) of the slope in the initial design condition was sufficient for the slope to remain stable (Fig. 12).

Although the design shown in Fig. 12 looks stable, the flow-type mass movement has developed in the slope. The claystone in the Y3 slope was detailed with weathering products instead of a single unit and the design

**Fig. 12** Initial state analysis of slope geometry where Y3 mass movement develops, drawn in Slide2 software ( $D=0$ )

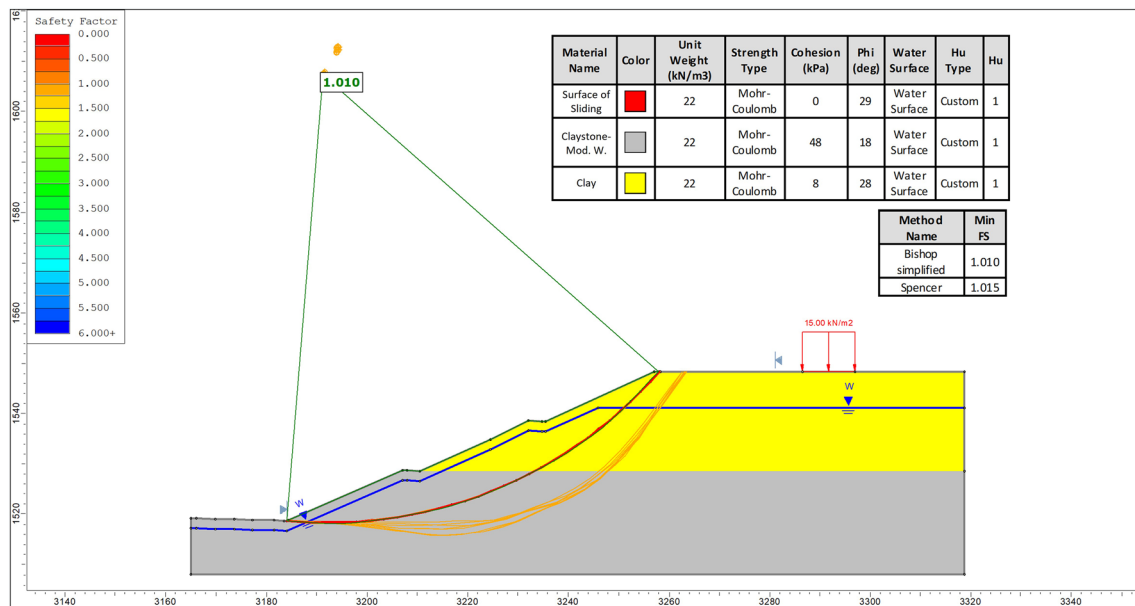
The claystone unit belonging to the Ypresian Korucu Formation differs within itself in terms of weathering. This situation was reflected in the model, the slip parameter values determined in Table 5 were assigned based on the engineering geology evaluation, and long-term stability on the slope was investigated. The static condition analysis of the Y1 is given in Fig. 15.

**Fig. 15** Sliding plane finding with back analysis method of km: 170+300–170+400 (Y1) mass movement and slope stability analysis after strength parameters are inputted in Slide2 software (Static Condition)

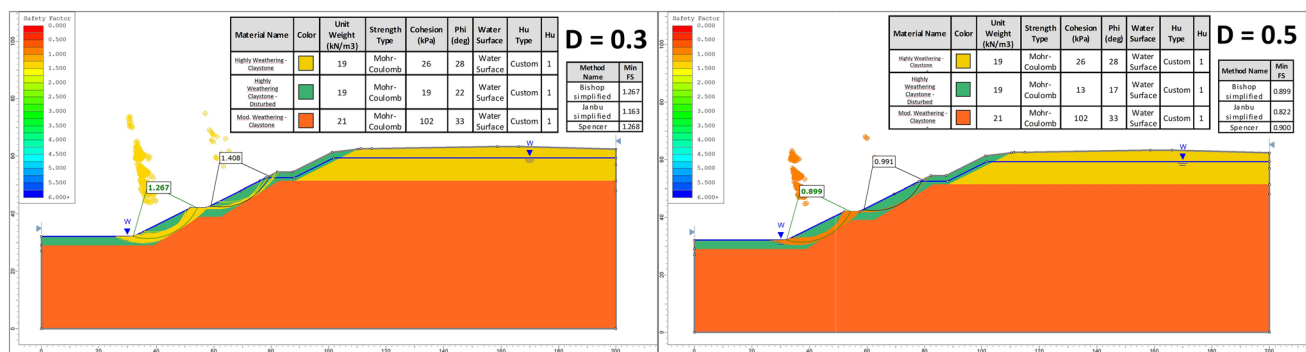
**Fig. 16** Analysis of the possibility of sliding-type movement in slope geometry with Slide2 after the Y3 mass movement ( $D=0.3$  and  $0.5$ )

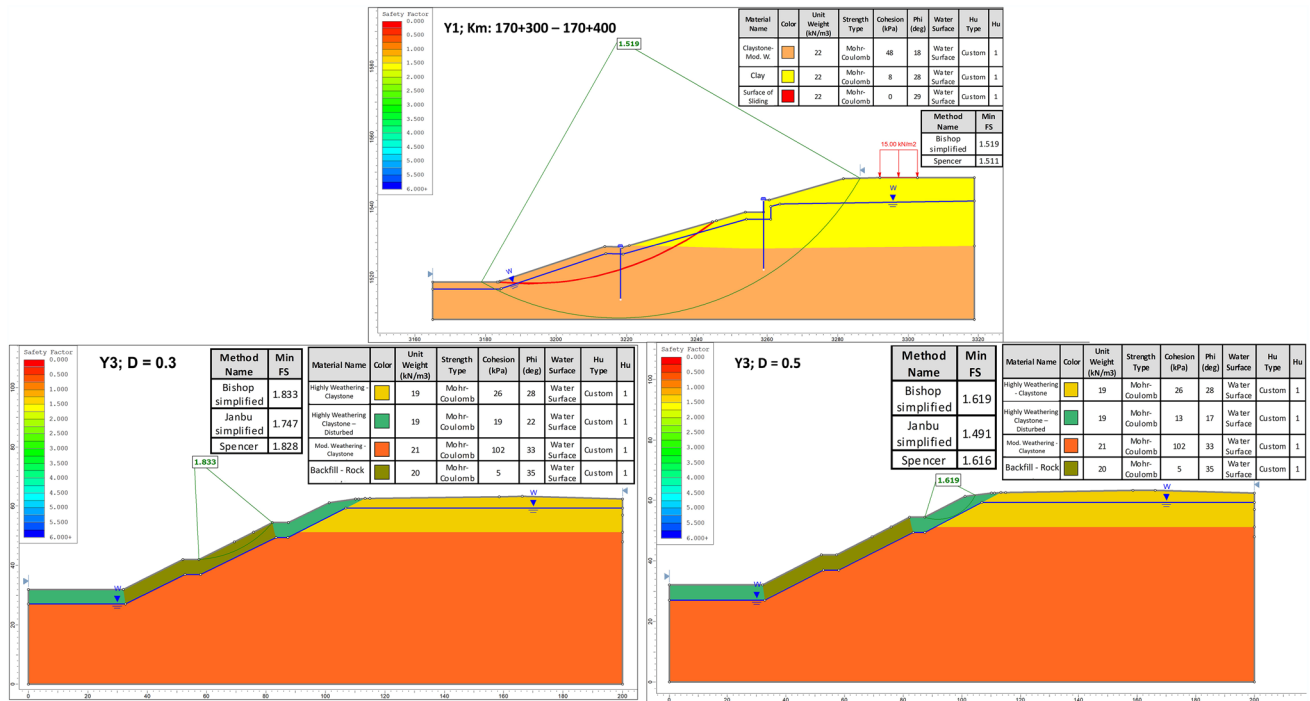
As a result of the suggested stability improvements techniques, it has been observed that the slope maintains its stability in static (Fig. 17) and dynamic (Fig. 18) conditions in the case of  $D = 0.3$  and  $D = 0.5$  disturbances.

Fig. 17 Static condition analysis of slope improvement in Y1 and Y3 mass movements

| Mass Movement No | Suggested Stability Improvement Techniques | |
|---|---|---|
| Y1 | Stage 1: It has been suggested that 29 pieces of $L = 15$ m length $\phi = 1.20$ m diameter piled (Concrete class: C30/37, Reinforcement: B420C, Pile Cover: 7.5 cm) retaining wall application should be applied on the lowest bench level | Stage 2: It has been suggested that 21 pieces of $L = 20$ m length $\phi = 1.20$ m diameter piled (Concrete class: C30/37, Reinforcement: B420C, Pile Cover: 7.5 cm) retaining wall application should be applied on the uppermost bench adjacent to the top of the slope |
| Y3 | <ol style="list-style-type: none"> <li>1. Prevention of water leakage originating from the dwelling</li> <li>2. Adding drainage to the slope</li> <li>3. Surface protection &amp; Ecological Restoration or Rip-Rap application</li> <li>4. Retaining structures for dynamic condition</li> <li>5. Support items and measures</li> </ol> | |

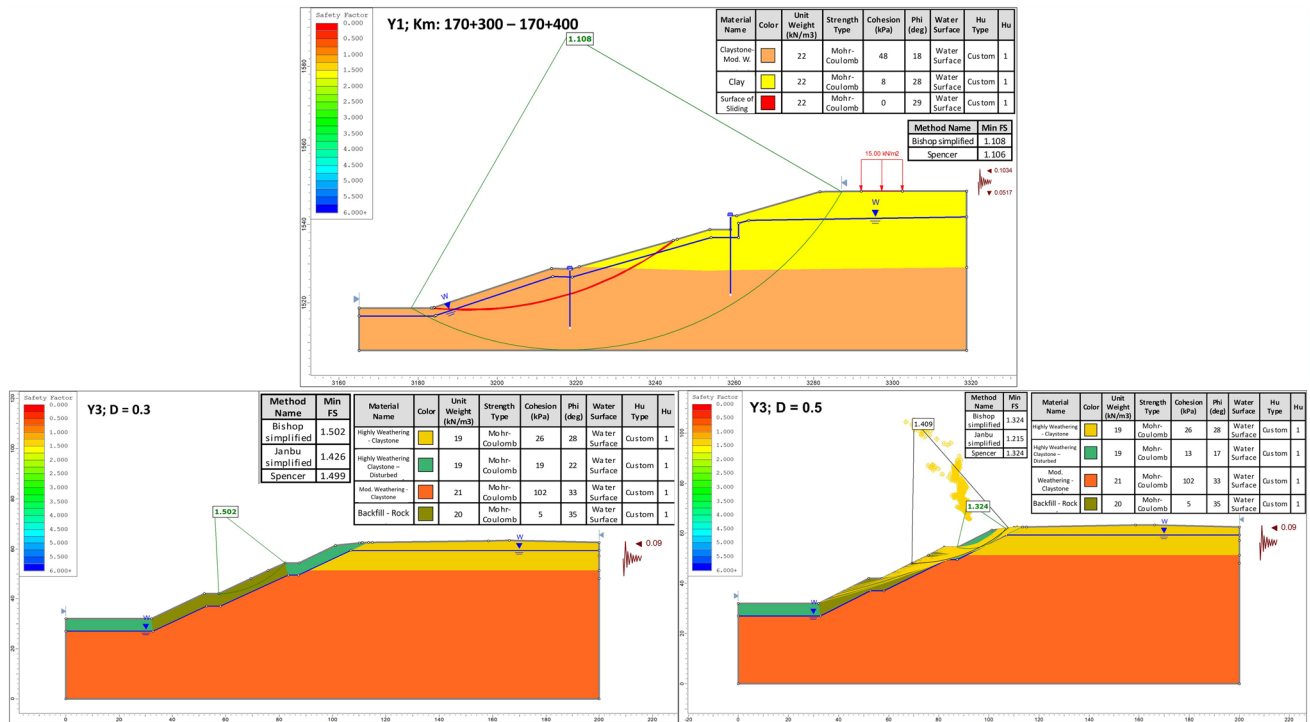
Fig. 18 Dynamic condition analysis of slope improvement in Y1 and Y3 mass movements
