**ISTANBUL TECHNICAL UNIVERSITY ★ GRADUATE SCHOOL**

**STRUCTURAL ASSESSMENT AND FATIGUE EVALUATION  
OF A 60-YEAR-OLD LINKSPAN BRIDGE  
IN NORTHEAST OF ENGLAND**

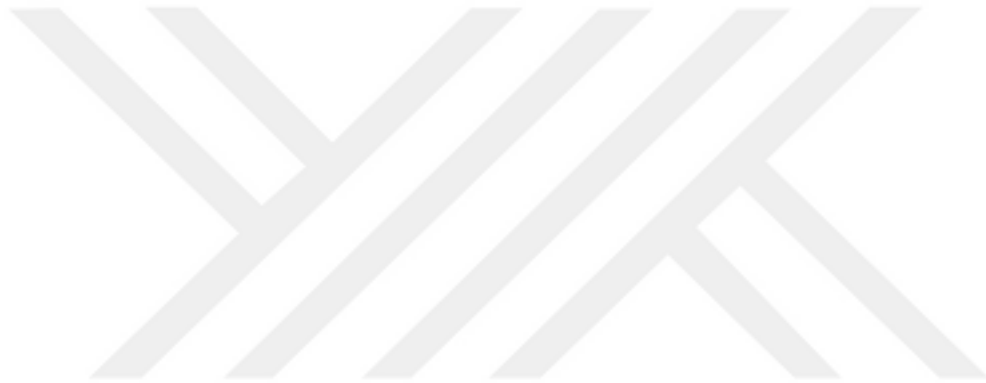
$f_y$	: Yield strength
$f_u$	: Tensile strength
$E$	: Elasticity Modulus
$\gamma_m$	: Material partial safety factor
$\gamma_s$	: Unit weight of steel
$q_w$	: surface loading
$I_p$	: Moment of Inertia
$k_p$	: spring stiffness coefficient of bearings
$k_s$	: spring stiffness coefficient of buffers
$R_A$	: Reaction forces
$UC$	: Utilisation Ratio
$N$	: Number of cycles
$\Delta\sigma_p$	: Allowable stress
$\Delta\sigma_R$	: Direct Stress range
$\Delta\sigma_c$	: Detail category
$\gamma_{MF}$	: Partial safety factor for fatigue strength
$\gamma_{FF}$	: Partial safety factor for stress range
$\Delta\sigma_D$	: Constant amplitude fatigue limit
$\Delta\sigma_L$	: Cut-off limit

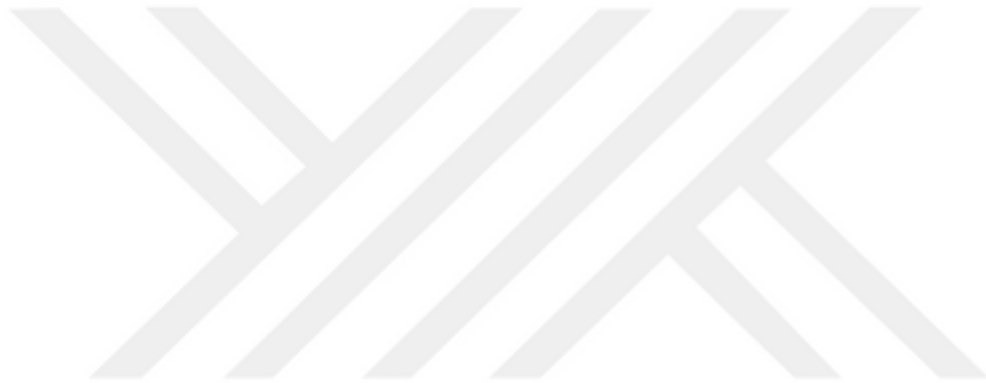
<u>Page</u>
<b>Table 3.1</b> : Thickness Readings on Cross Girders. ....	18
<b>Table 3.2</b> : Thickness Readings on Longitudinal Stiffeners. ....	19
<b>Table 4.1</b> : Overview of assumed material properties.....	22
<b>Table 4.2</b> : Overview of material partial safety factors for steel bridges. ....	22
<b>Table 4.3</b> : Partial factors for load combinations. ....	28
<b>Table 5.1</b> : Utilisation ratios from calculation of the original main girder. ....	37
<b>Table 5.2</b> : Utilisation ratios for as-built and corroded cross girders - 10% section loss. ....	38
<b>Table 5.3</b> : Utilisation ratios for as-built and corroded longitudinal deck stiffeners - assuming 10% section loss.....	39
<b>Table 6.1</b> : Recommended values for partial factors for fatigue strength (Table 3.1 in EN 1993-1-9).....	39

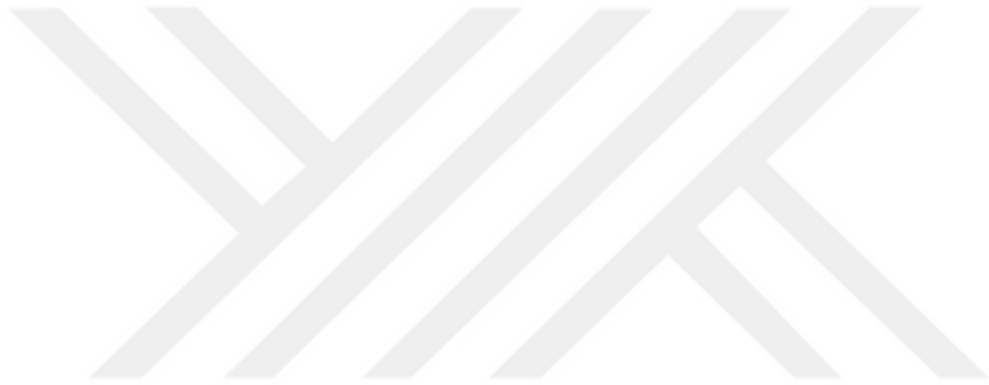
## KUZEYDOĞU İNGİLTERE'DE 60 YILLIK LINKSPAN KÖPRUSÜNÜN YAPISAL DEĞERLENDİRMESİ VE YORULMA ANALİZİ

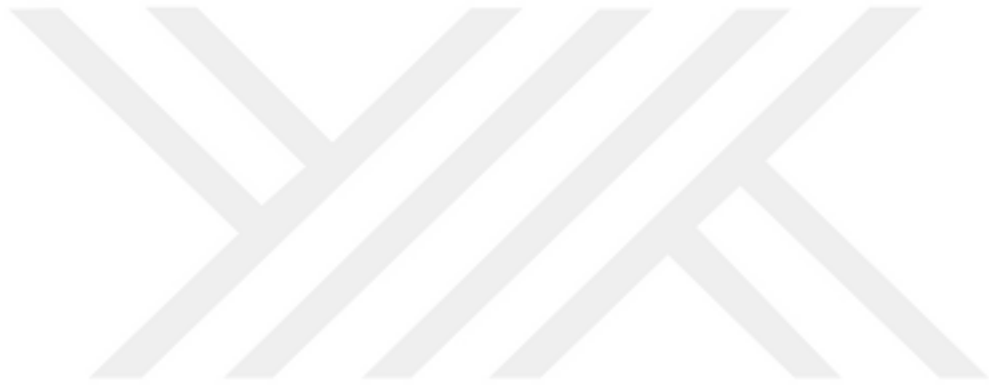
## **1. INTRODUCTION**

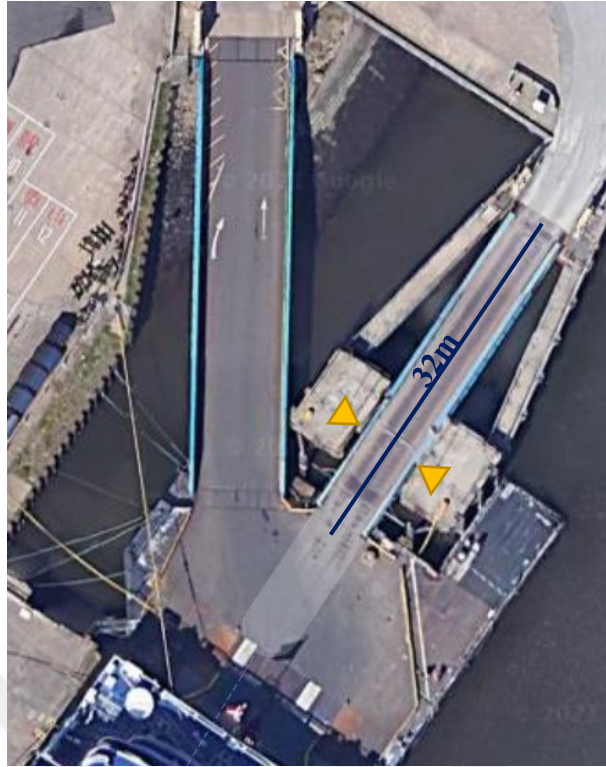
**Figure 2.3 :** Horizontal support condition of the bridge.

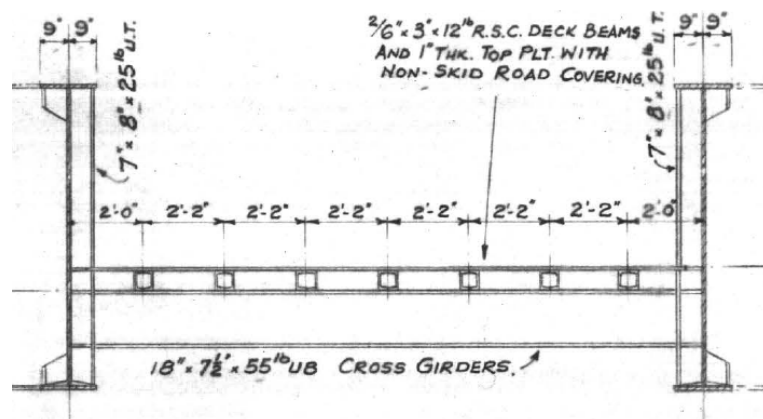
**Figure 2.4 :** Typical cross section of the linkspan.

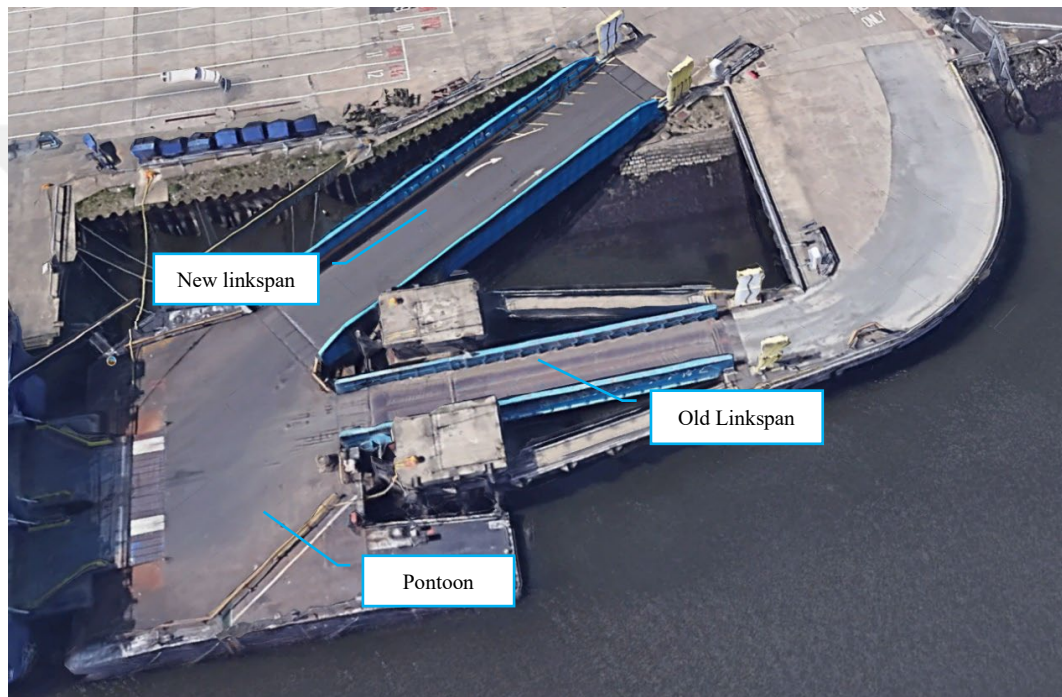
**Figure 3.1 : Location Plan.**

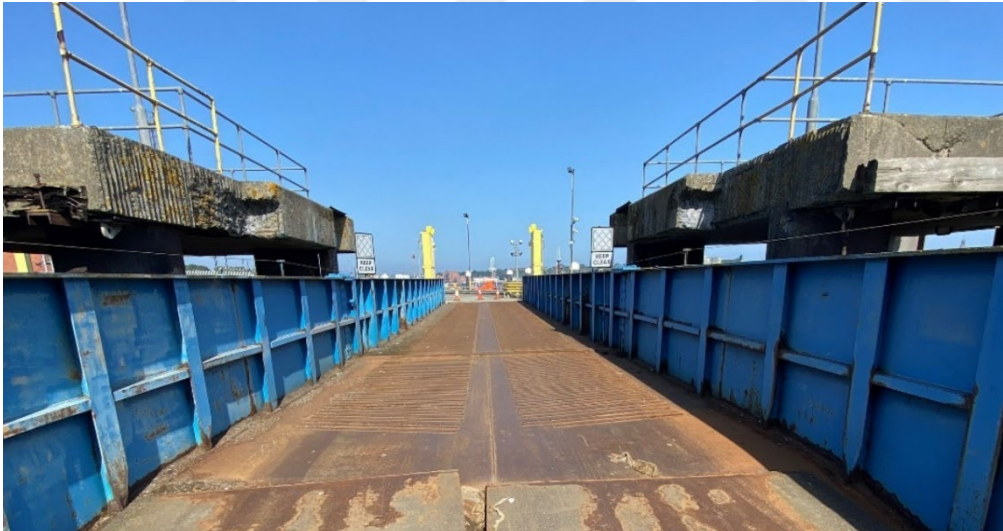
Figure 3.2 : Overall Condition of Deck Plate – Pontoon End.

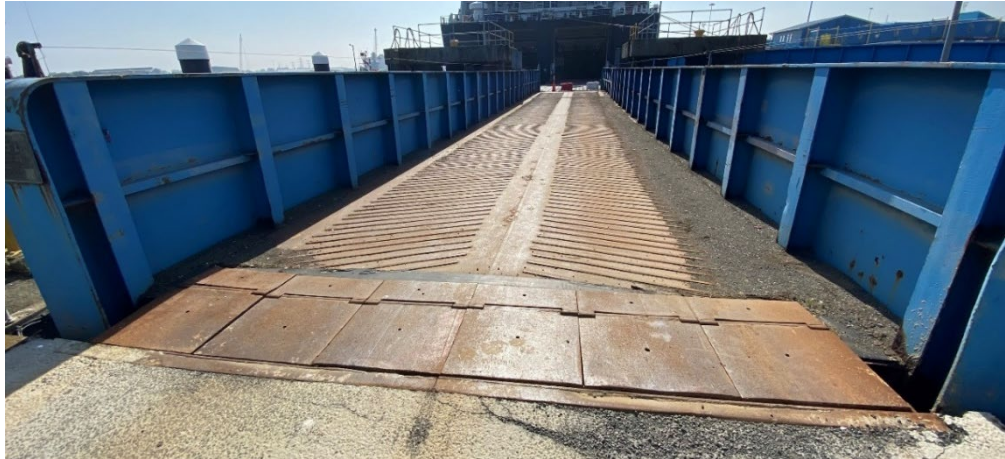
**Figure 3.3 :** Overall Condition of Deck Plate – Abutment End.

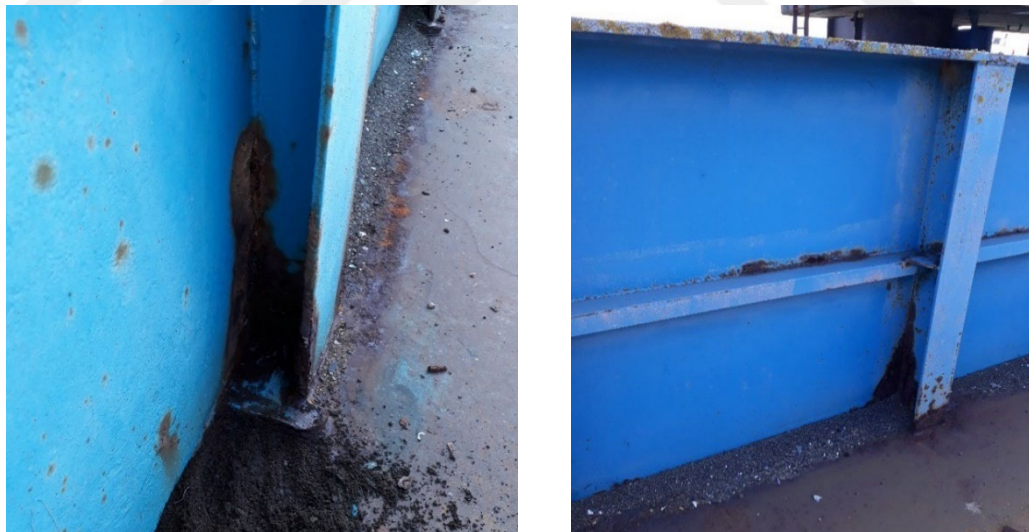
**Figure 3.4 :** Main Girder – Deck Plate Connections.

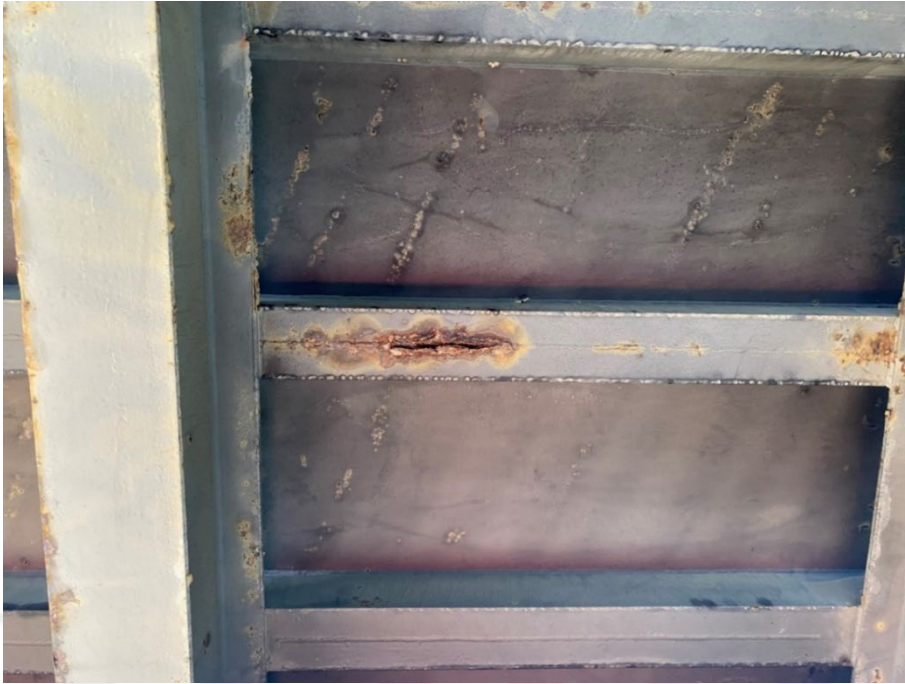
**Figure 3.5 :** Deck Soffit – Corrosion at Strip Locations.

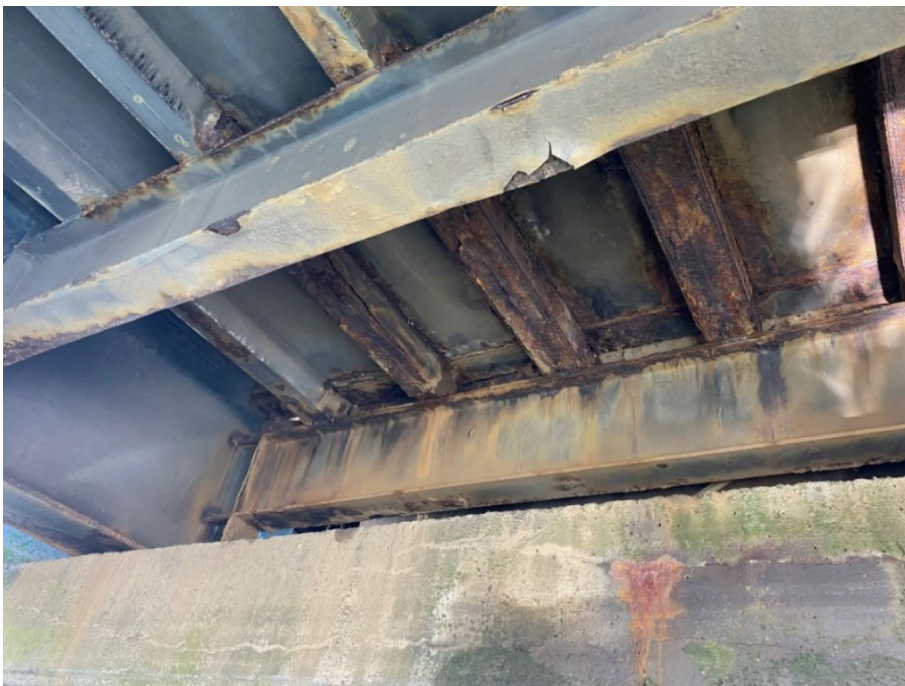
**Figure 3.6 :** Highly Corroded Longitudinal Stiffeners and Moderate Corrosion on Cross Girders at Abutment End.

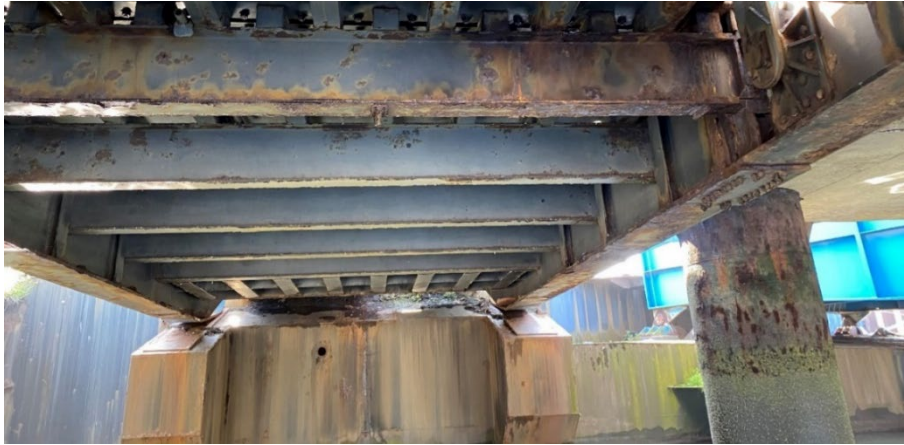
**Figure 3.7 :** Highly Corroded Cross Girder at Pontoon End.

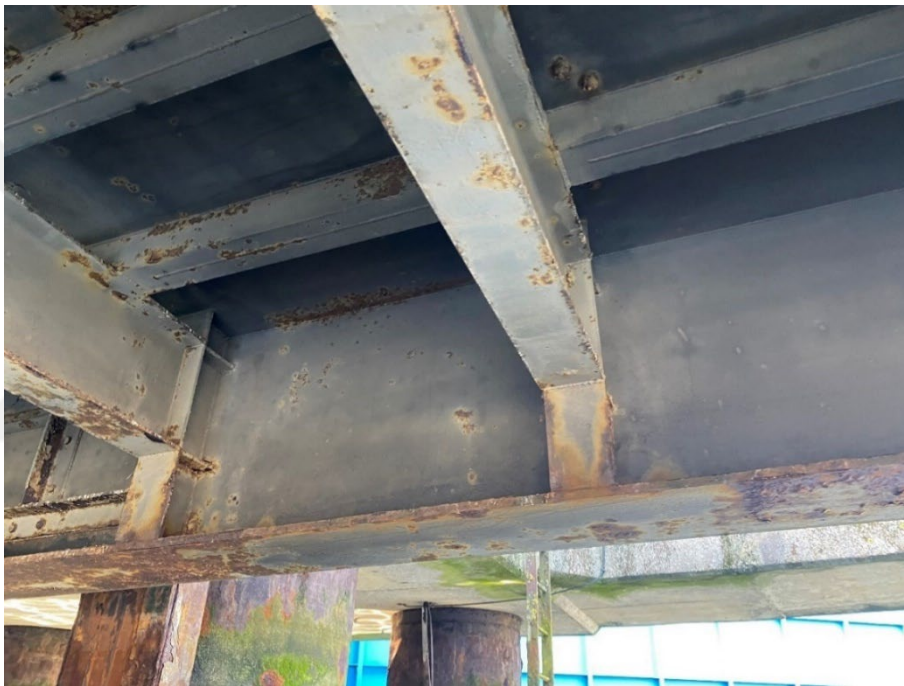
**Figure 3.8 :** General Attack Corrosion at Bottom Flange of Main Girder and Localised Corrosion at Cross Girders – Extension Area.

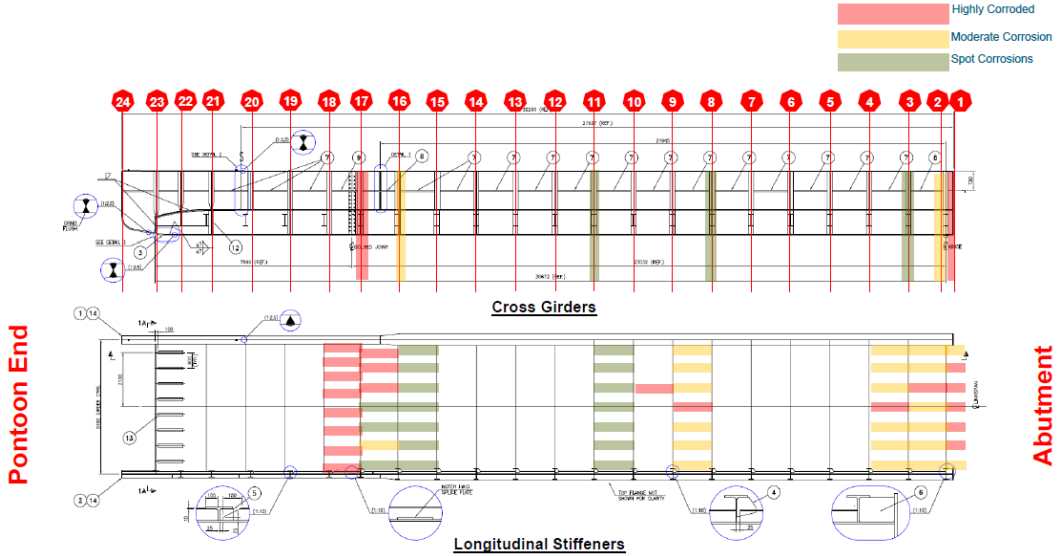
**Figure 3.9 : Defects Map.**

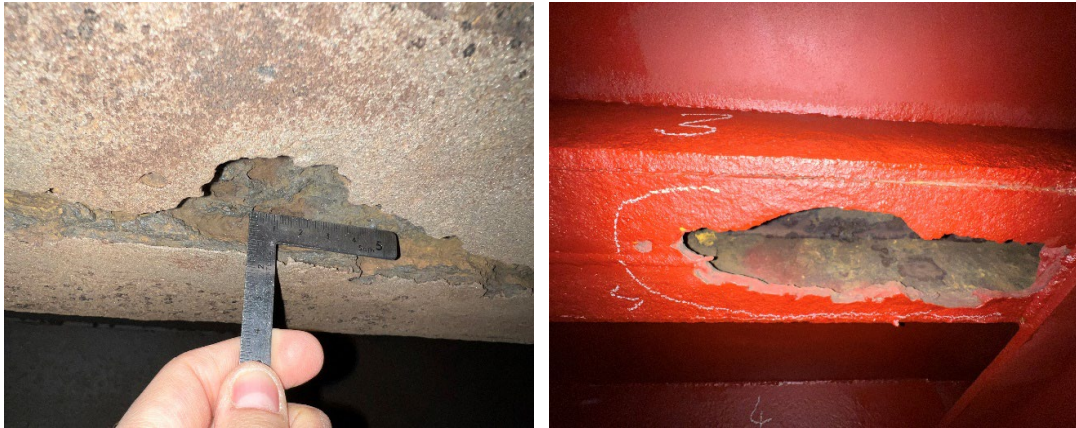
**Figure 3.10 :** Dimensional Inspection of Longitudinal Stiffeners.

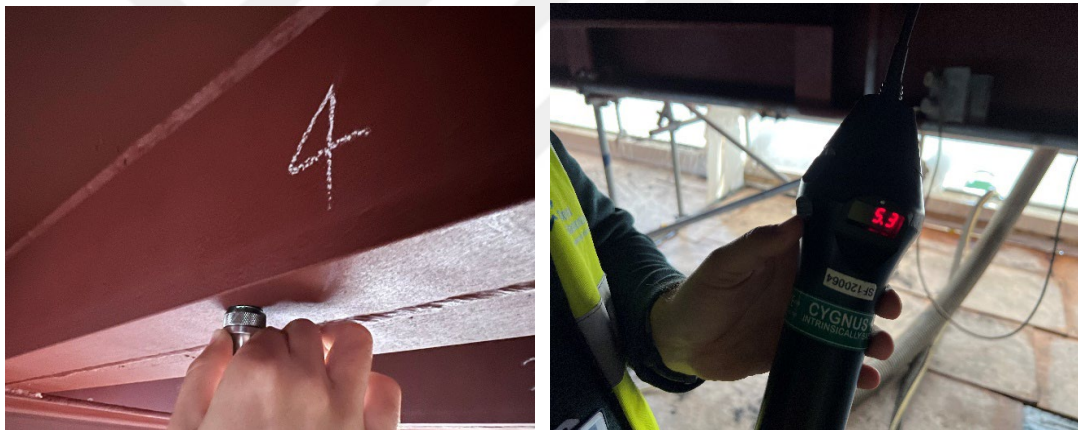
**Figure 3.11 :** UT Thickness Measurements on Longitudinal Stiffeners.

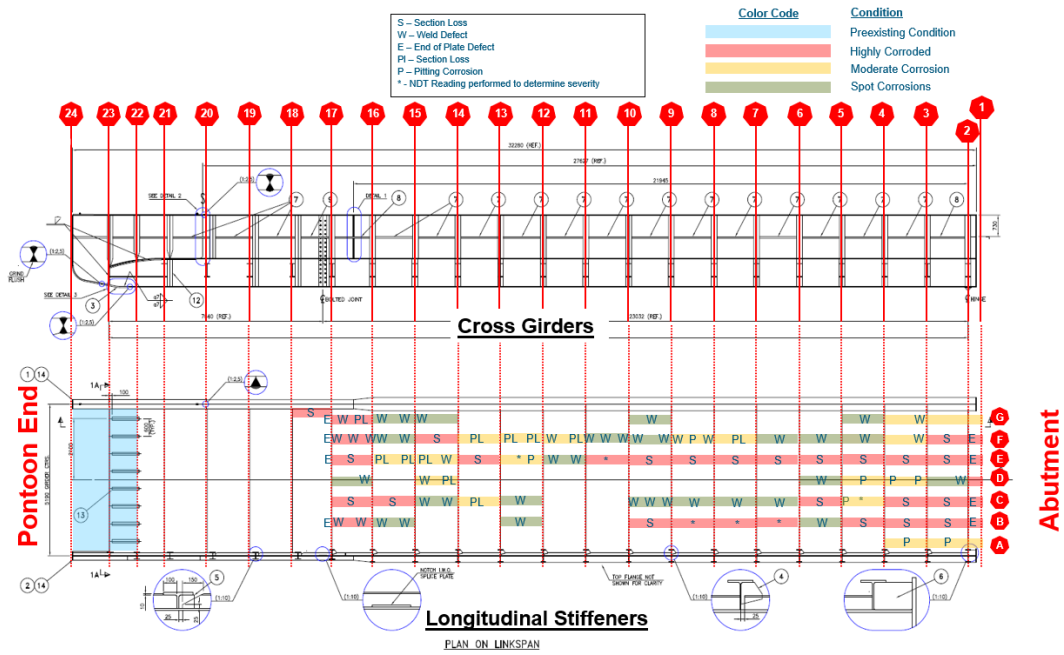
**Figure 3.12 : Defects Map Indicating Corrosion Levels.**

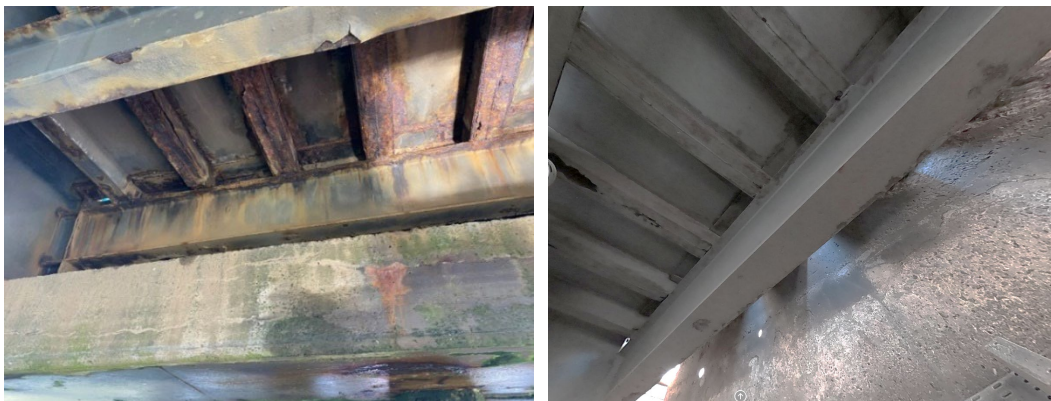
**Figure 3.13 : General corrosion of box section longitudinal stiffeners.**

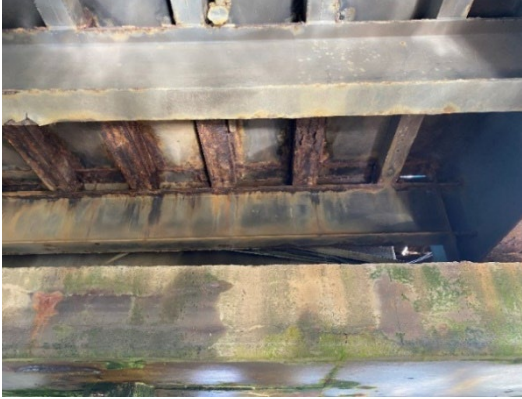
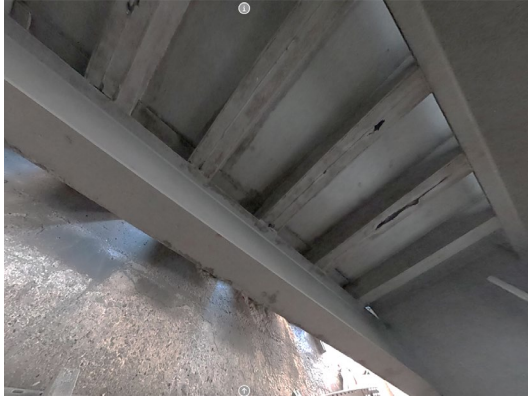
**Figure 3.14 :** General corrosion of box section longitudinal stiffeners.

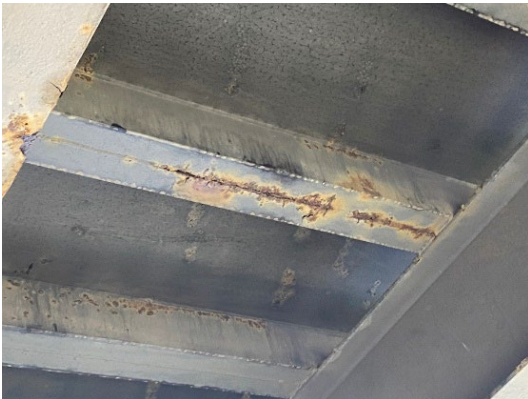
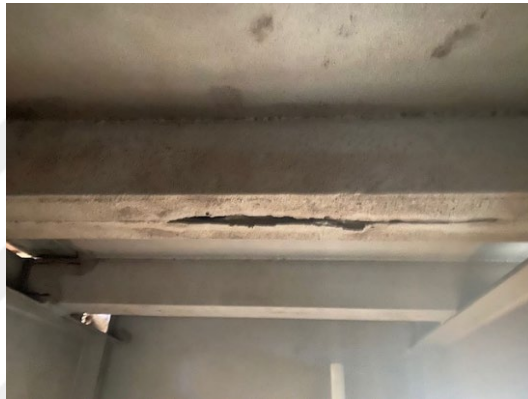
**Figure 3.15 :** Corrosion of seam weld on longitudinal stiffeners.

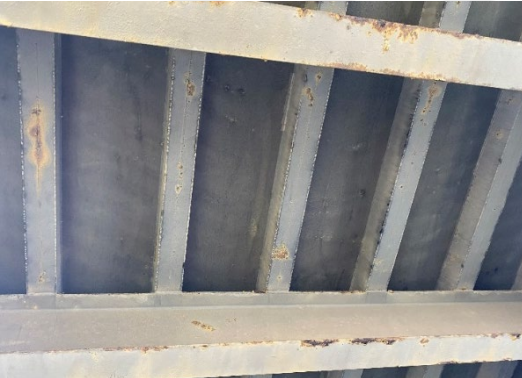
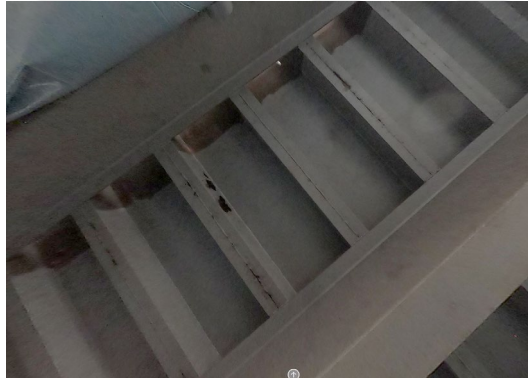
**Figure 3.16 :** Surface corrosion to transverse beams and longitudinal stiffeners.

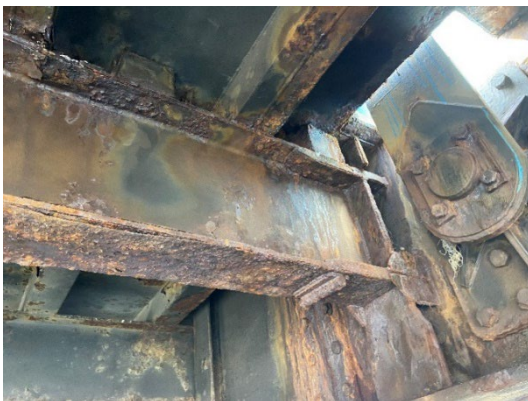
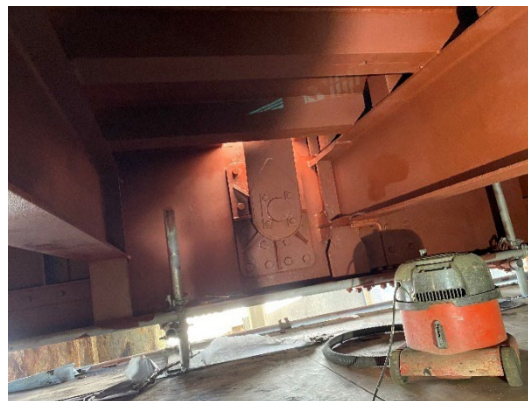
**Figure 3.17 :** Heavier corrosion beneath opening for redundant winching point.

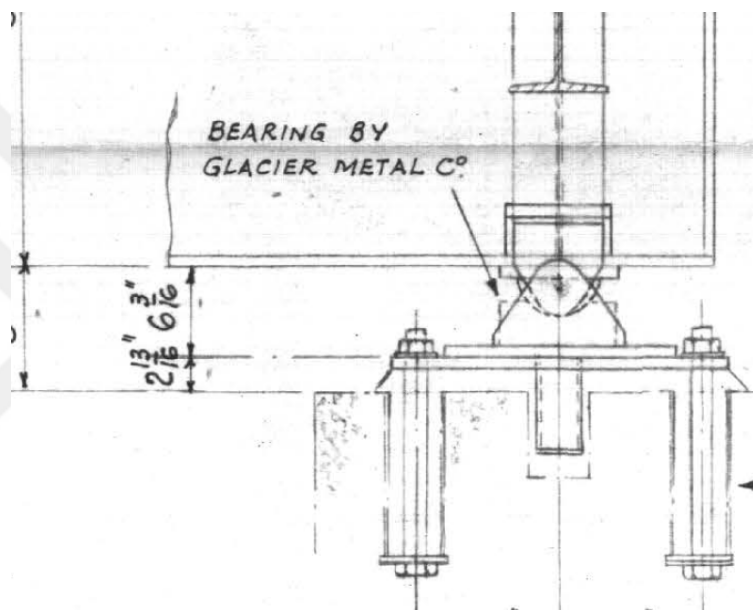
**Figure 4.13 :** Support condition at the shore end.

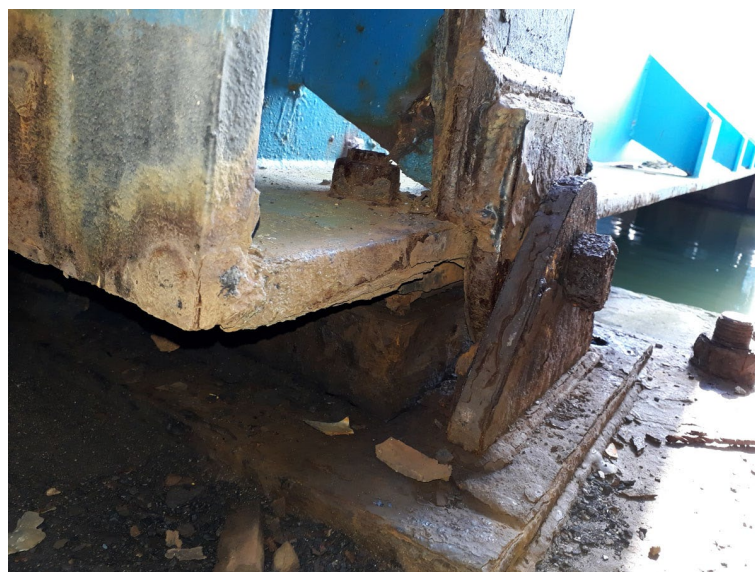
**Figure 4.14 :** Existing condition of bearings at the shore end.

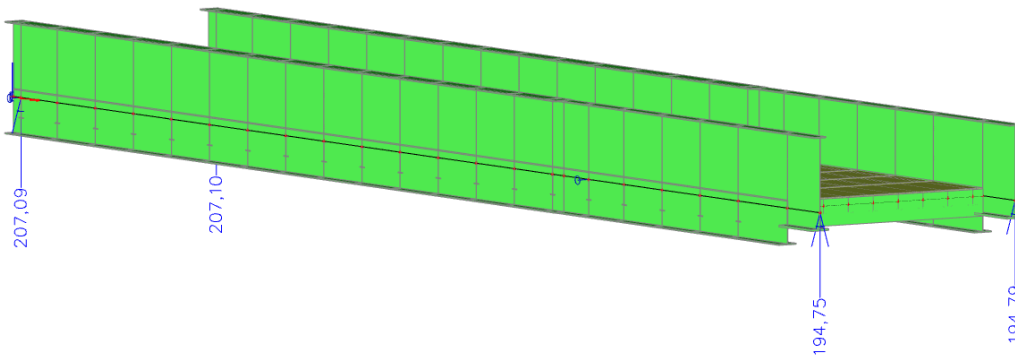
**Figure 4.18 :** Reaction forces from model for dead load of the structure.

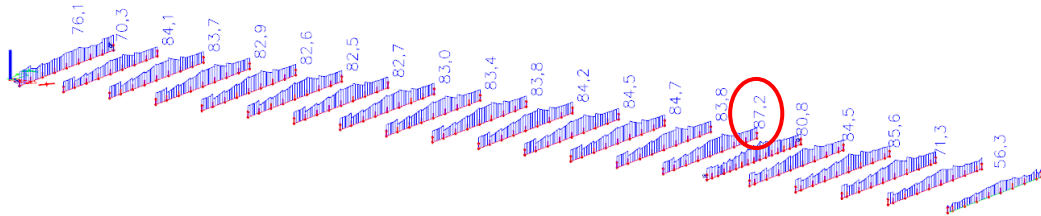
**Figure 5.2 :** Von Mises stress in the cross girders for ULS load combinations.

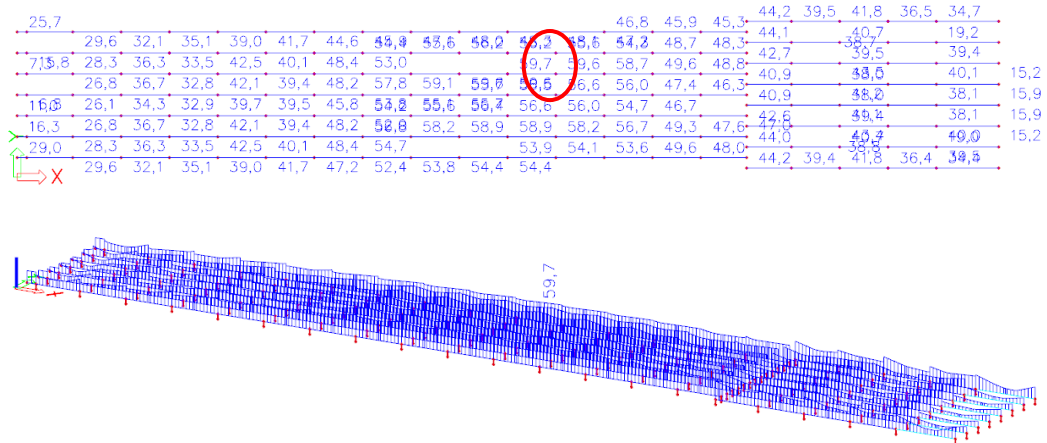
**Figure 5.3 :** Von Mises stress in the longitudinal stiffeners of the deck.

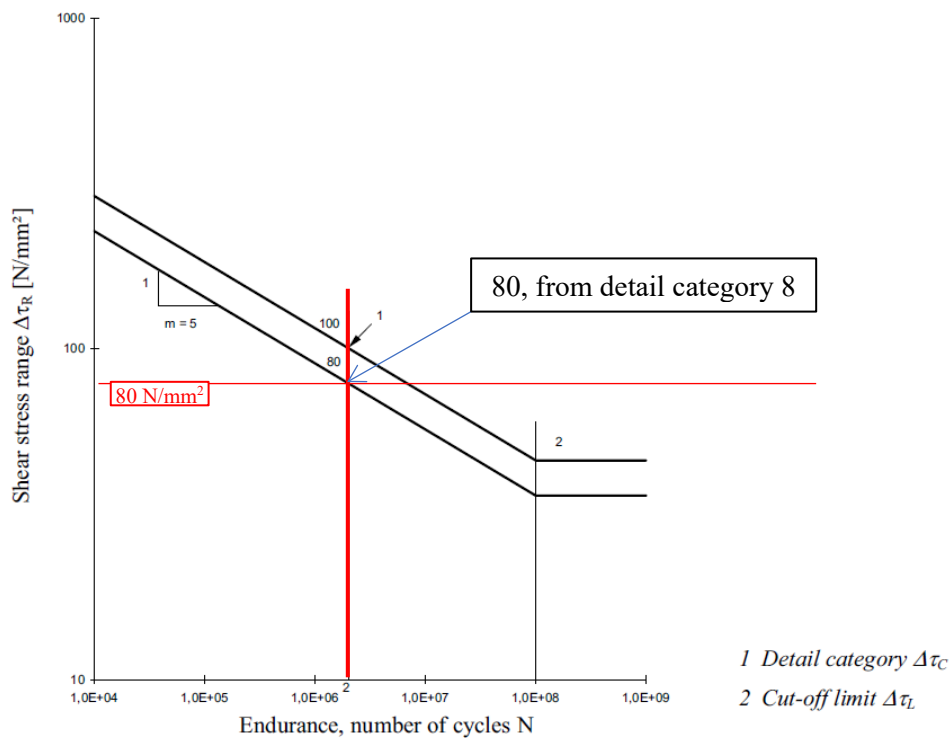
**Figure 6.8 :** Fatigue strength curves for shear stress ranges, BS EN 1993-1-9:2005.

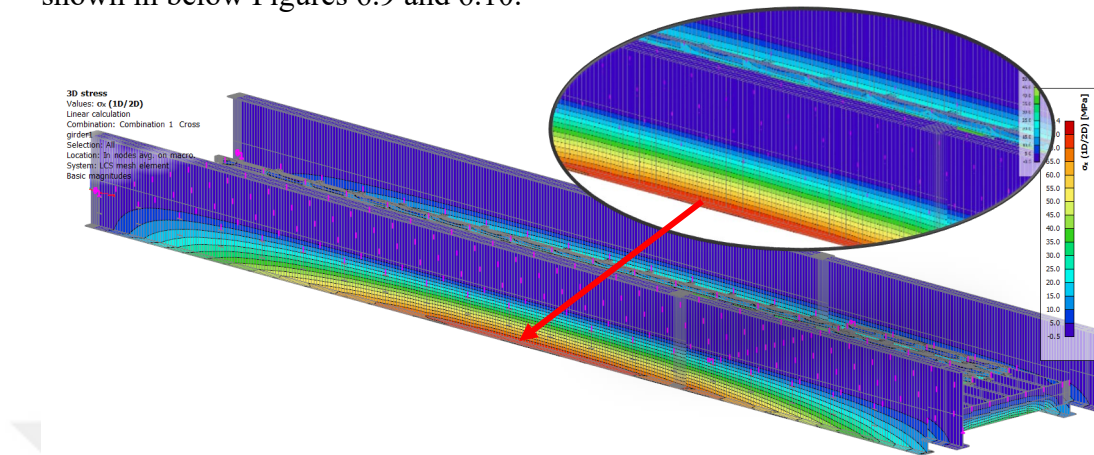
**Figure 6.9 :** Maximum Stress Results under Fatigue Load Model.

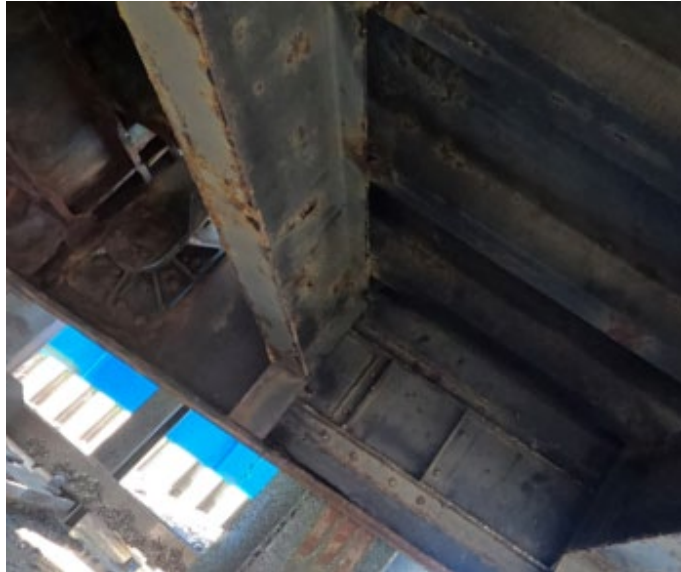
**Figure 7.1 :** Initial Condition of the Cross Girder and Longitudinal Stiffeners.

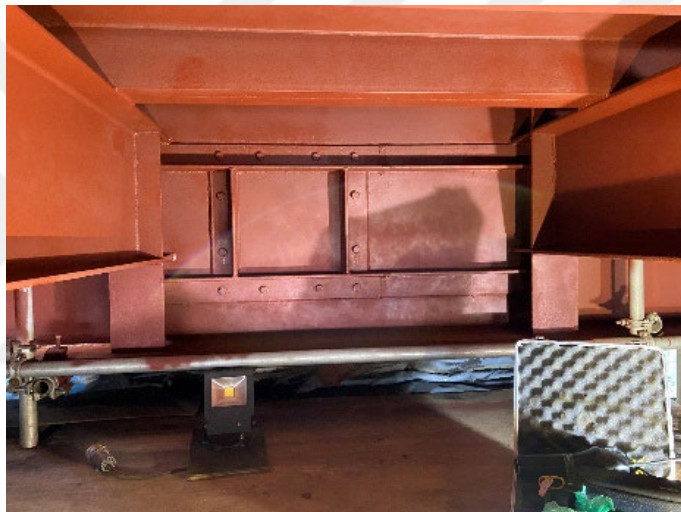
**Figure 7.2 :** Blasted and Shop Primed Condition of the Cross Girder and Longitudinal Stiffeners.

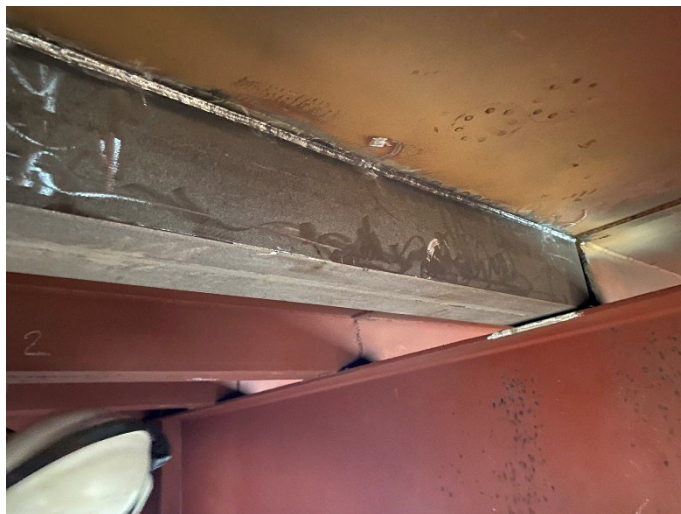
**Figure 7.3 :** Fit-up and welding of new longitudinal stiffeners.

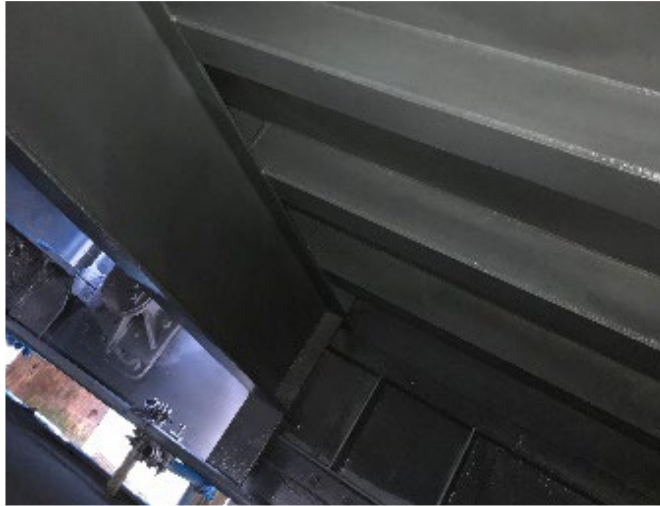
**Figure 7.4 :** Final Condition of the Cross Girder and Longitudinal Stiffeners after Like-a-like replacement.

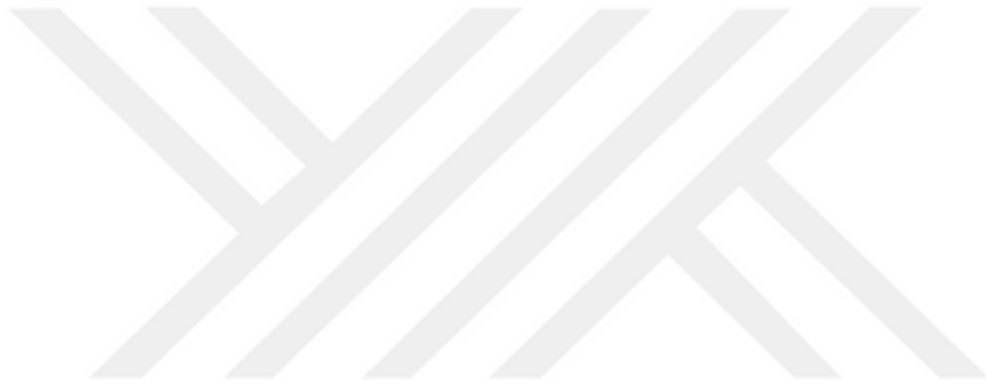
**APPENDIX A: Linkspan Drawings**

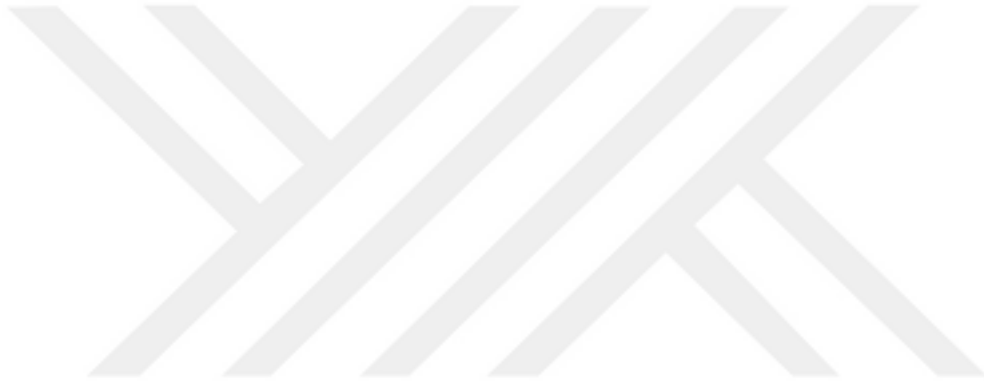
## **APPENDIX B: Structural Inspection Defects Map**

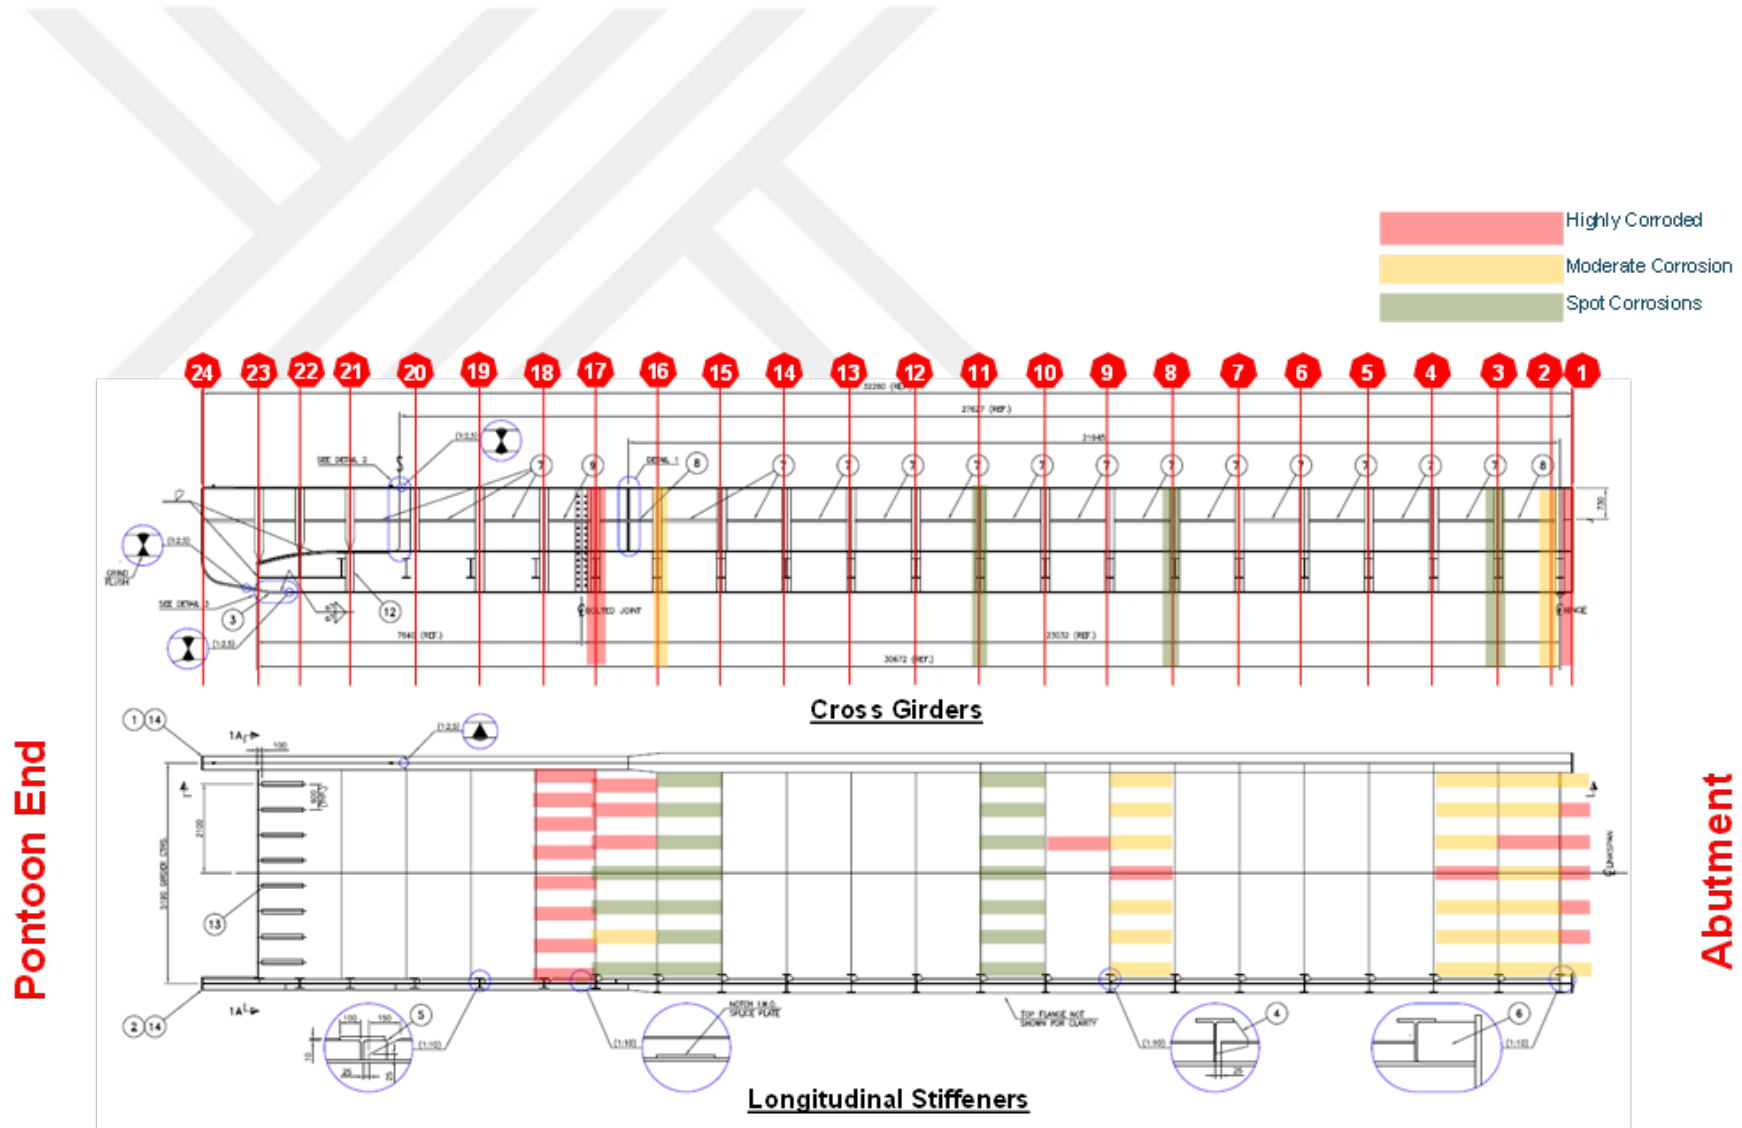
**Figure B.1 : Structural Inspection Initial Defects Map.**

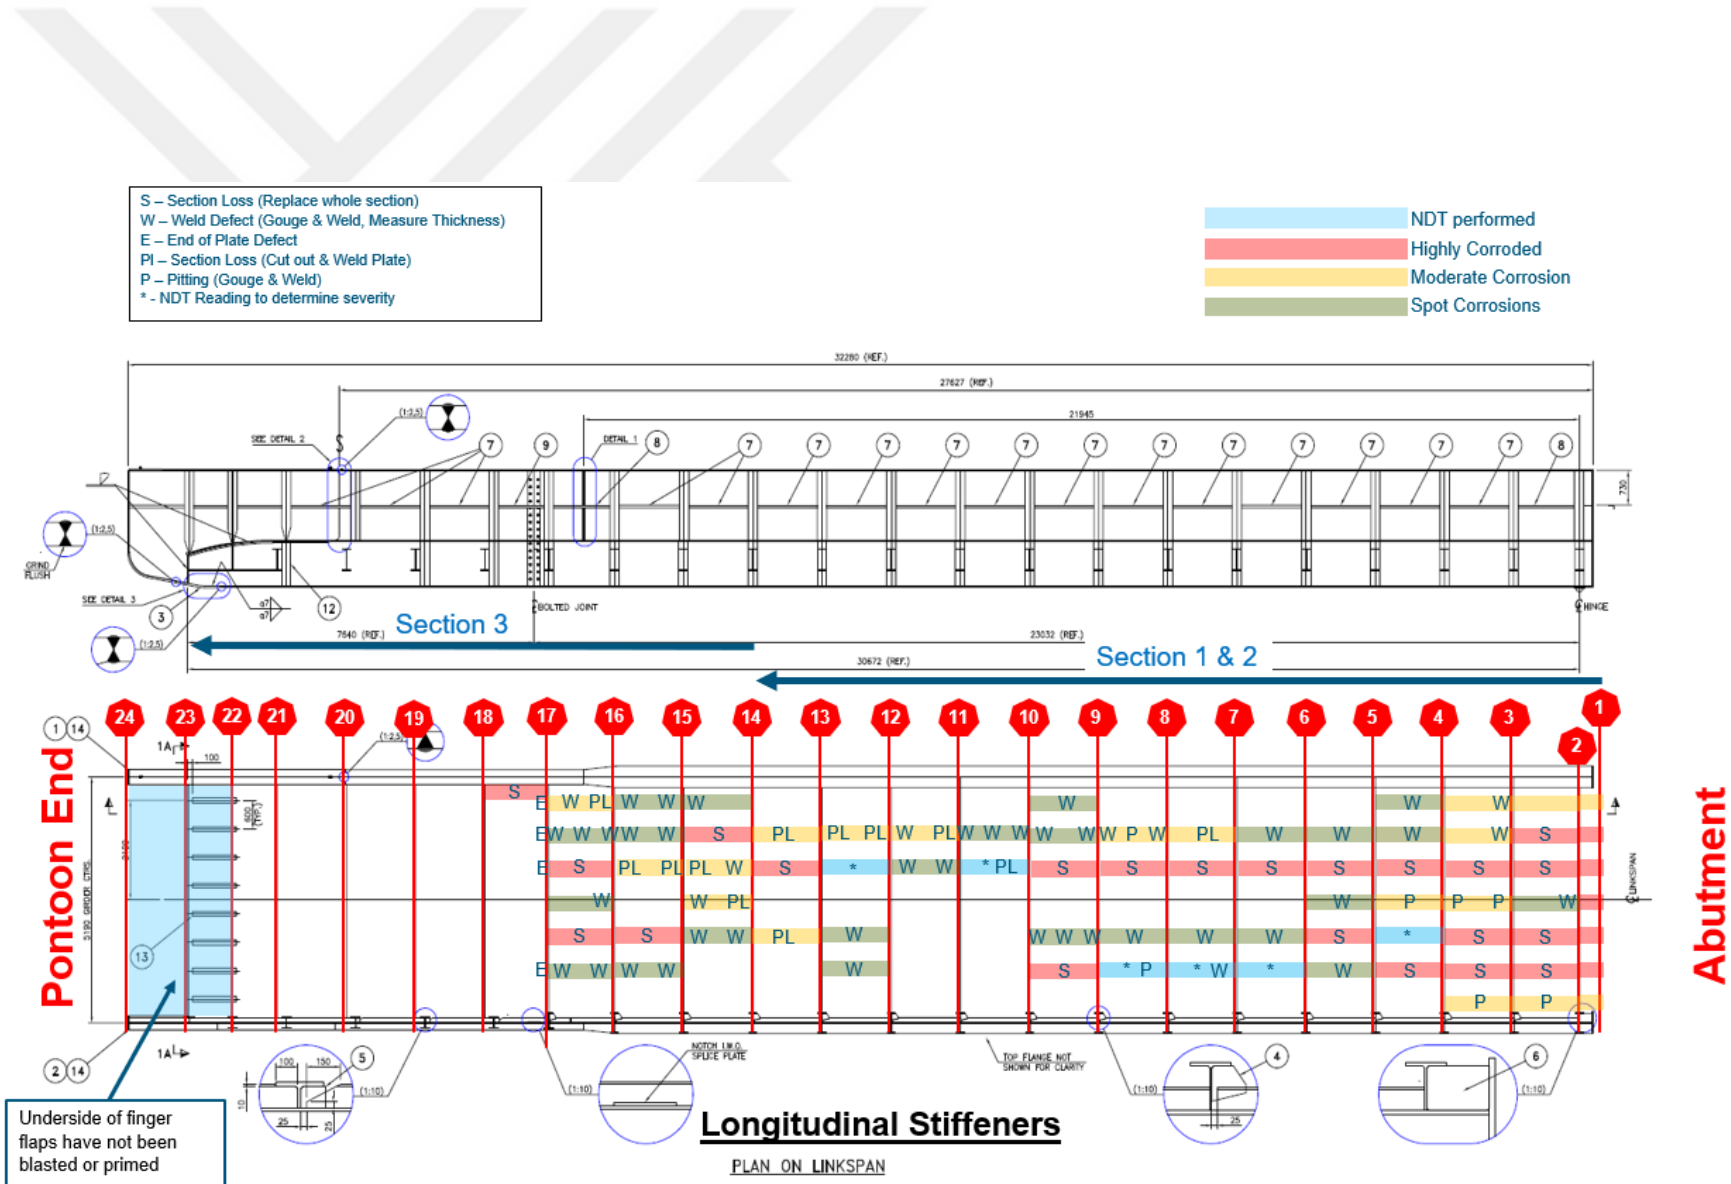
Figure B.2 : Structural Inspection Findings Updated Defect Map.

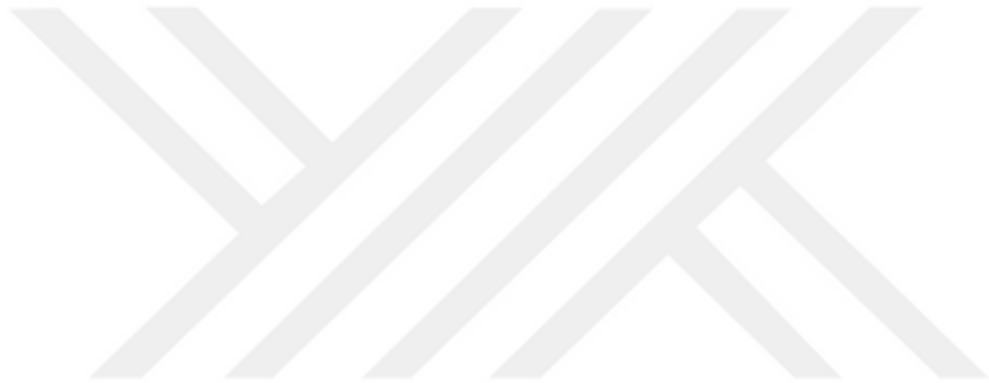
## **CURRICULUM VITAE**
