**EFFECTS OF BUILDING COLLAPSE DIRECTION  
AND BRIDGE FUNCTIONALITY ON ROAD  
NETWORKS FOLLOWING AN EARTHQUAKE**

**Ph.D. THESIS**

**Betül ERGÜN KONUKCU**

**Geomatics Engineering Department**

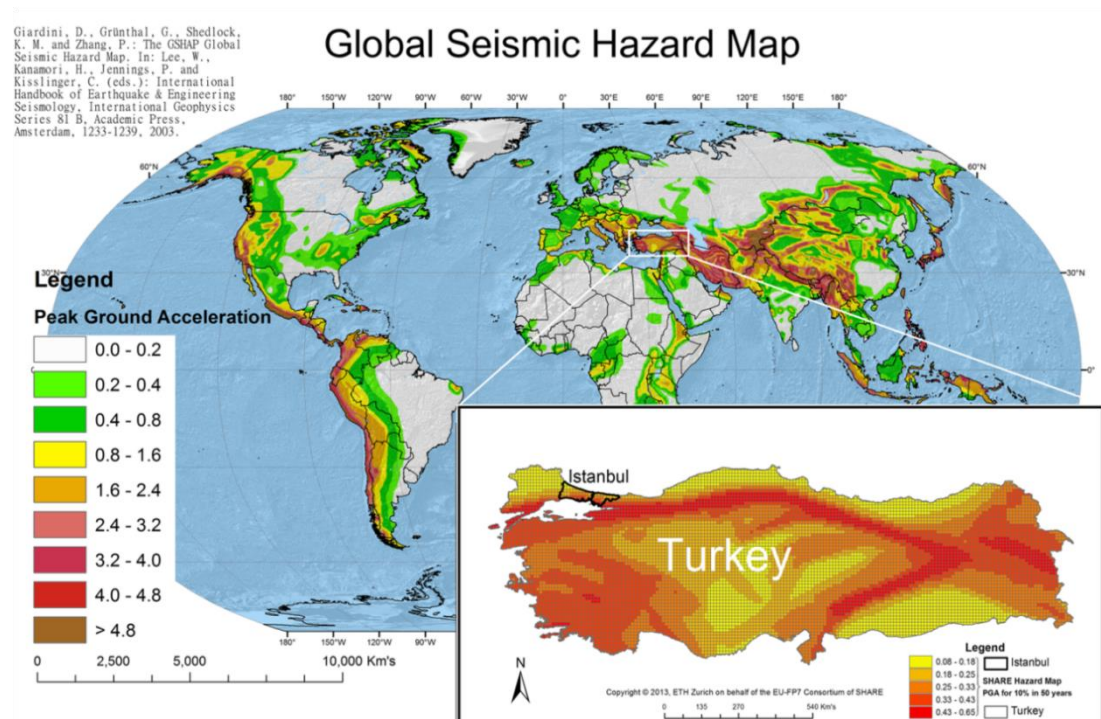
**Figure 1.1 :** Global seismic hazard map and location of the study area (Giardini et al. 2003; Karaman and Erden 2014).

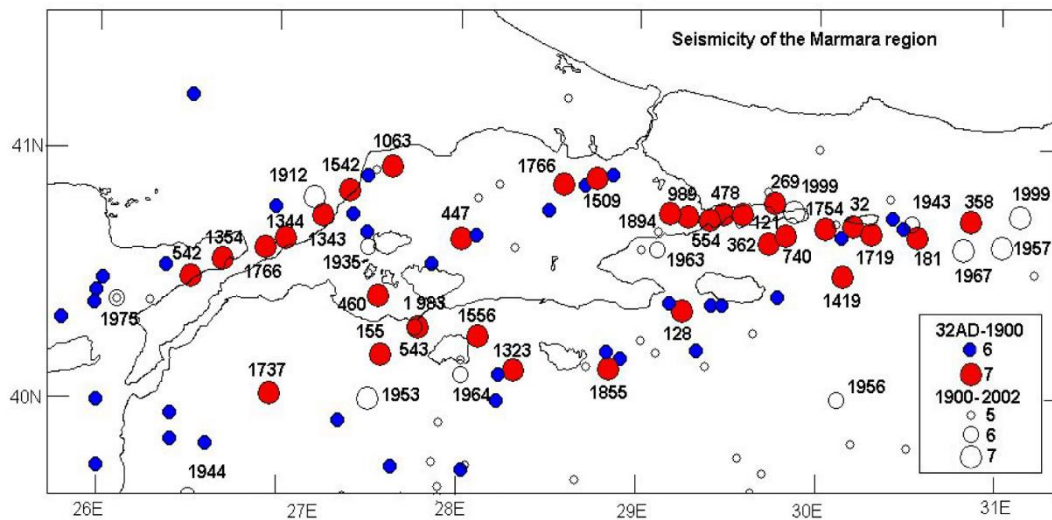
Istanbul has been affected by earthquakes throughout its history. Based on worldwide historical earthquake catalogues, Istanbul has suffered repeated damage due to earthquakes (Utsu, 1990). When the historical earthquake data of Istanbul is analysed, we see that the city has been affected by a moderate intensity earthquake every fifty years and a high intensity earthquake every 300 year (Ambraseys & Finkel, 1991) (Figure 1.2).

**Figure 1.2 :** Historical earthquakes of Marmara Region, (Ambraseys&Finkel, 1991).

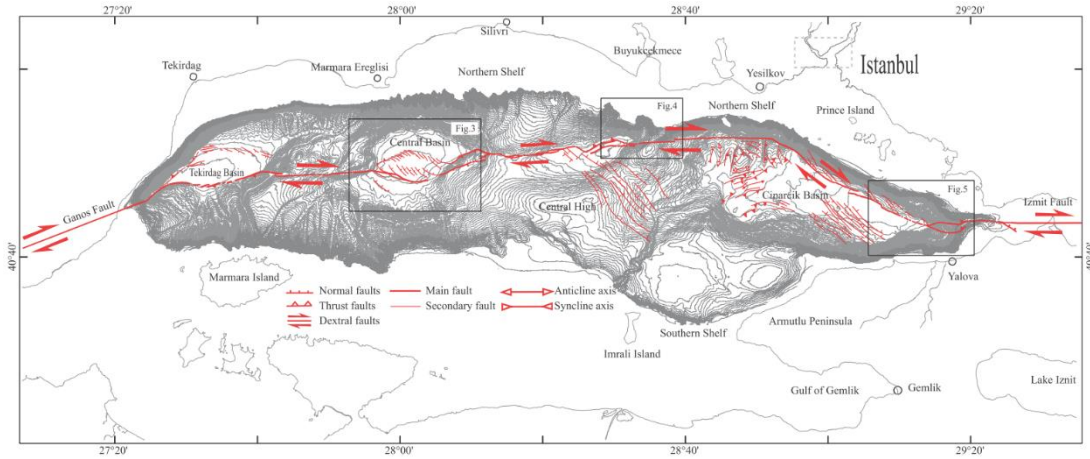
**Figure 1.3 :** Marmara fault model according to Le Pichon et. al, (2003).

Istanbul is going to face a major earthquake in the near future and this will cause severe damage to the built environment. Some of these studies have been made to determine the characteristics of the Marmara Fault. According to the works of Le Pichon, Chamot-Rooke, Rangin, and Sengör (2003); Rangin et al. (2001), the North Anatolian fault has been determined as a right-lateral fault which lengthens to the northern side of Marmara Sea (Figure 1.3).

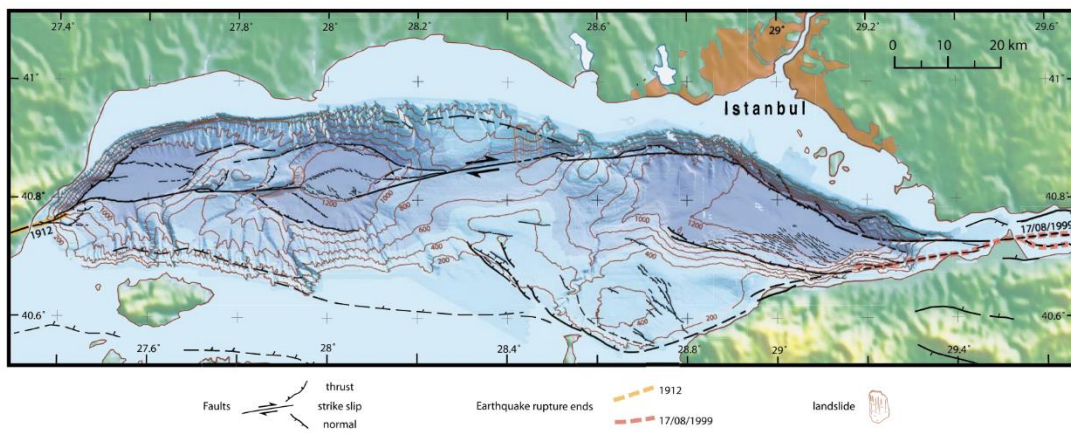
Regarding to another study made by Armijo, Meyer, Navarro, King, and Barka (2002); (2005), the Marmara Fault is considered as a complex structure including the Ganos pull-apart system and the Izmit lateral slip with normal faulting in the Cinarcik trench (Figure 1.4).

**Figure 1.4 :** Marmara fault model according to Armijo et. al, (2005).

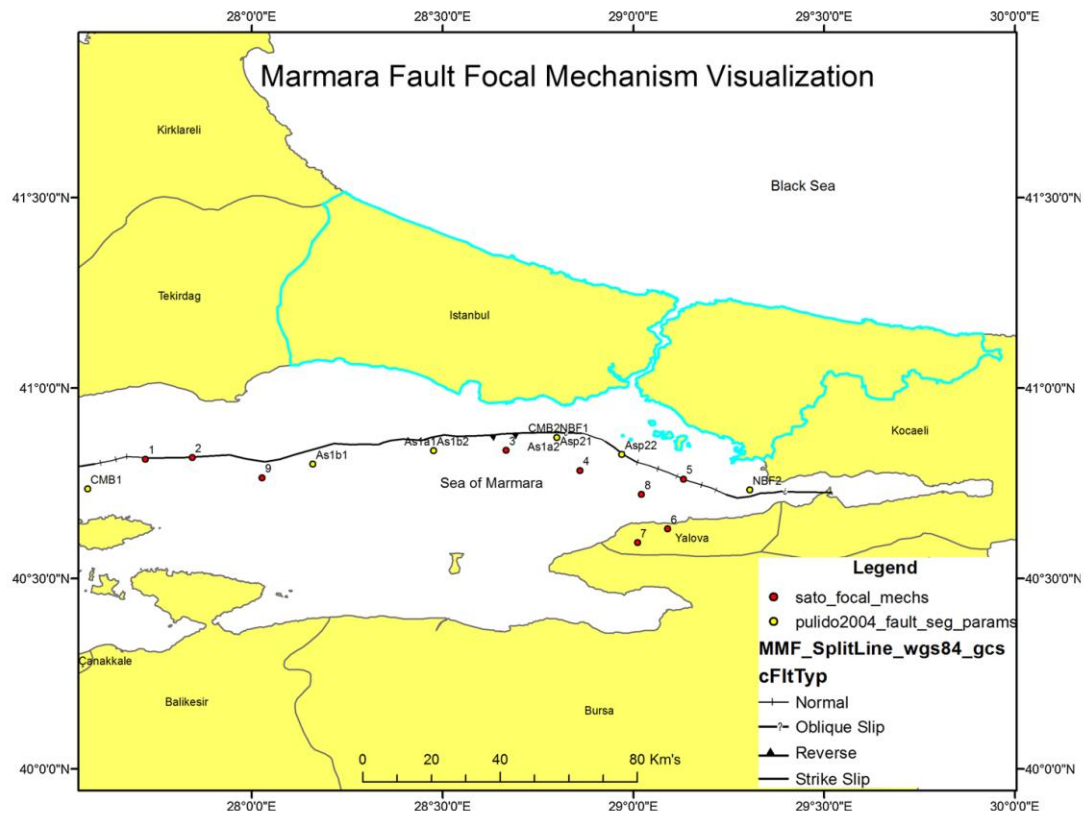
(2002) concludes that the region of Marmara Sea has been shaken by an earthquake of more than Mw 6.7 in the last 2000 years which caused serious devastation. According to Parsons (2004), the probability is between 29% and 66% of a Marmara earthquake with a magnitude of more than 7.0 occurring in the following 30 years. A study conducted by Karaman and Erden (2014) has combined all these studies about the fault mechanism for the Sea of Marmara (Figure 1.5) and combined all the separate fault mechanism results in one Marmara fault line map.

**Figure 1.5 :** Marmara fault focal mechanism visualization, (Karaman&Erden, 2014).

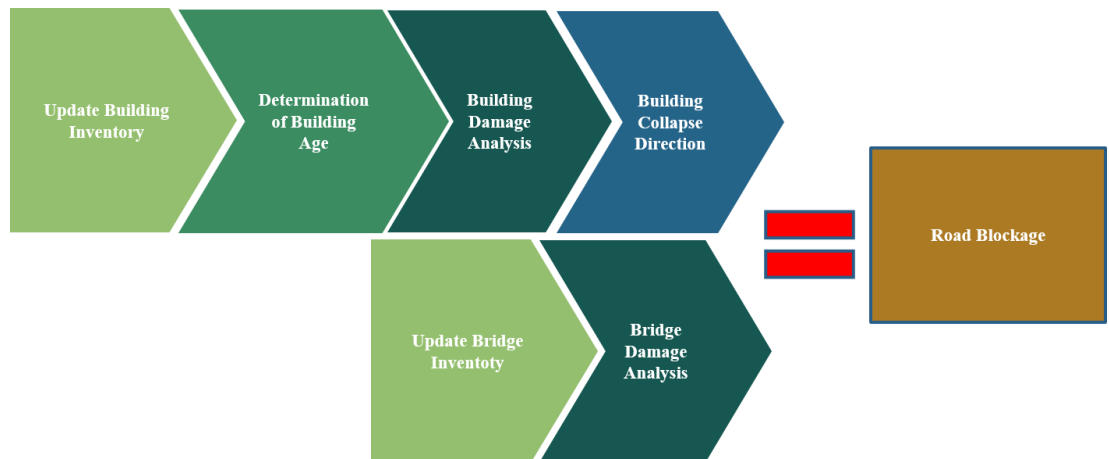
**Figure 1.6 :** Steps of determination road blockage in this study.

In order to determine building collapse direction in Istanbul a collapsed building in Gölcük during the 1999 Kocaeli earthquake was studied. According to this study, two methods for studying buildings collapse direction have been obtained and these two methods have been applied to the buildings in Istanbul that have damage possibility. In regard to the direction and distances of buildings collapse, we are going to determine the potential road blockage in Istanbul. The second step will then be to determine the bridge damage and functionality after an earthquake because, following an earthquake, non-functional bridges have cause roads to lose their accessibility. Firstly, recent bridge data was created from the paper data and then by using this update bridge data, bridge damage and functionality analysis were made. By combining these two data sets, the potential road blockage in Istanbul has been revealed (Figure 1.6).

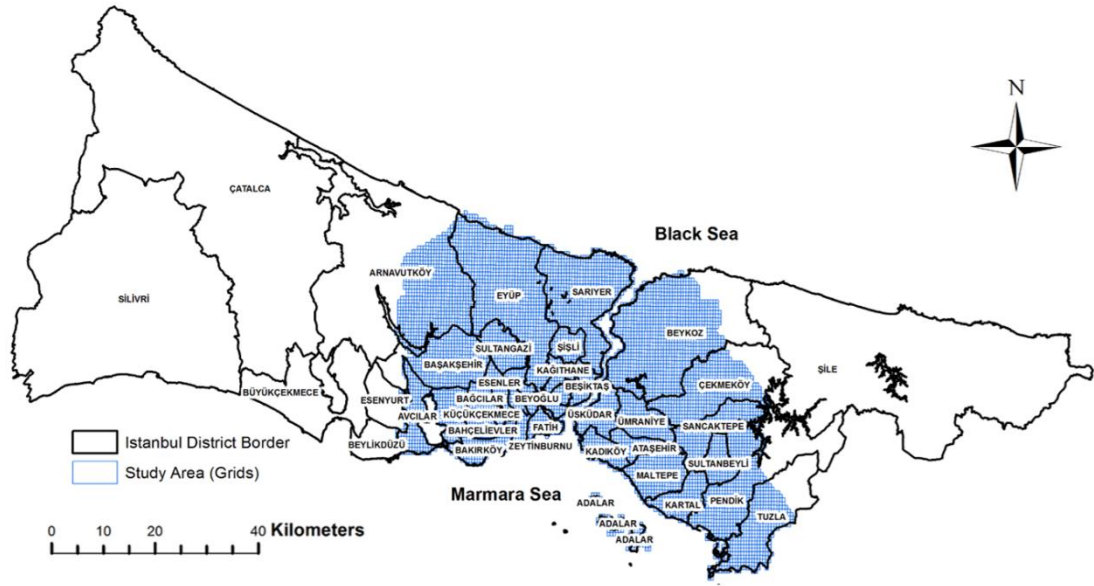
Building inventory of BU-ARC (2002) study was created by using aerial photographs from 1995 and 1999 (Figure 2.2) (BU-ARC, 2002). However, this data producing from aerial photographs does not contain building attributes information. For this reason, TUIK 2000 data (TUIK, 2014) (construction type, number of floors, construction year) was assigned to building inventory data by using a geocoding method in this study. Construction year data is divided into two classes: pre 1979; and post 1980. The study area divided into grids of approximately 400m x 600m (BU-ARC, 2002). Building age data cannot be acquired for every single building using the BU-ARC (2002) study. For this reason, it is impossible to obtain a building age from a BU-ARC (2002) study database based on every single building. In addition, this data was produced before 2000.

**Figure 2.2 :** The study area of BU-ARC project.

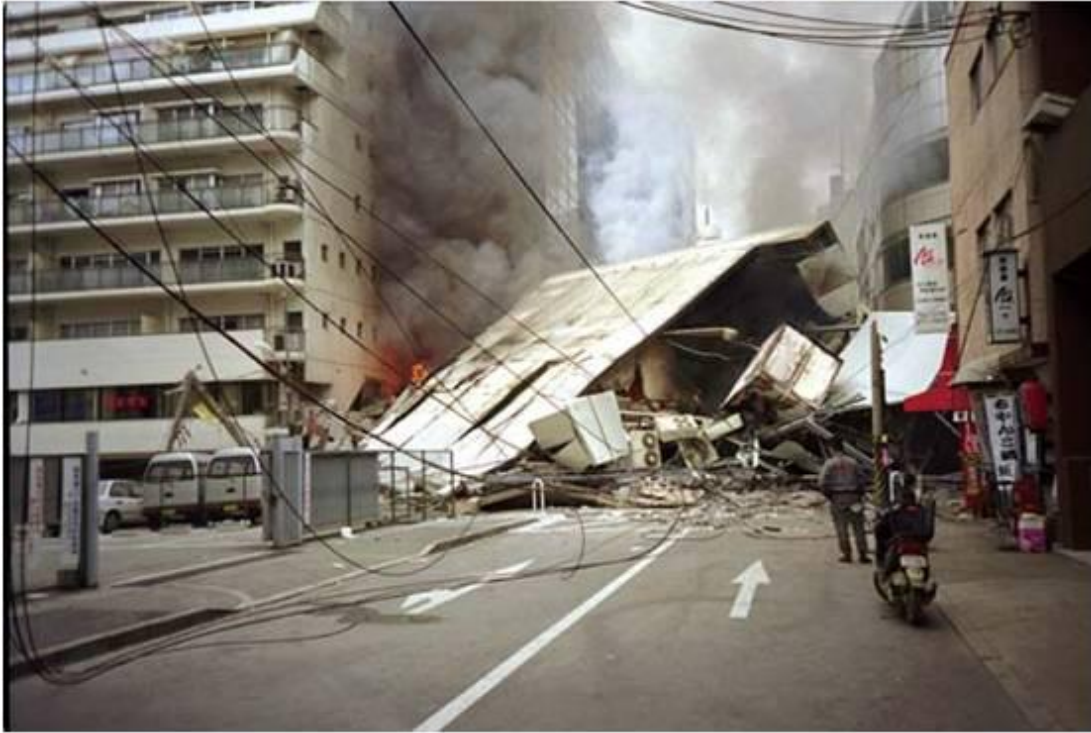
**Figure 2.3 :** Road blockage due to the building collapse from 1995 Kobe Earthquake, (2015).

Building damage is one of the highest causes of death and injuries during earthquakes. Besides this, the collapsed buildings can create debris around the buildings and this debris may cause road blockages in the vicinity of the damaged buildings, especially in narrow roads (Figure 2.3). Road blockages decrease road functionality during a disaster. The inability to use roads makes it difficult and impossible for some activities during the response and recovery time; such as search and rescue, firefighting and accessibility to temporary shelter areas. This situation could cause an increase in the number of deaths and injuries. For this reason, it is important to define the direction of building collapse during the earthquake.

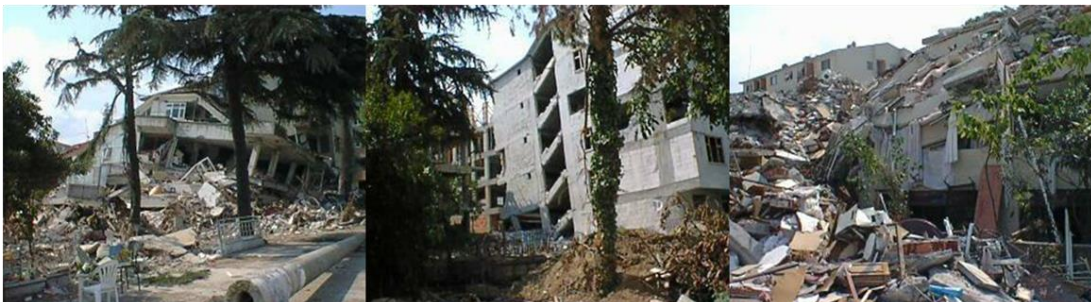
**Figure 2.4 :** Collapsed buildings photo from Gölcük.

In this part of the study, we have estimated the building collapse direction and debris spreading distance (debris area radius of buildings) of collapsed buildings for the buildings in Istanbul, which have the possibility of damage during the potential Istanbul earthquake. One of the basic methods for determining “building collapse direction” is to reveal the road blockages and then road functionality after an earthquake in order to identify open roads and suitable response routes. This method of definition building collapse direction was developed for Gölcük based on the investigations of collapsed buildings after the 1999 Kocaeli earthquake. It used the 1994 and 1999 aerial images of Gölcük, where the highest amount of buildings collapsed in various directions (Figure 2.4).

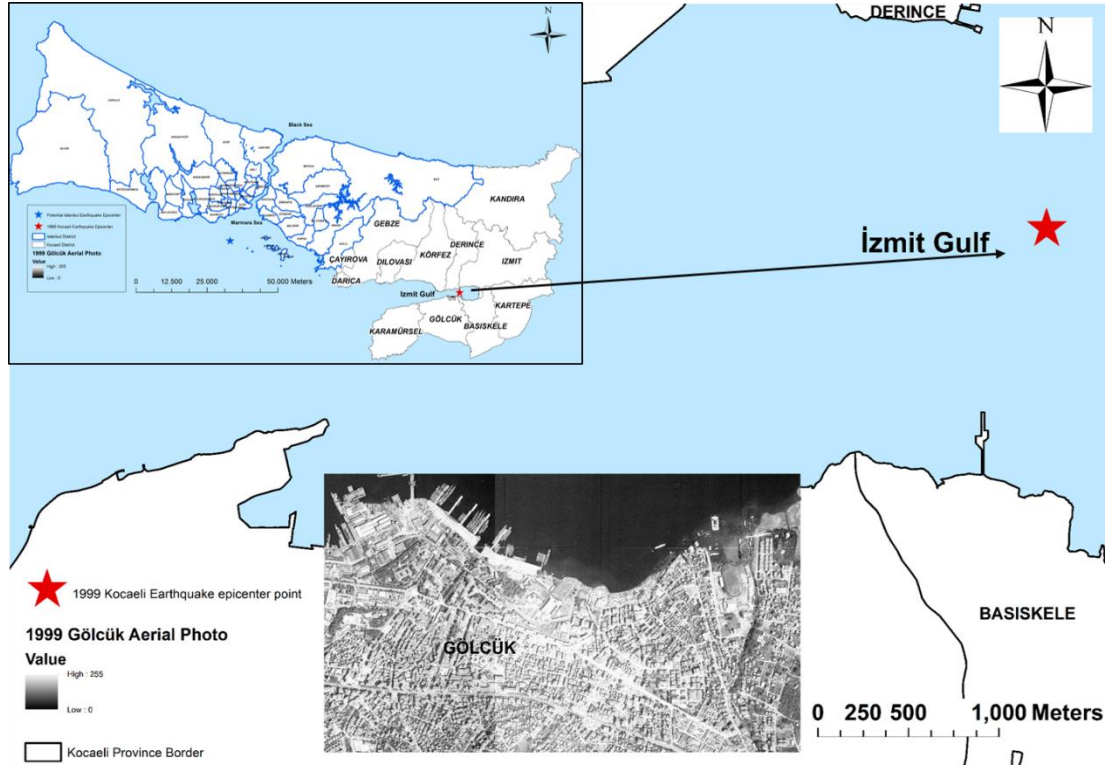
Gölcük has been chosen as a study area for this developing method. According to Özmen (2000), 35.7 % of buildings in Gölcük were heavily damaged, while 5,025 people died in Gölcük because of the 1999 Izmit Earthquake. The study area in Gölcük is located to the northeast of the Gölcük district of the Kocaeli province (Figure 2.5).

**Figure 2.5 :** Study area in Gölcük.

As seen in Figure 2.5, the 1999 Kocaeli Earthquake Epicenter was located in the north east part of Gölcük. However, the location of a potential Istanbul earthquake epicenter is estimated to be in the southern part of the city. To make an affinity between Gölcük and Istanbul, there should be a spatial conformity between the epicenter location and the building inventory belonging to both samples. In the circumstances, it was approved for us to use the Near angle references, which was the nearest axis, instead of the azimuth angle referencing fixed north axis during the affinity. For this reason, the process of transformation from the Near angle to azimuth angle mentioned in previous section was used here.

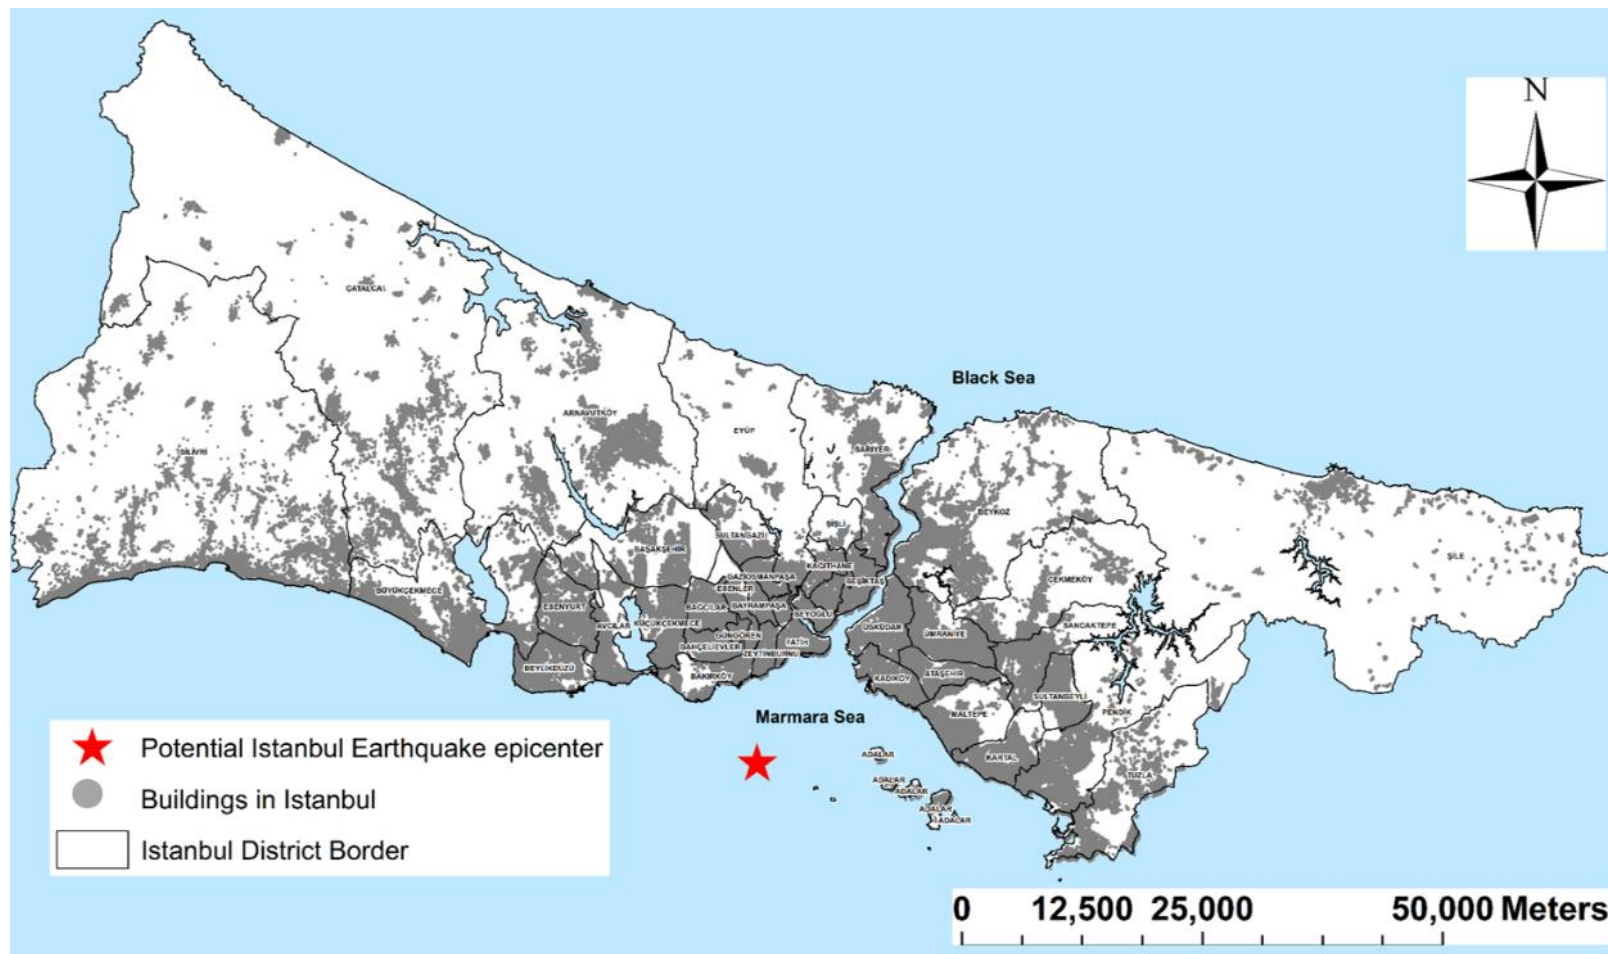
Up to now all of the building damage estimations for Istanbul used that structure data instead of the building data. This study used the building data generated from the structure data of ADNKS. Thus, the number of buildings in Istanbul determined as 990,584 for the year of 2013. This data set consists of location, construction type, number of floors and building usage. These data was also used to determine the building age as a 2013 data (Figure 4.1).

**Figure 4.1 :** Buildings distribution in Istanbul.

It was determined that there were 990584 buildings in Istanbul in 2013 (Figure 4.1). In order to determine the potential collapsed building spreading direction and distance, it was necessary to calculate the building damage possibility for every single building in Istanbul against the anticipated Istanbul earthquake risk.

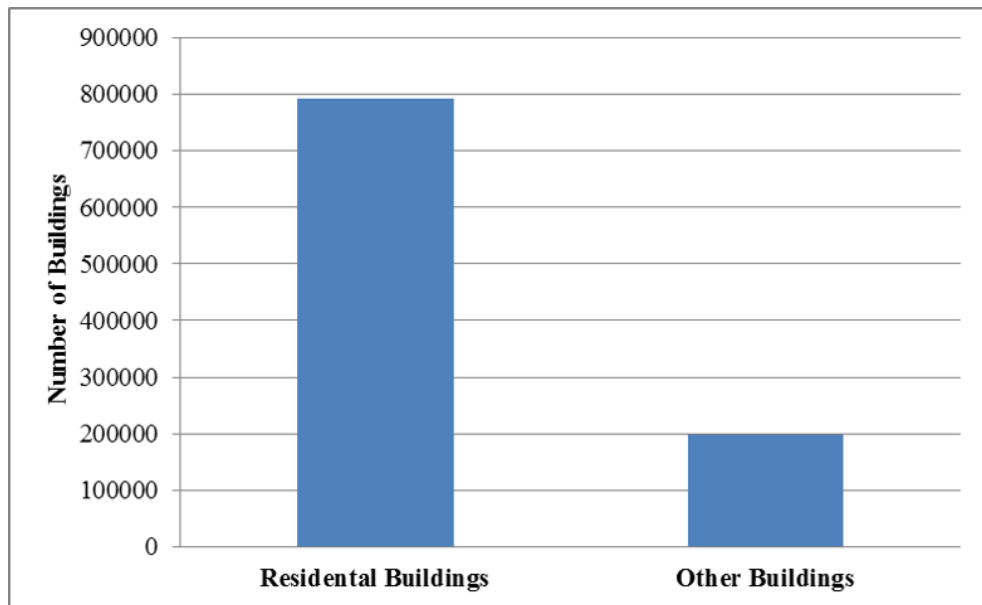
This database field names were reclassified in order to be suitable for damage analysis with HAZTURK. When the buildings in Istanbul were examined with regard to usage types, more than 80% of the buildings are used as residential buildings (Figure 4.2).

**Figure 4.2 :** Building occupancy classes in Istanbul.

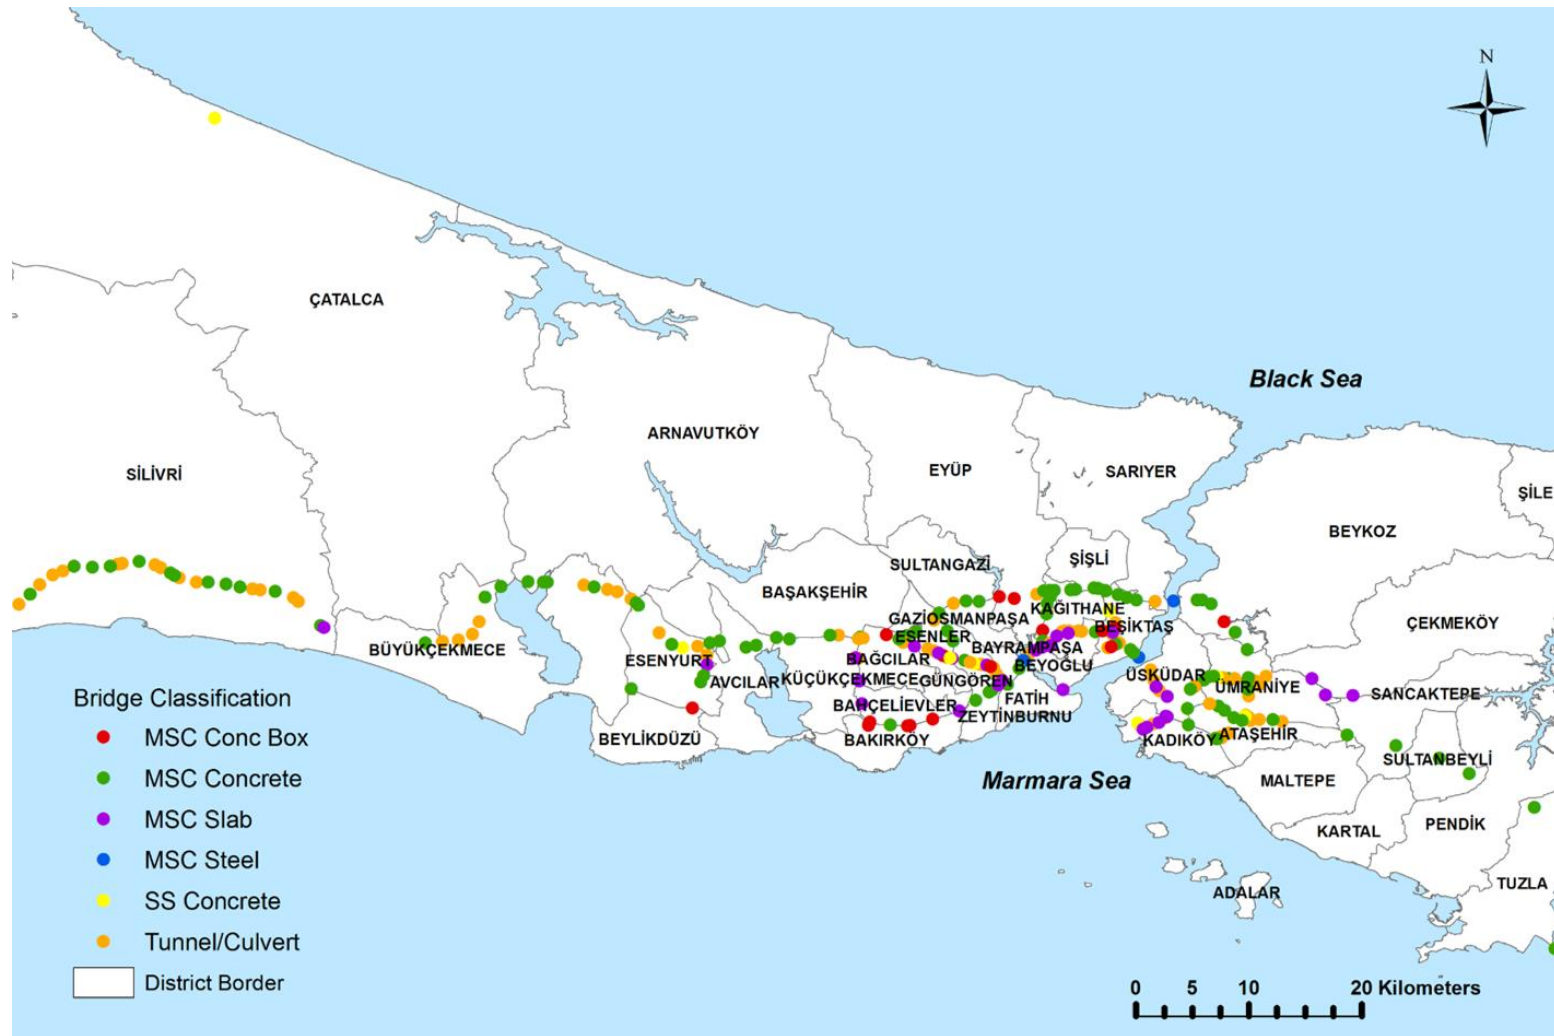
Every bridge has been classified according to Bridge classification given in Table 4.11 by using their attributes. This classifications describes the bridges according to their span configuration – simply supported (SS), multi-span simply supported (MSSS), multi-span continuous (MSC) – and their girder material type – concrete or steel. The distribution of bridge classification in Istanbul is given in Figure 4.3.

**Figure 4.3 :** Distribution of bridge classification in Istanbul .

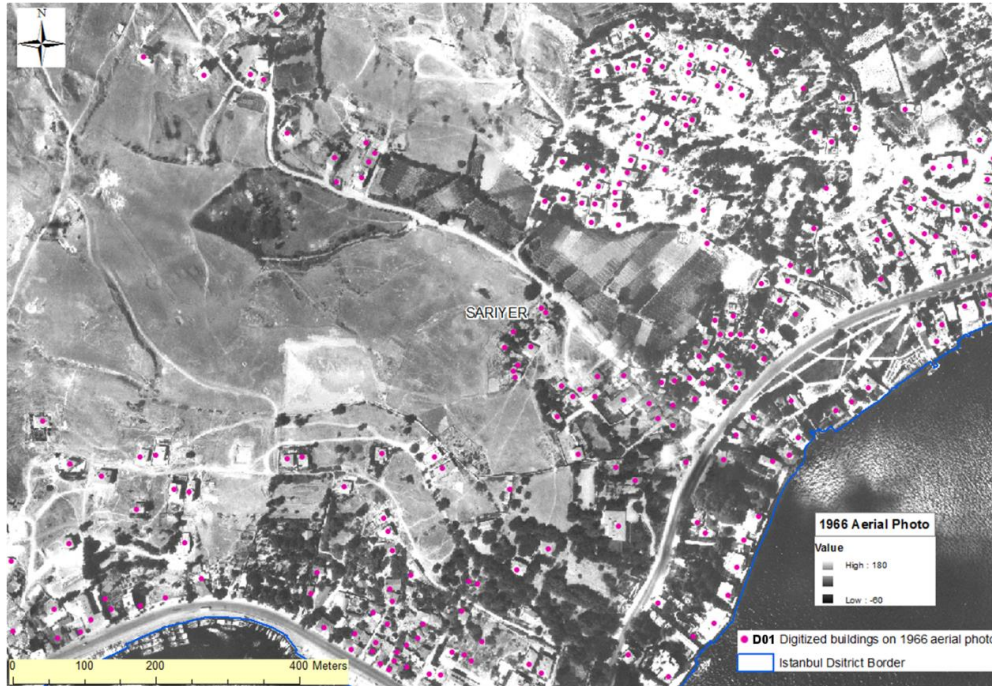
data format and data type was selected as point. The first digitized aerial or satellite image year was named as D01 (Figure 5.2).

**Figure 5.2 :** Digitized buildings in Sariyer district by using 1966 Aerial image.

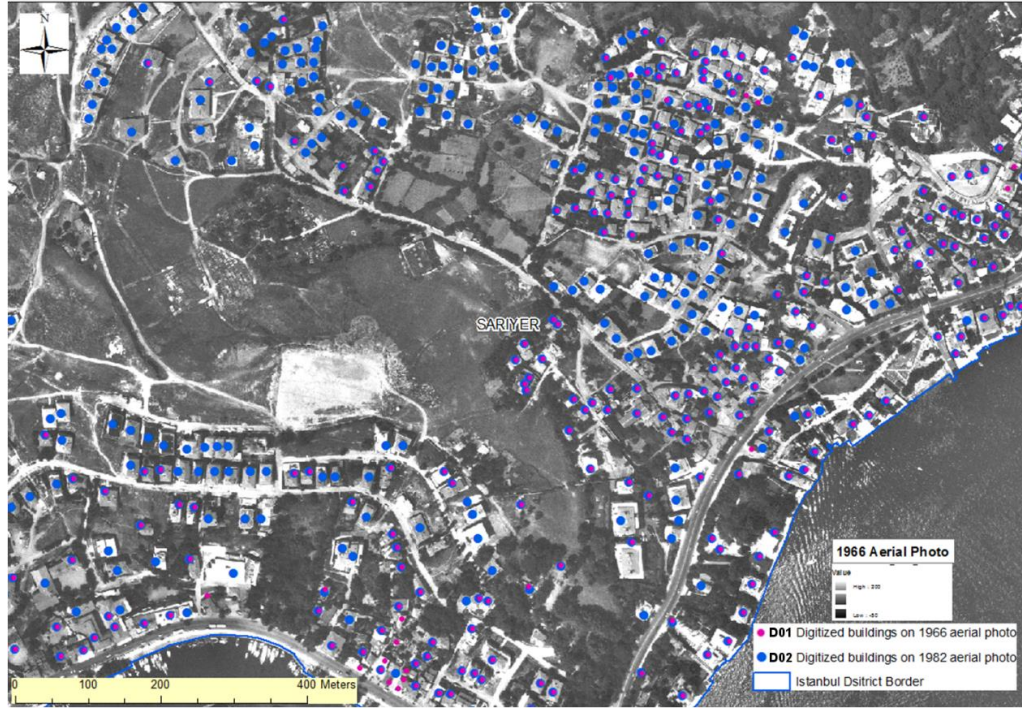
Then the ending years' image has been digitized based on the previous steps and named as D02. Following the digitisation of two end of an assigned code level, the D02 was used as a base map to compare the beginning and the ending years' images building data. D01 and D02 building data were compared using the spatial join tool to bind two different version of same data according to spatial characteristics on ArcMap software (Figure 5.3).

**Figure 5.3 :** Digitized buildings in Sariyer district by using 1982 Aerial Image.

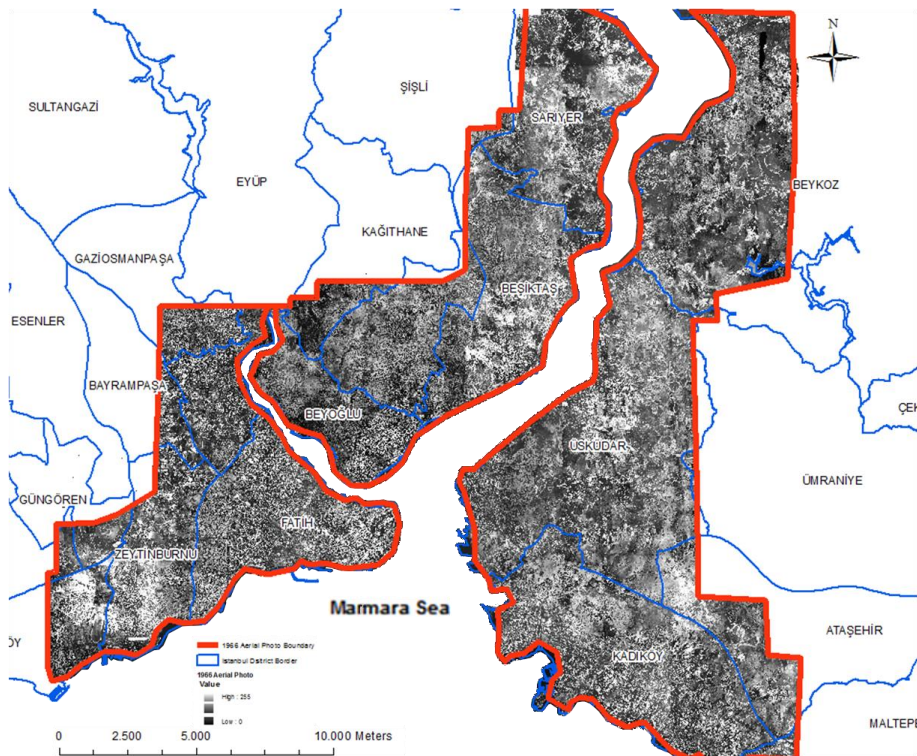
1966 Aerial Photograph covers Fatih, Kadıköy, Üsküdar, Beşiktaş, Şişli, Sarıyer, Zeytinburnu districts and some parts of the Bakırköy, Güngören, Bayrampaşa, Gaziosmanpaşa, Eyüp, Kağıthane, Beykoz ve Ataşehir districts (Figure 5.4). By digitisation of the 1966 aerial image, the total number buildings within the 415 km<sup>2</sup> urban area determined as 98239 and assumed as built prior to 1968.

**Figure 5.4 : 1966 aerial image of Istanbul.**

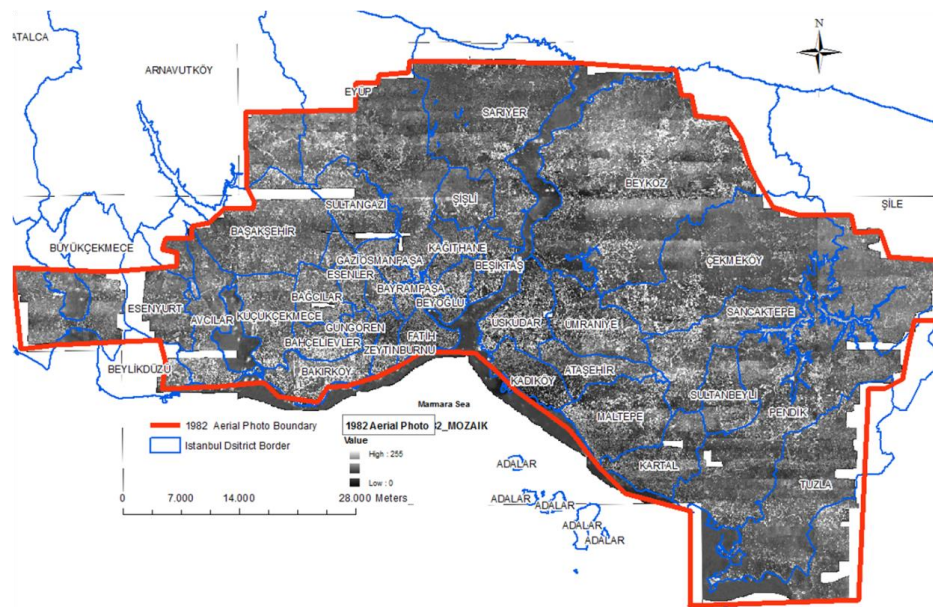
1982 Aerial image was digitized to determine the buildings constructed between 1969 and 1982. The 3200 km<sup>2</sup> urban area of the Istanbul for the year of 1982 contains all the current districts except for the Şile, Arnavutköy, Çatalca, Silivri, Büyükçekmece ve Beylikdüzü districts (Figure 5.5). According to the digitisation results, the total number buildings within the study area was determined as 432150. However, this number contains the buildings constructed before 1968. Following the spatial join method described in section 5.1, the number of buildings that were constructed between 1969 and 1982 has been determined as 333494.

**Figure 5.5 : 1982 aerial image of Istanbul.**

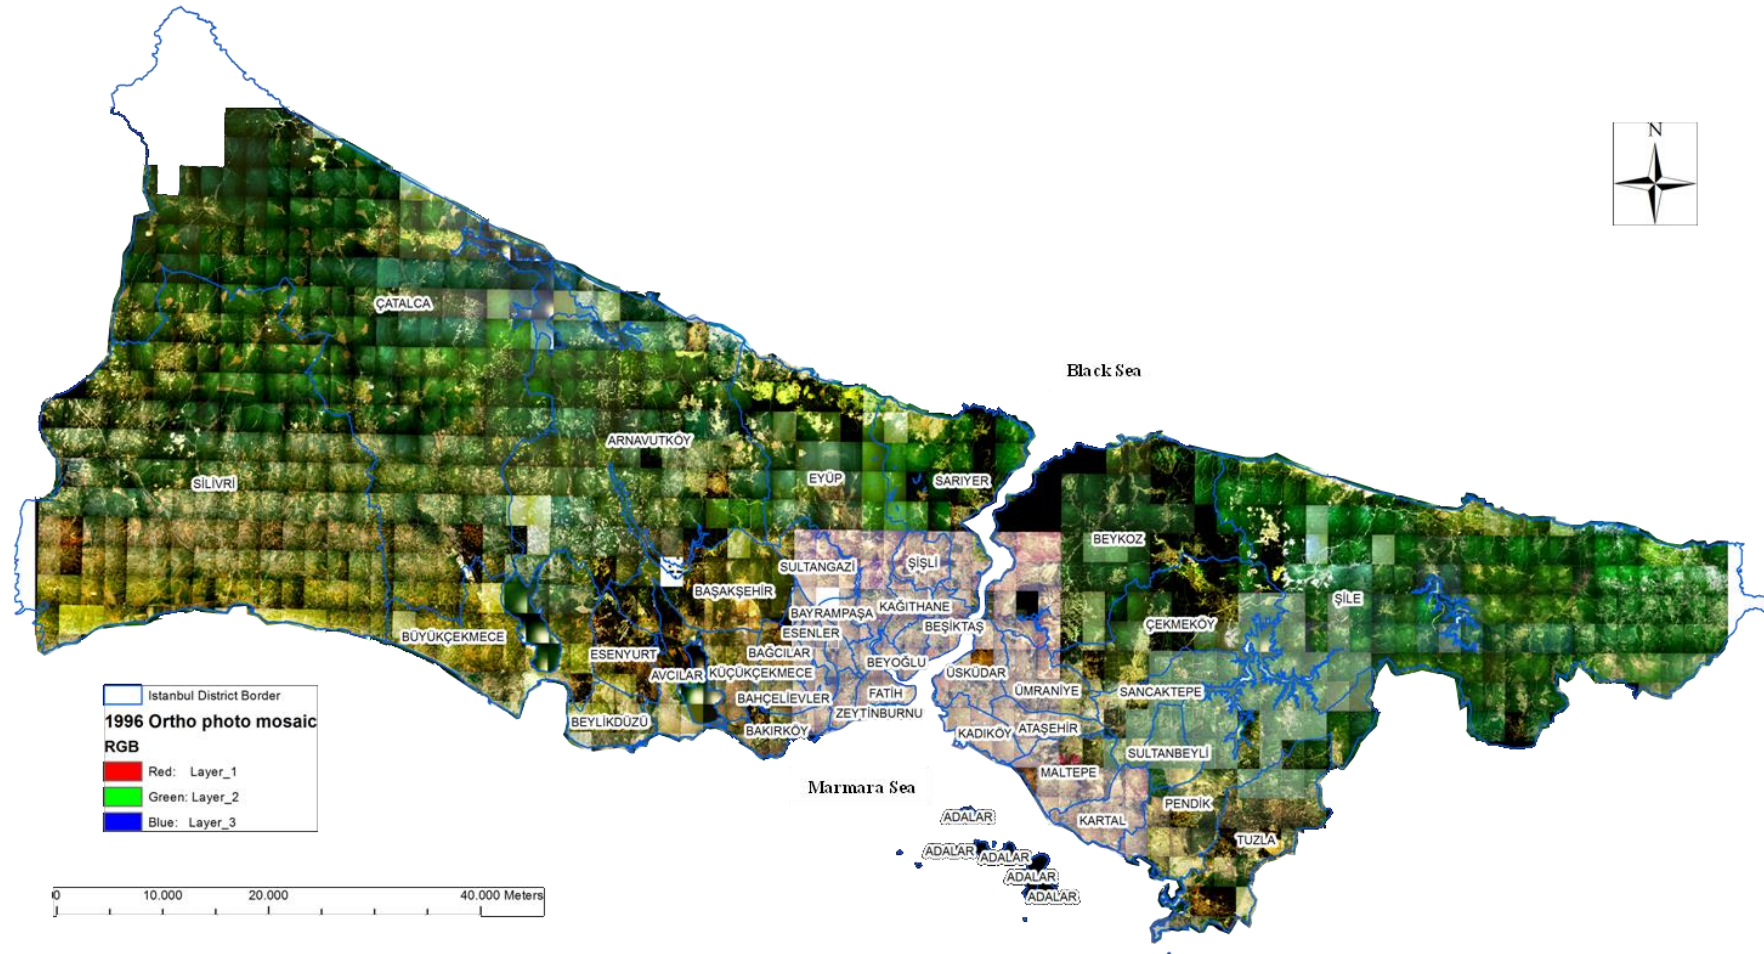
In order to detect the buildings that were constructed between 1983 and 1996, 2 m resolution 1996 ortho-photo mosaic which covers the whole Istanbul area was digitized (Figure 5.6). The total number of structures that were detected from 1996 ortho-photo was 839288. After the elimination of the previously constructed structures by using the spatial join analysis, the number of buildings that were constructed between 1983 and 1996 determined as 407138.

**Figure 5.6 :** 1996, Ortho-Photo mosaic of Istanbul.

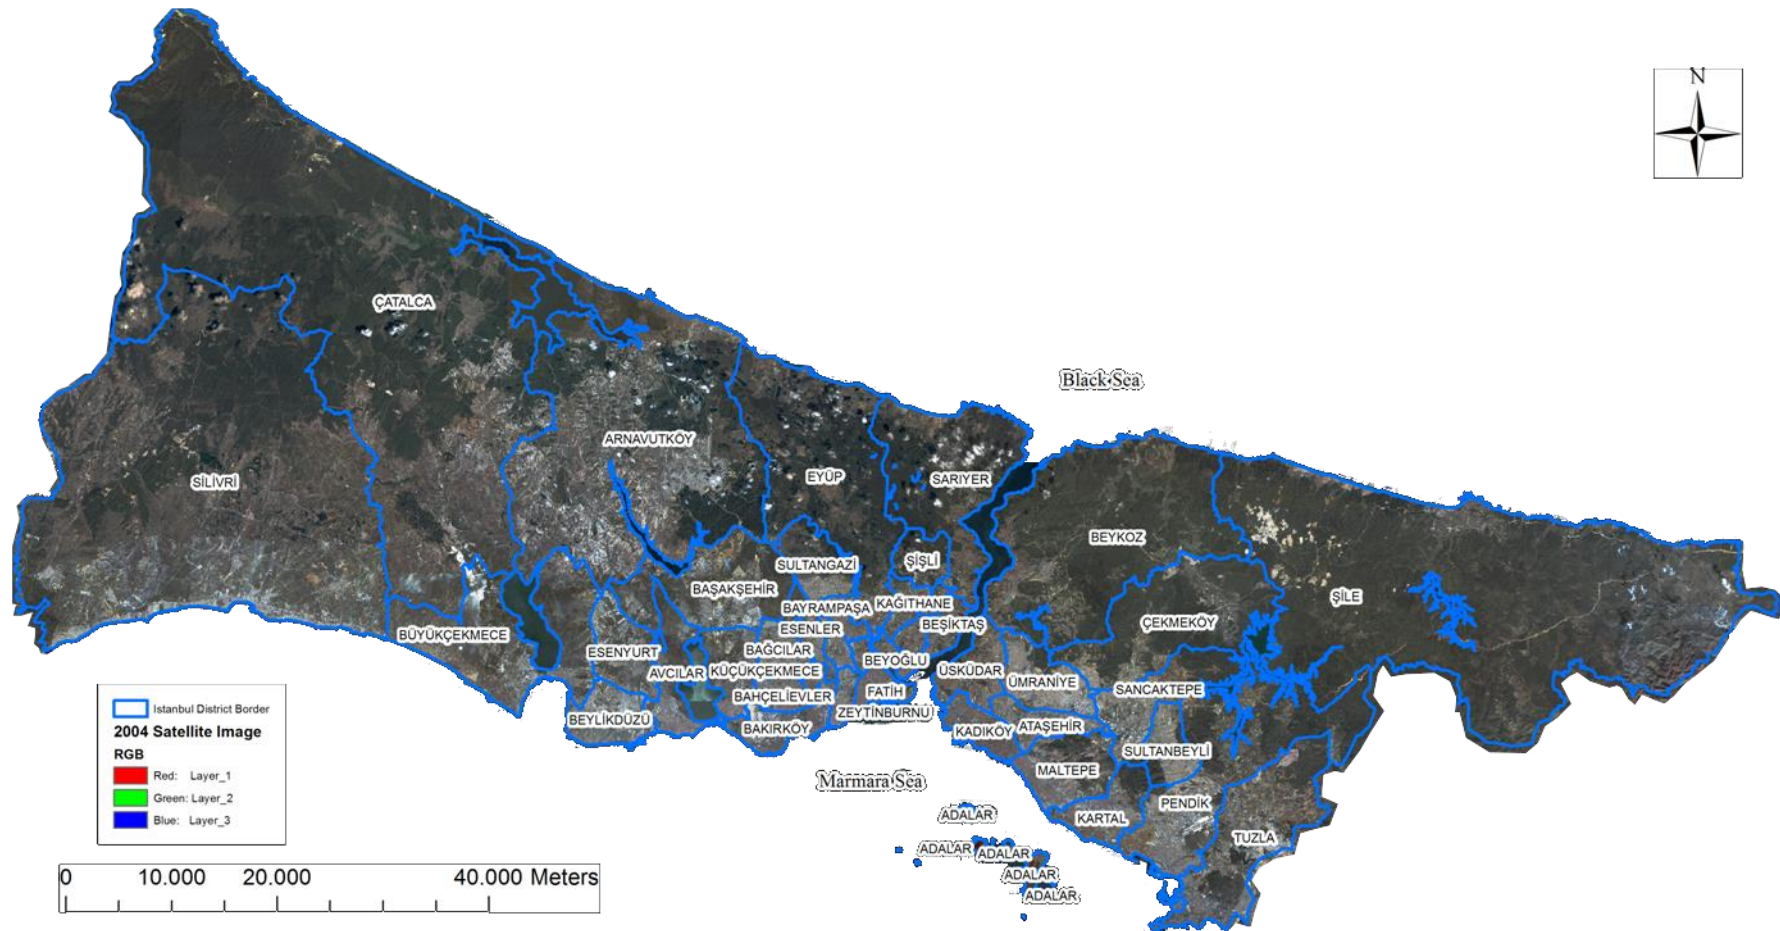
To detect the structures that were constructed before 2004, the buildings that were constructed between 1997 and 2004 were identified by using a 2004 satellite image from IKONOS with 1 m resolution (Figure 5.7). Total number of 196259 buildings were detected after the digitisation of 2004 IKONOS satellite image. Following the spatial join process of digitized 1996 orto-photo structure data 114480 structures that were built between 1997 and 2004 are determined.

**Figure 5.7 :** 2004, 1m resolution IKONOS satellite image of Istanbul.

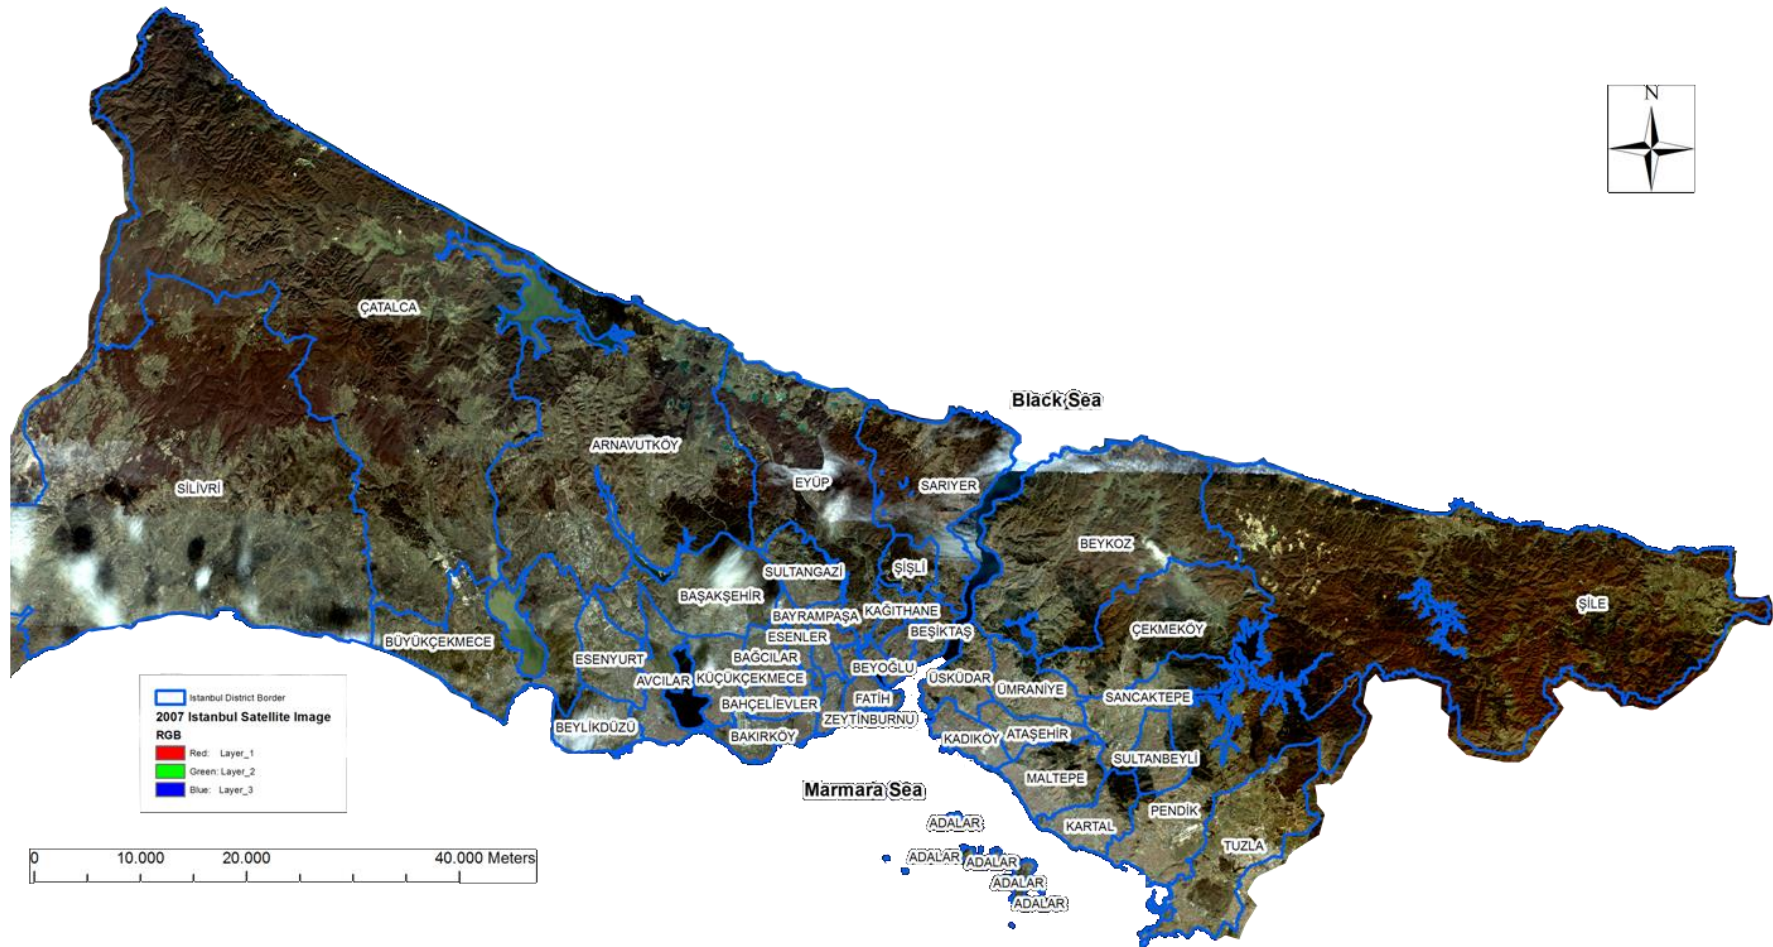
The structures that were built between 2005 and 2007 were detected by the use of 1 m resolution 2007 IKONOS Satellite Image (Figure 5.8). The digitisation and spatial join processes detected total number of 46336 structures that were constructed between 2005 and 2007.

**Figure 5.8 :** 2007, 1m resolution IKONOS satellite image of Istanbul.

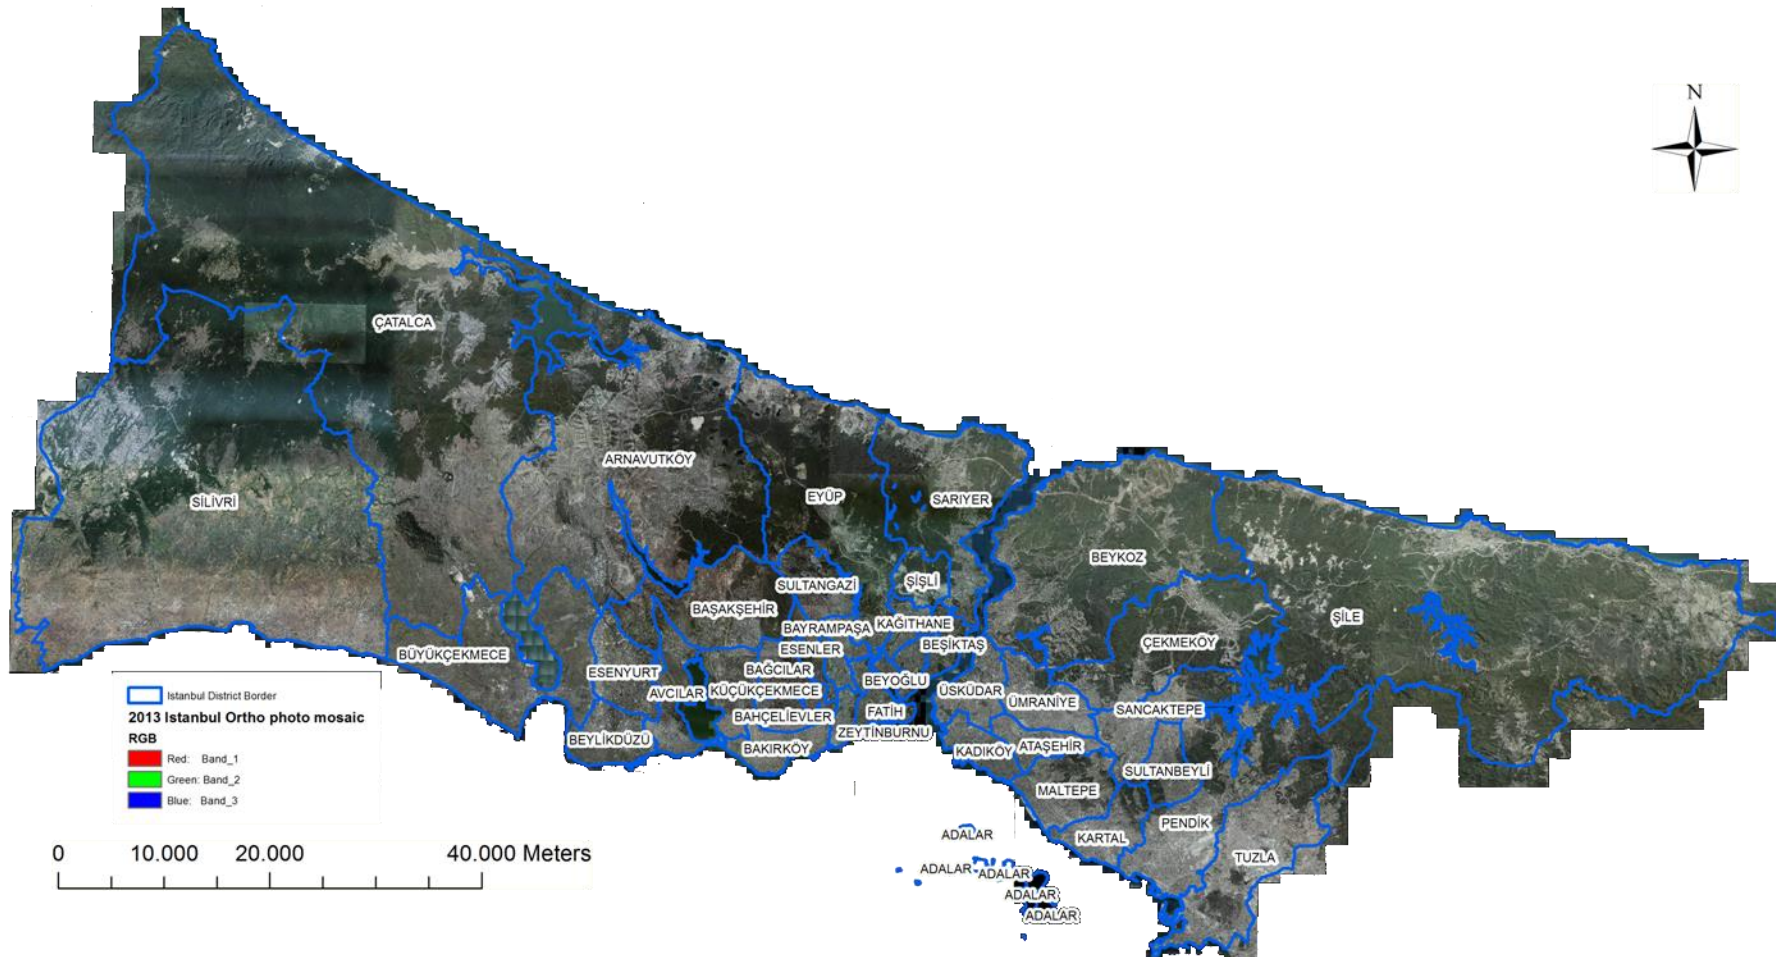
The detection of the structures that were constructed between the year of 2008 and 2013 constituted by digitizing the ortho-photo mosaic of 2013 (Figure 5.9) with cm resolution. 35443 structures were detected by spatially joining the digitized 2007 satellite image structures.

**Figure 5.9 :** 2013, 50 cm resolution Ortho-Photo mosaic of Istanbul.
