**EFFECTS OF BUILDING COLLAPSE DIRECTION  
AND BRIDGE FUNCTIONALITY ON ROAD  
NETWORKS FOLLOWING AN EARTHQUAKE**

**Ph.D. THESIS**

**Betül ERGÜN KONUKCU**

**Geomatics Engineering Department**

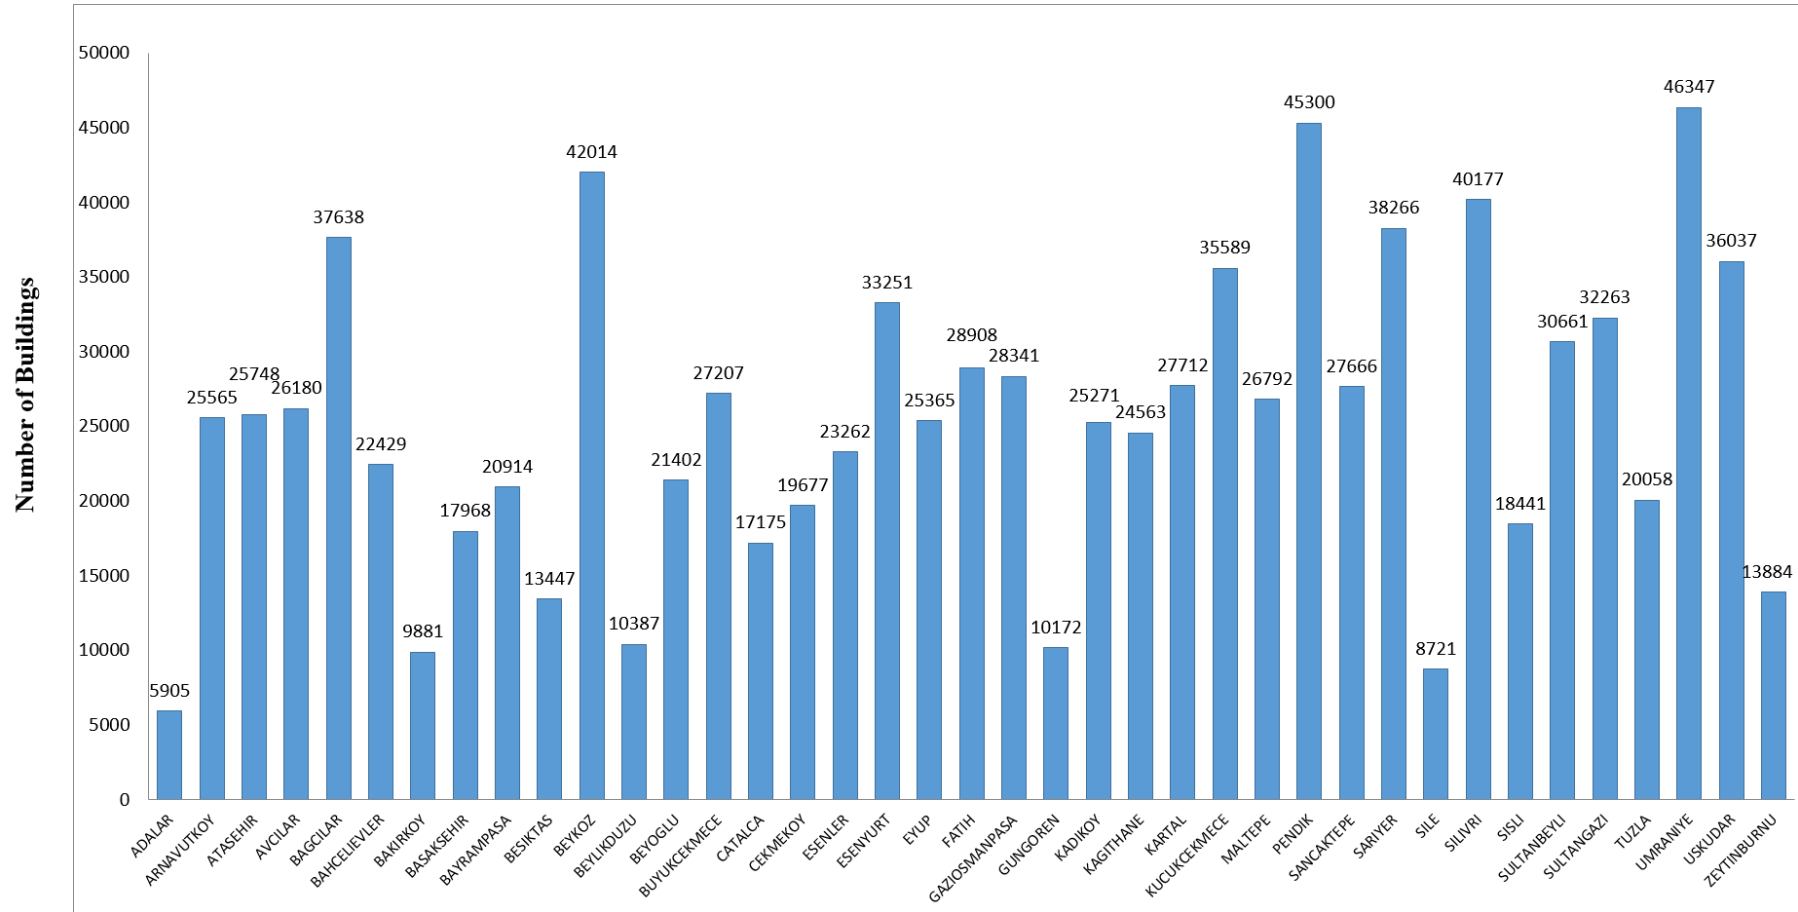
**Figure 5.10 :** Building number distribution in Istanbul with respect to districts for 2013.

As it was mentioned in section 4, some of the structures of the 2013 ADNKS shapefile formatted Istanbul Structure Data contains 1439981 structures and this data includes the attributes of location, construction type, number of floors and occupancy types of buildings; however, does not contain building ages. This polygon shaped vector building data intersected with the created structure data and the structures that has the attributes which does not meets the building definition were eliminated from the dataset. Hereunder, the number of buildings in Istanbul was determined as 990584 for the year of 2013 (Figure 5.10).

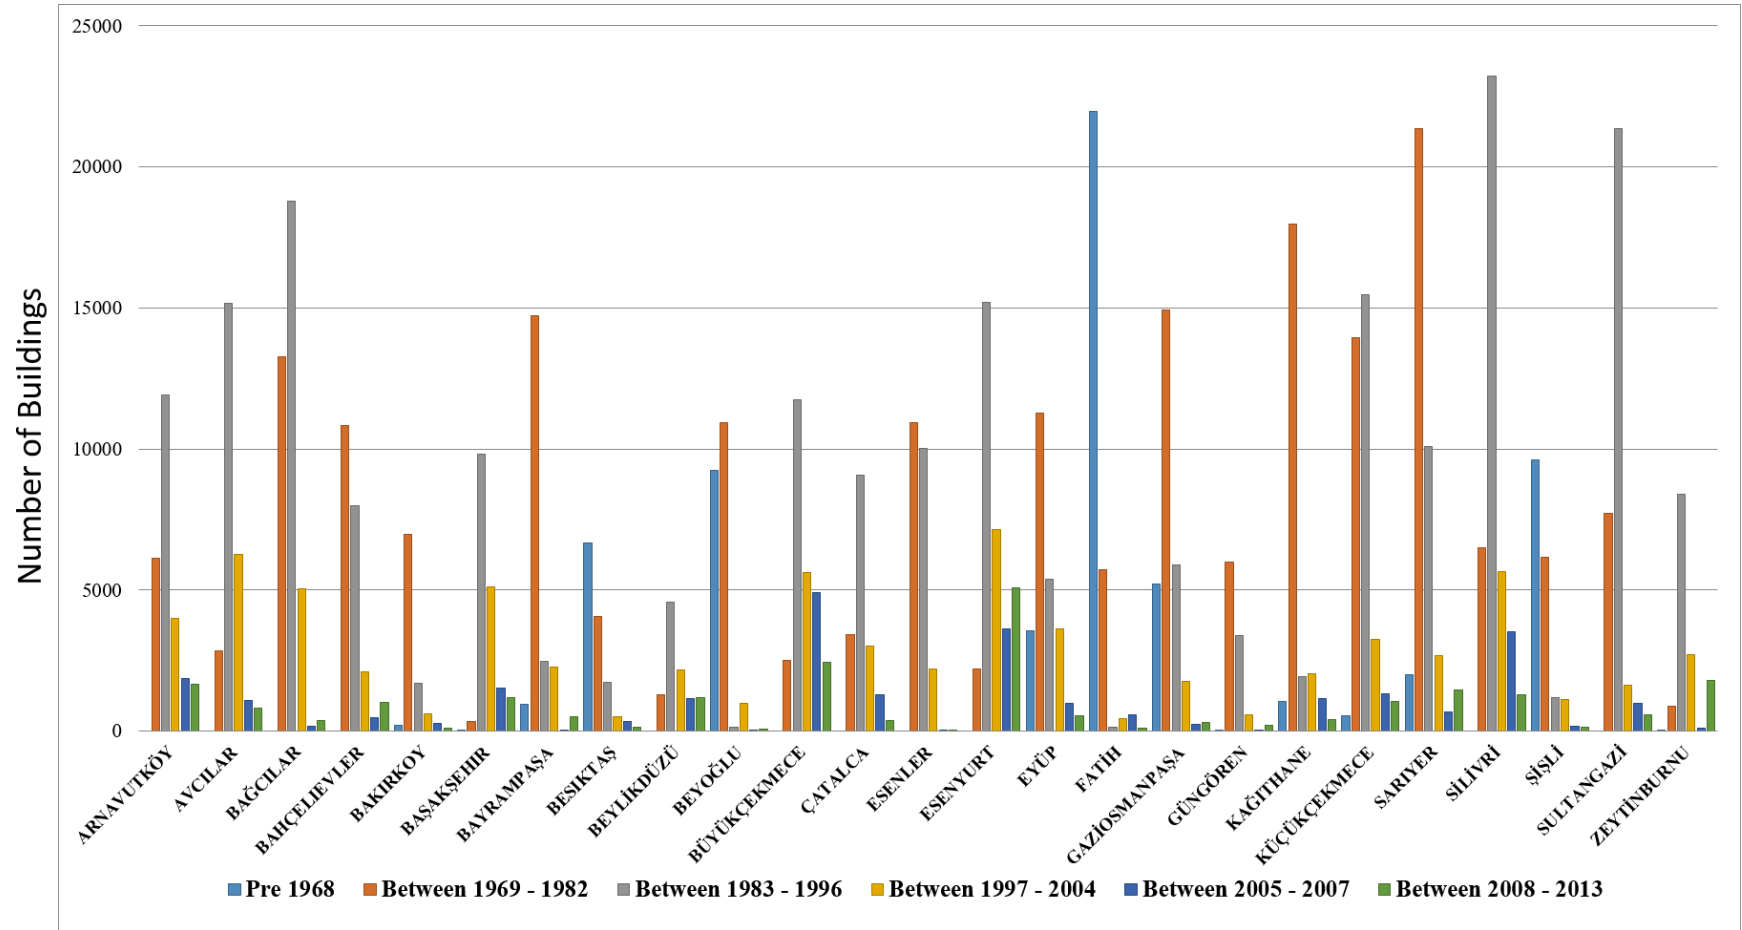
**Figure 5.11 :** Number of building age distributions at European Side of Istanbul.

The city of Istanbul divided into two parts by the Bosphorus Strait. Western part of the city was named as European Side and the eastern part was the Asian or Anatolian Side and the total number of districts are today 39 within the city while 25 districts were occupied in European side. The oldest buildings were located in the Fatih district of the European side. The increase in the number of buildings between 1969 and 1982 was seen mostly in the Sarıyer, Kağıthane, Gaziosmanpaşa, Bayrampaşa and Bağcılar districts. Between 1983 and 1996 the Silivri, Sultangazi, Bağcılar, Avcılar and Esenyurt distircts have had the highest increases in the number of buildings. Districts with the highest increase rate from 1997 to 2004 were Esenyurt, Silivri, Büyükçekmece, Avcılar and Başakşehir. The highest increase rate occurred in Büyükçekmece, Esenyurt, Arnavutköy, Avcılar and Silivri between 2005 and 2007, while Esenyurt, Büyükçekmece, Arnavutköy, Sarıyer and Zeytinburnu districts increase rate maximized between 2008 and 2013 (Figure 5.11).

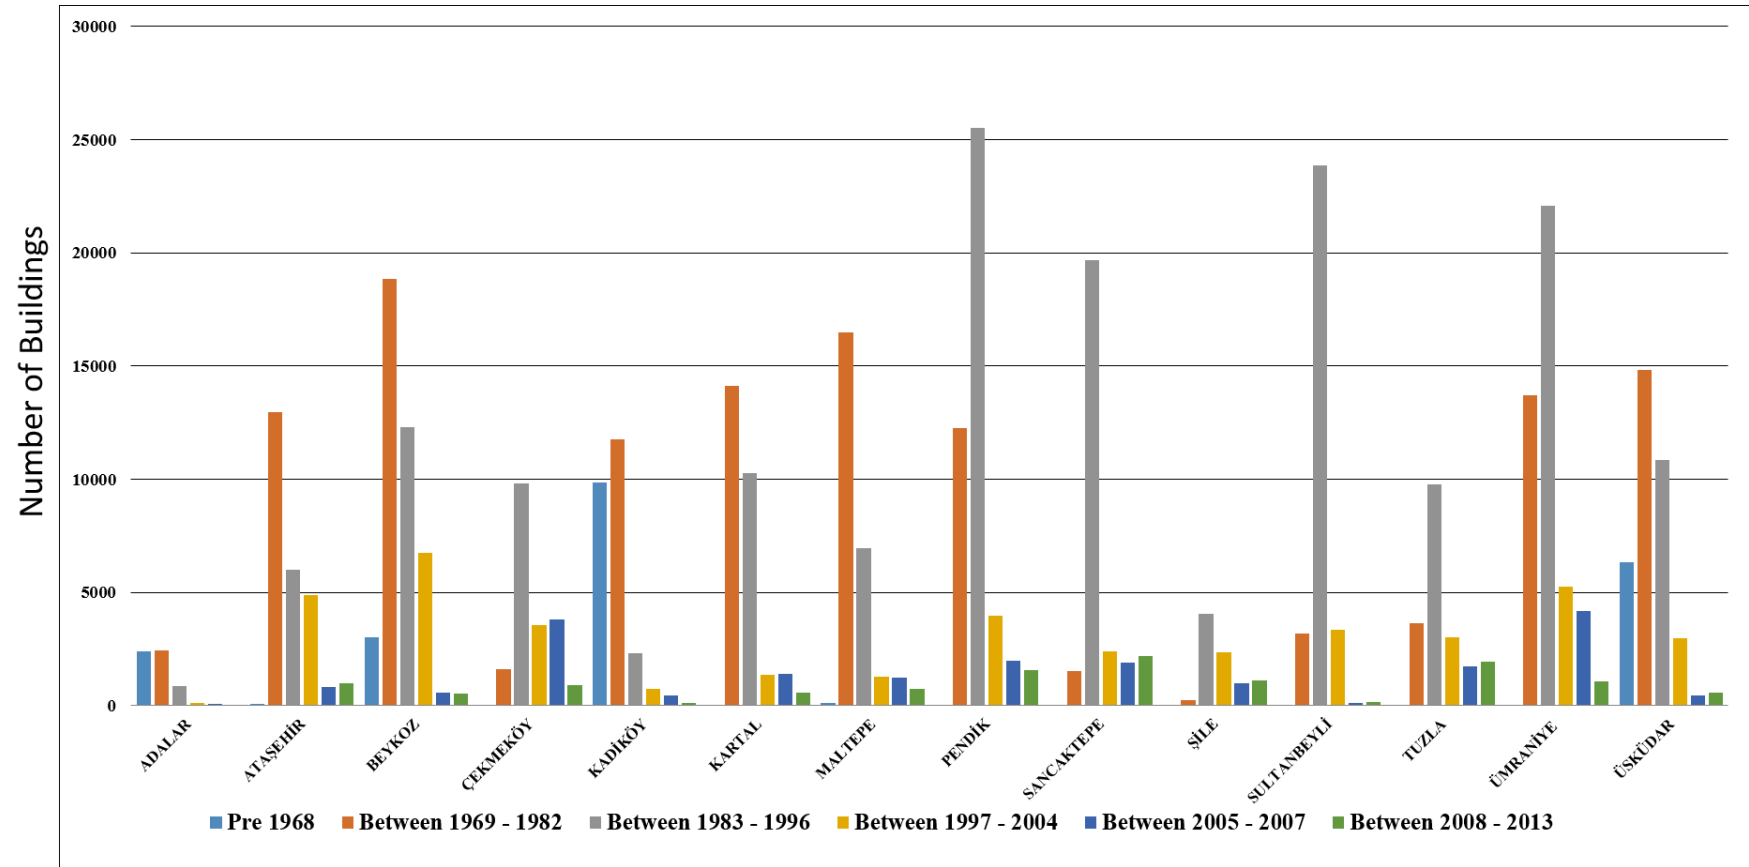
**Figure 5.12 :** Number of building age distributions at Asian Side of Istanbul.

Asian side hosts 14 districts were most of the buildings that were constructed before 1969 mostly located in Kadiköy and Üsküdar districts. Between 1969 and 1982, the number of buildings were mostly increased in Üsküdar, Beykoz, Ümraniye, Kartal and Maltepe districts. Pendik, Sultanbeyli, Ümraniye, Sancaktepe ve Beykoz were the top five districts where the increase rates are the most between the years of 1983 and 1996. Between 1997 and 2004, the Beykoz, Ataşehir, Ümraniye, Pendik, Çekmeköy districts saw the highest increase. The increase in the number of buildings between 2005 and 2007 occurred mostly in Çekmeköy, Ümraniye, Sancaktepe, Pendik and Maltepe. Between 2008 and 2013, the Tuzla, Sancaktepe, Pendik, Ataşehir ve Çekmeköy saw the highest increase in buildings (Figure 5.12).

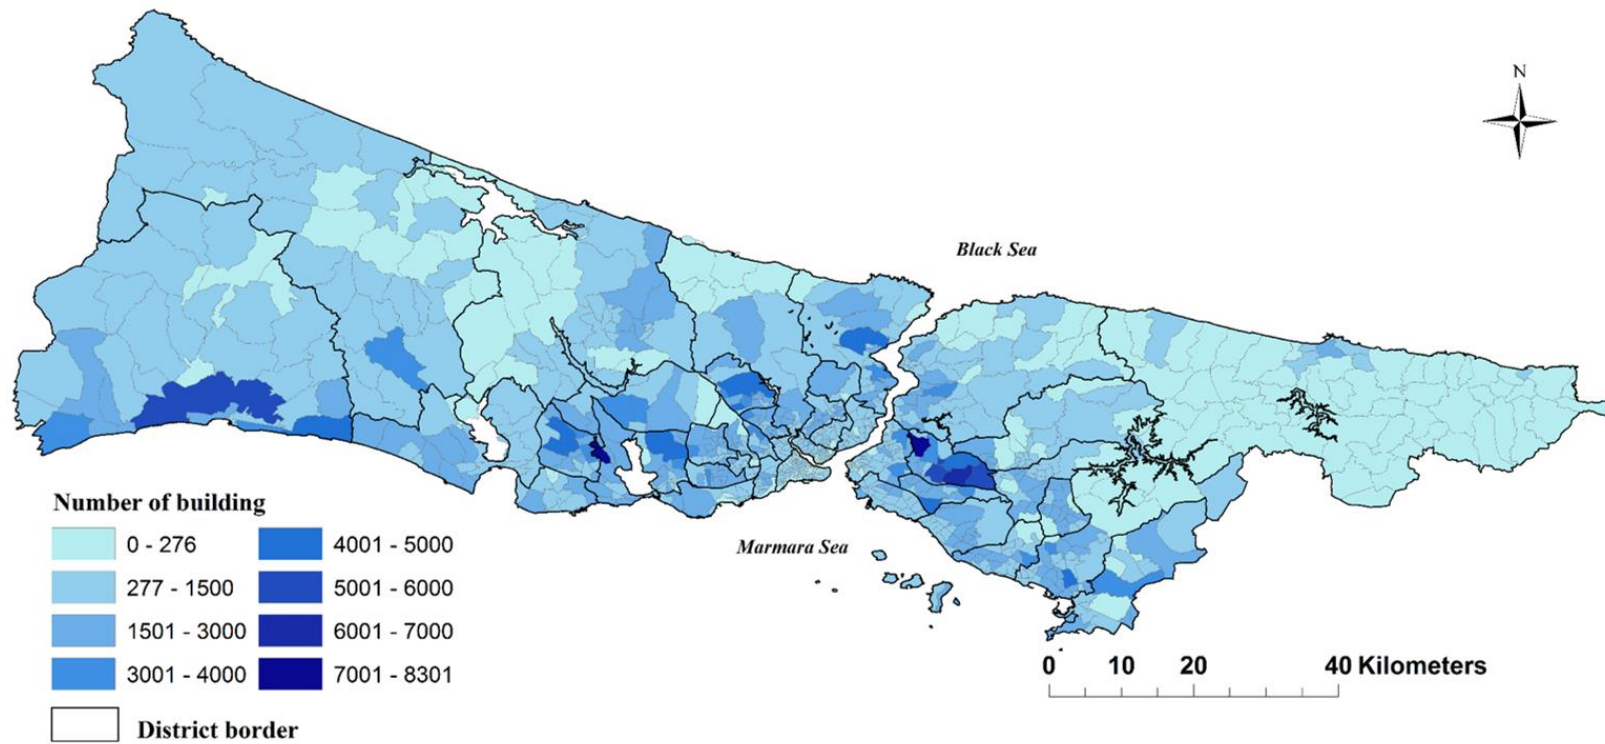
**Figure 5.15 :** Building counts of the sub-districts of Istanbul.

With 46347 buildings, the highest number of buildings, were located in the Ümraniye district at the Asian side of the city, while the smallest number of buildings were respectively located in Adalar with 5905 buildings. 196529 buildings were constructed in Istanbul between years of 1997 and 2013. Esenyurt, Büyükçekmece, and Ümraniye respectively, are the top three districts where the most buildings were constructed. Büyükçekmece, Esenyurt, and Küçükçekmece are the districts where the newest buildings were located, while the oldest buildings are located in Fatih, Beyoğlu, and Beşiktaş. Nowadays, the numbering project for the buildings is ongoing for Istanbul and this means that, the new buildings constructed after 2013 can be added to this dataset directly as a GIS building data. It is also available today to use most recent building detection techniques for the recently constructed buildings. It can be easily seen at Figure 5.13, that, the city of Istanbul is expanding both in area and in the number of buildings against the earthquake risk. As a result of this part of this study, Figure 5.14 shows the number of buildings in Istanbul according to distribution of based on district. In addition to this, the distribution of based on sub-district is given at Figure 5.15.

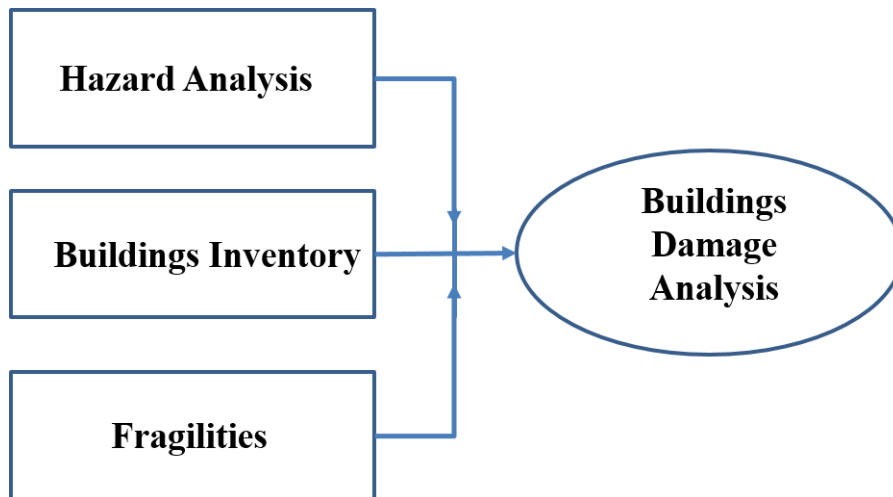
**Figure 6.1 :** The necessary data for building damage.

Building damage analysis computes the structural damage to buildings based on a particular hazard. It quantifies probabilities of physical damage states as well as an estimation of the overall expected damage level of buildings in the study region (Himmet Karaman et al., 2008). Within the context of this study, building damage analysis were calculated for every single 990584 buildings in Istanbul. The necessary data for this analysis is given in Figure 6.1.

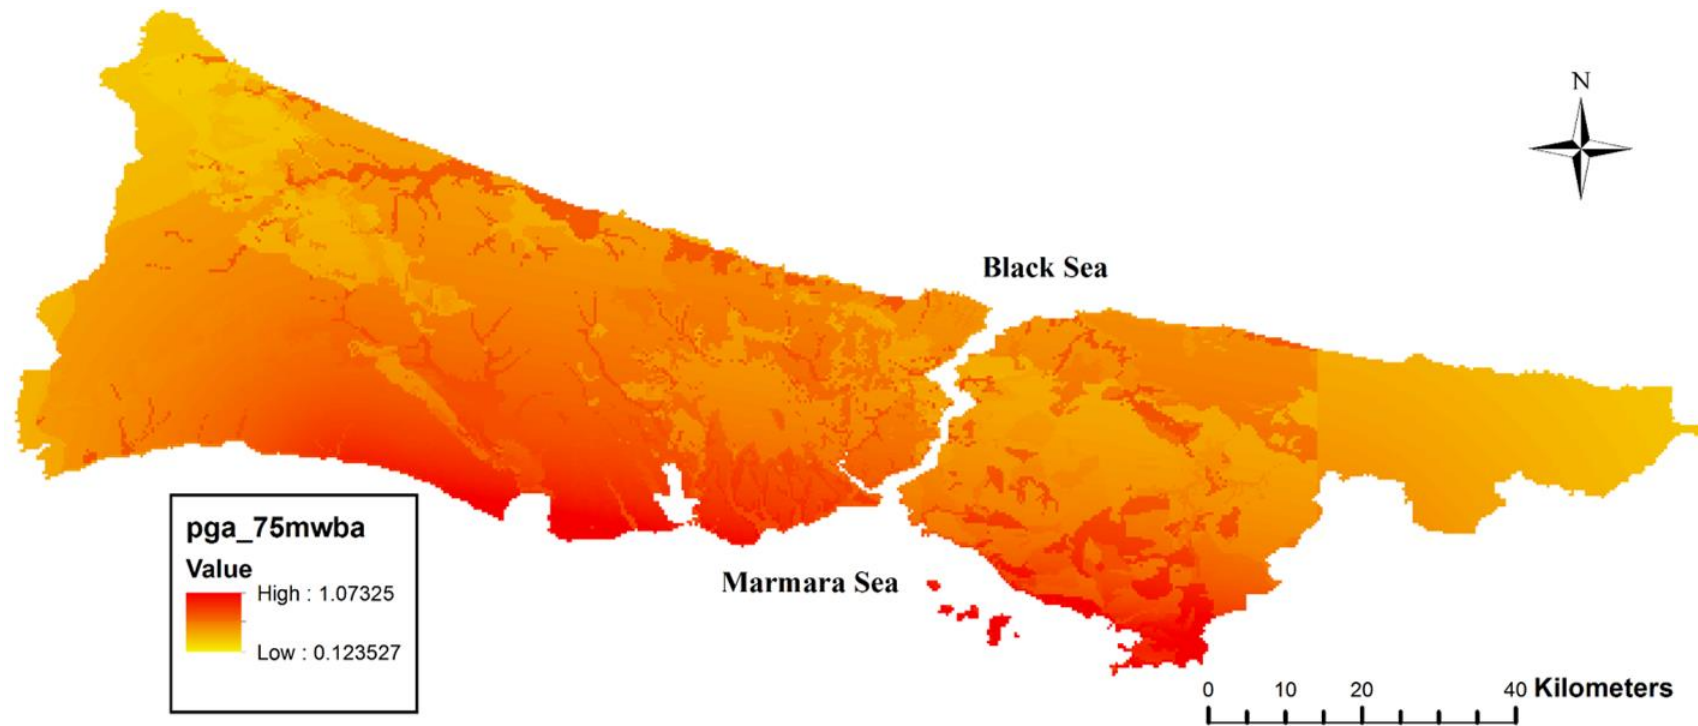
**Figure 6.2 :** Istanbul Earthquake Hazard Map according to Boore & Atkinson (2008) PGA.

Hazard is described as an input ground motion parameter or a spectral response value (Himmet Karaman et al., 2008). The magnitude of acceleration in a specific site is associated with earthquake magnitude, depth of focus, type of fault, distance of fault, soil class, average shear wave velocity, the morphology and several related criteria. In this study, Boore and Atkinson (2008) ground motion estimation equation has been used to simulate the earthquake hazard map for Istanbul with PGA (Figure 6.2) and  $S_a$  ( $T=0.2s$ ) demands (Figure 6.3).

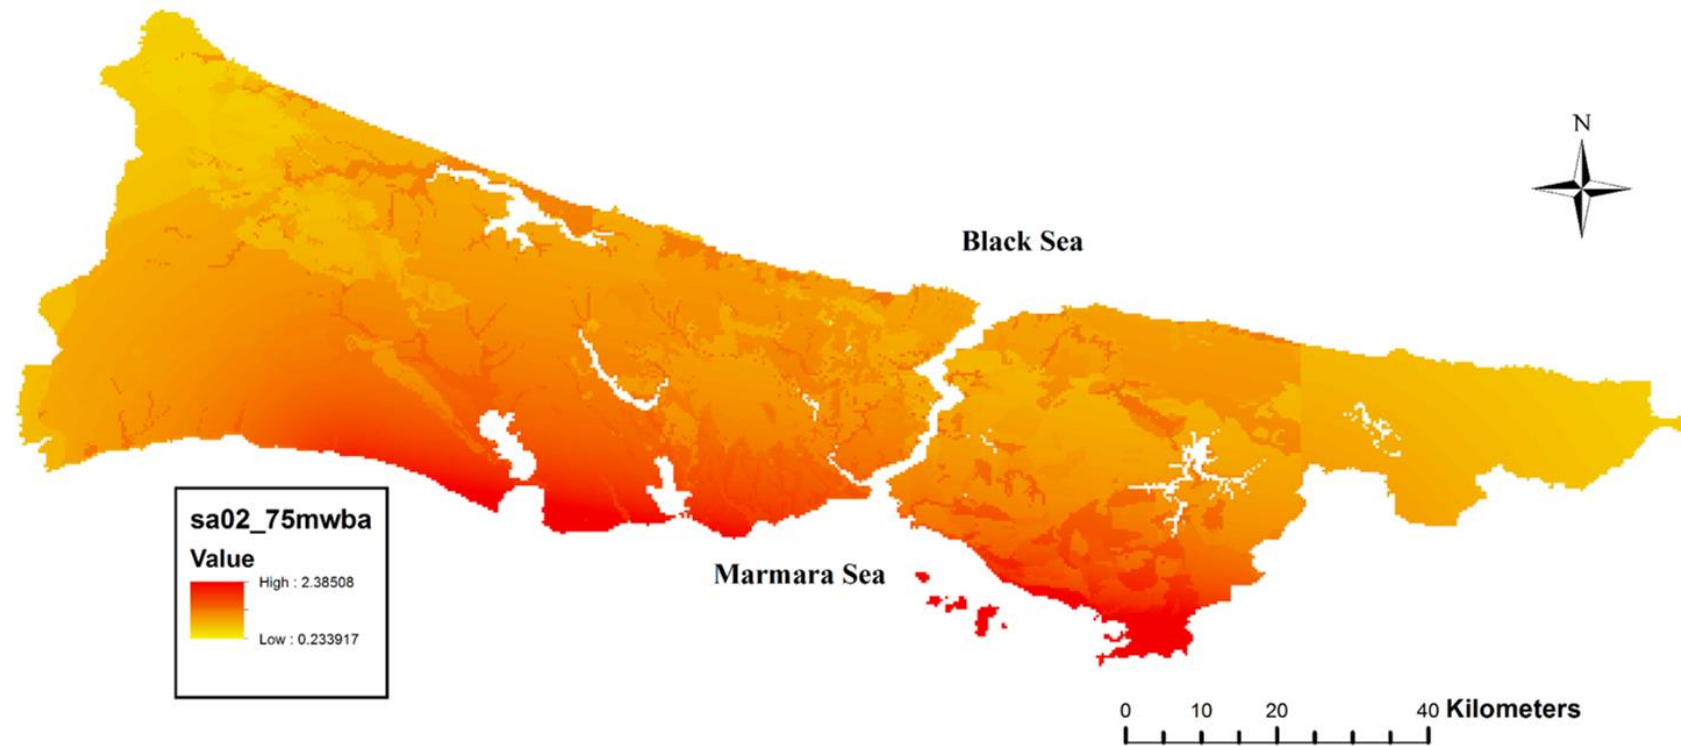
**Figure 6.3 :** Istanbul Earthquake Hazard Map according to Boore & Atkinson (2008) 0.2 second Sa.

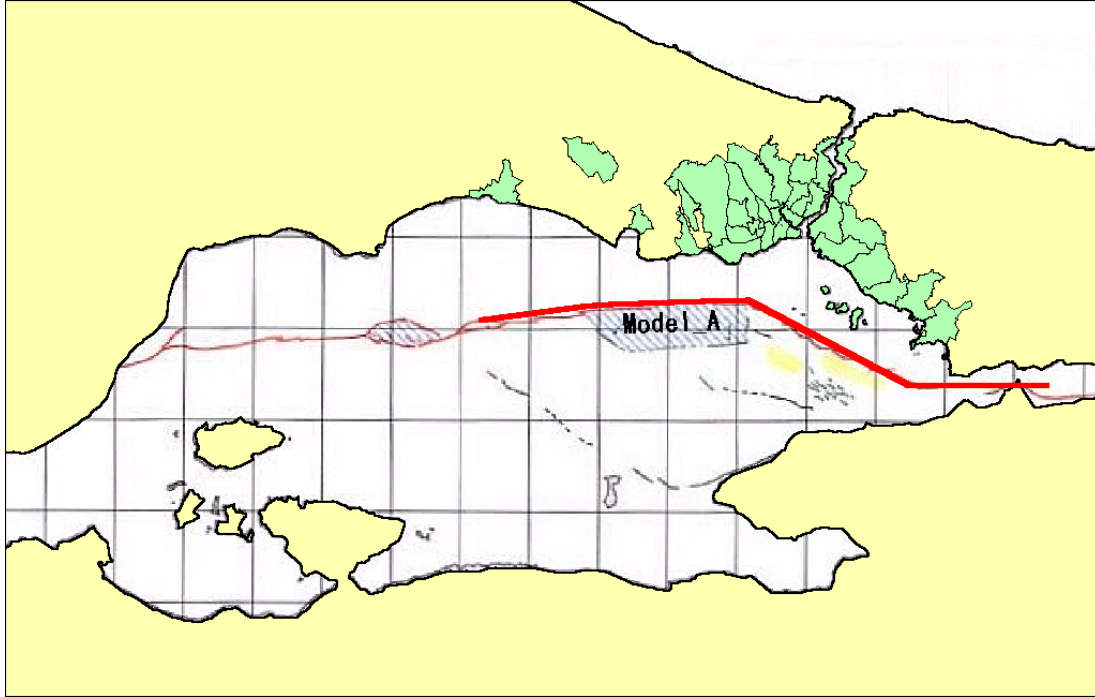
**Figure 6.4 :** Model A according to JICA and IMM (2002) study.

In this study; Model A produced by JICA and IMM (2002) study was used as a scenario earthquake (Figure 6.4). Model A is defined as a fracture in the eastern part of the fault line and is the most anticipated model. The magnitude of this scenario earthquake was assumed as Mw 7.5 (JICA & IMM, 2002).

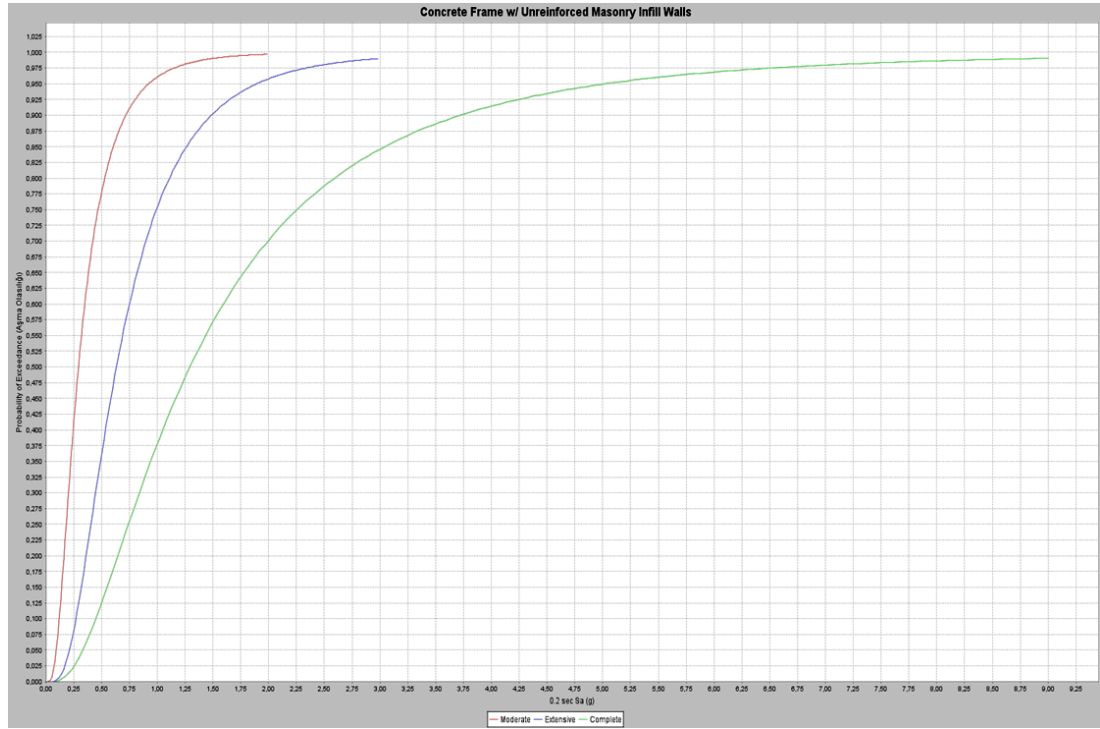
**Figure 6.5 :** Fragility curve for concrete frame with unreinforced masonry infill walls according to 0.2  $S_a$ .

In this study, fragility curves for both spectral acceleration and peak ground acceleration were used. The fragility curves for Istanbul buildings in HAZTURK software are shown in Figure 6.5 and Figure 6.6 respectively for 0.2 sec  $S_a$  and PGA demands for concrete frame with unreinforced masonry infill wall structures.

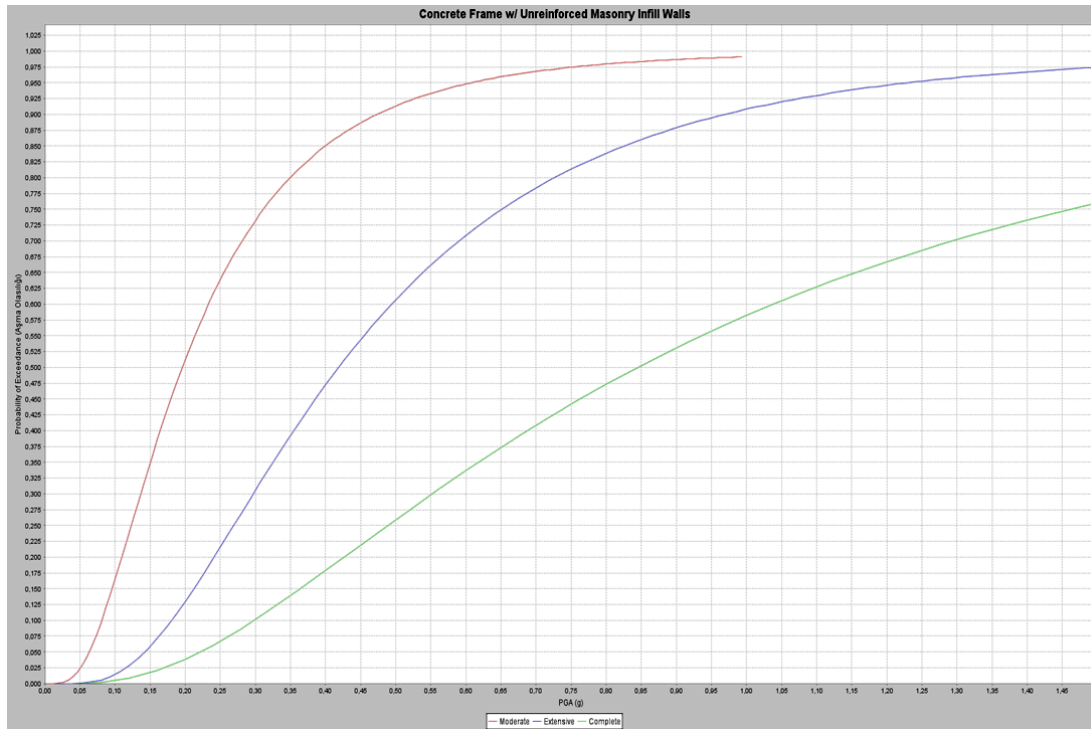
**Figure 6.6 :** Fragility curve for concrete frame with unreinforced masonry infill walls according to PGA.

In this study, fragility curves for buildings of Istanbul were already embedded inside the HAZTURK software and they were developed by using the Parameterized Fragility Method (PFM) of Jeong and Elnashai (2006). The probability of the damage to buildings is estimated by matching every building in the dataset to a fragility curve in the database by using the number of stories, construction year, construction type, and hazard values at the building location. HAZTURK calculates the probability of earthquake damage on a building in four limit states based on PGA, 0.2 sec  $S_a$  and  $S_d$  demands (Himmet Karaman et al., 2008).

The probability of damage is obtained from the probability of exceeding each limit state. The damage states used by HAZTURK are: Insignificant, Moderate, Heavy, and Complete. To get mean and standard derivation of damage, the damage probabilities are weighted (Himmet Karaman et al., 2008).

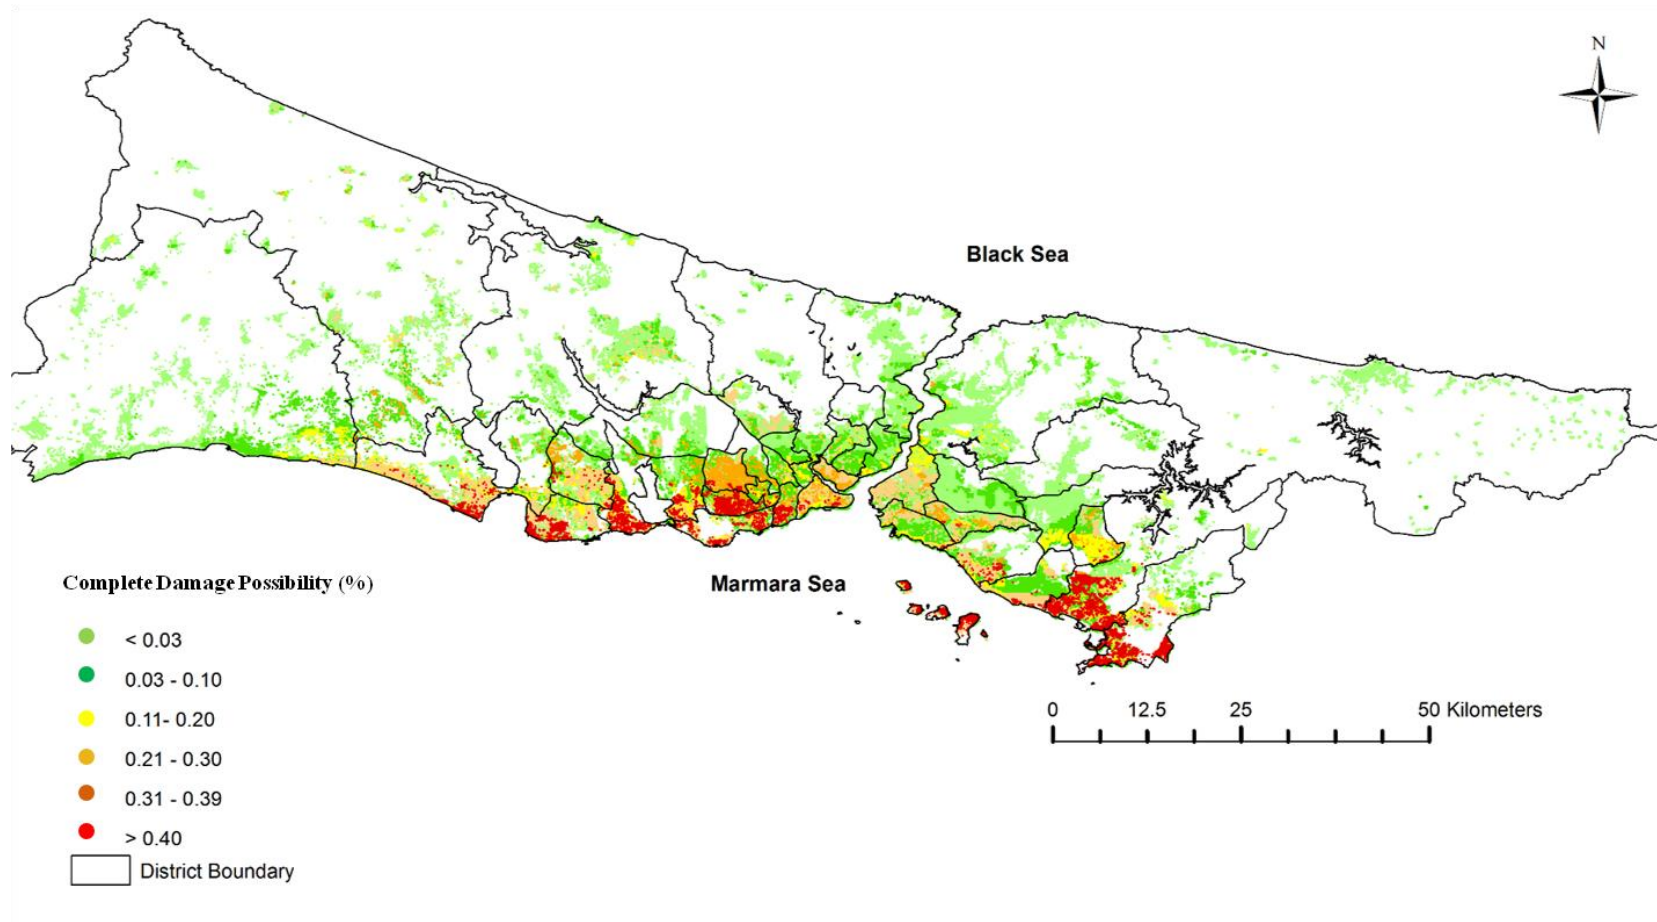
Complete damage distribution of the Istanbul buildings are based on 0.2 sec Sa is represented in Figure 6.7, while the heavy damage distribution according to Sa is shown in Figure 6.8.

**Figure 6.7 :** Complete damage possibility distribution of Istanbul buildings according to 0.2 Sa.

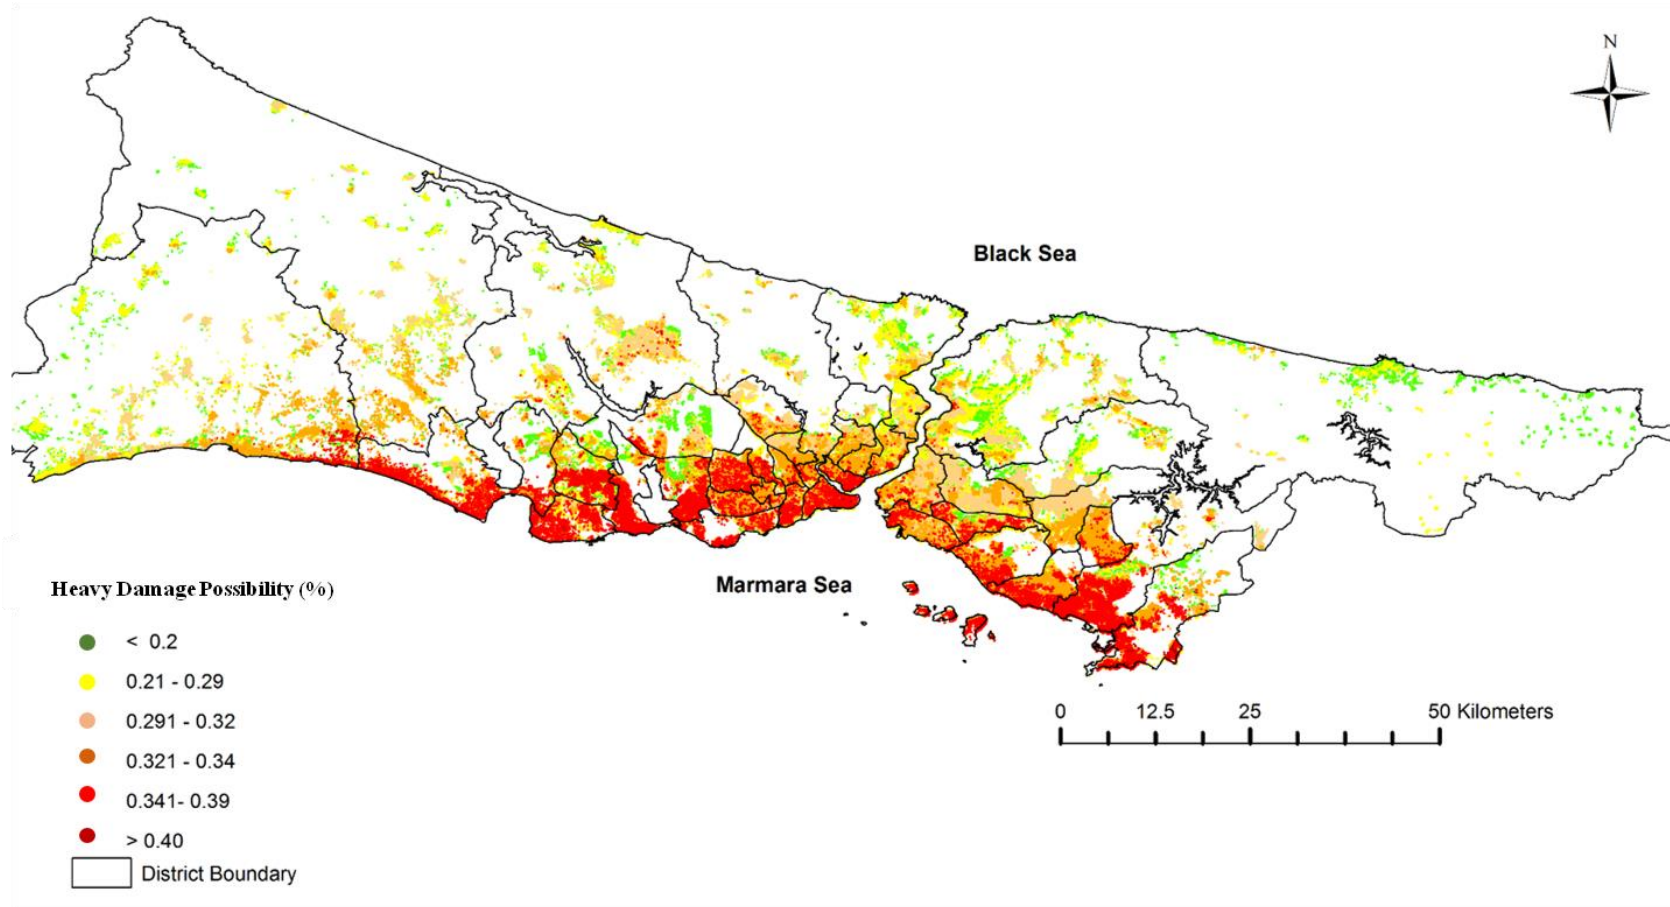
**Figure 6.8 :** Heavy damage possibility distribution of Istanbul buildings according to 0.2 Sa.

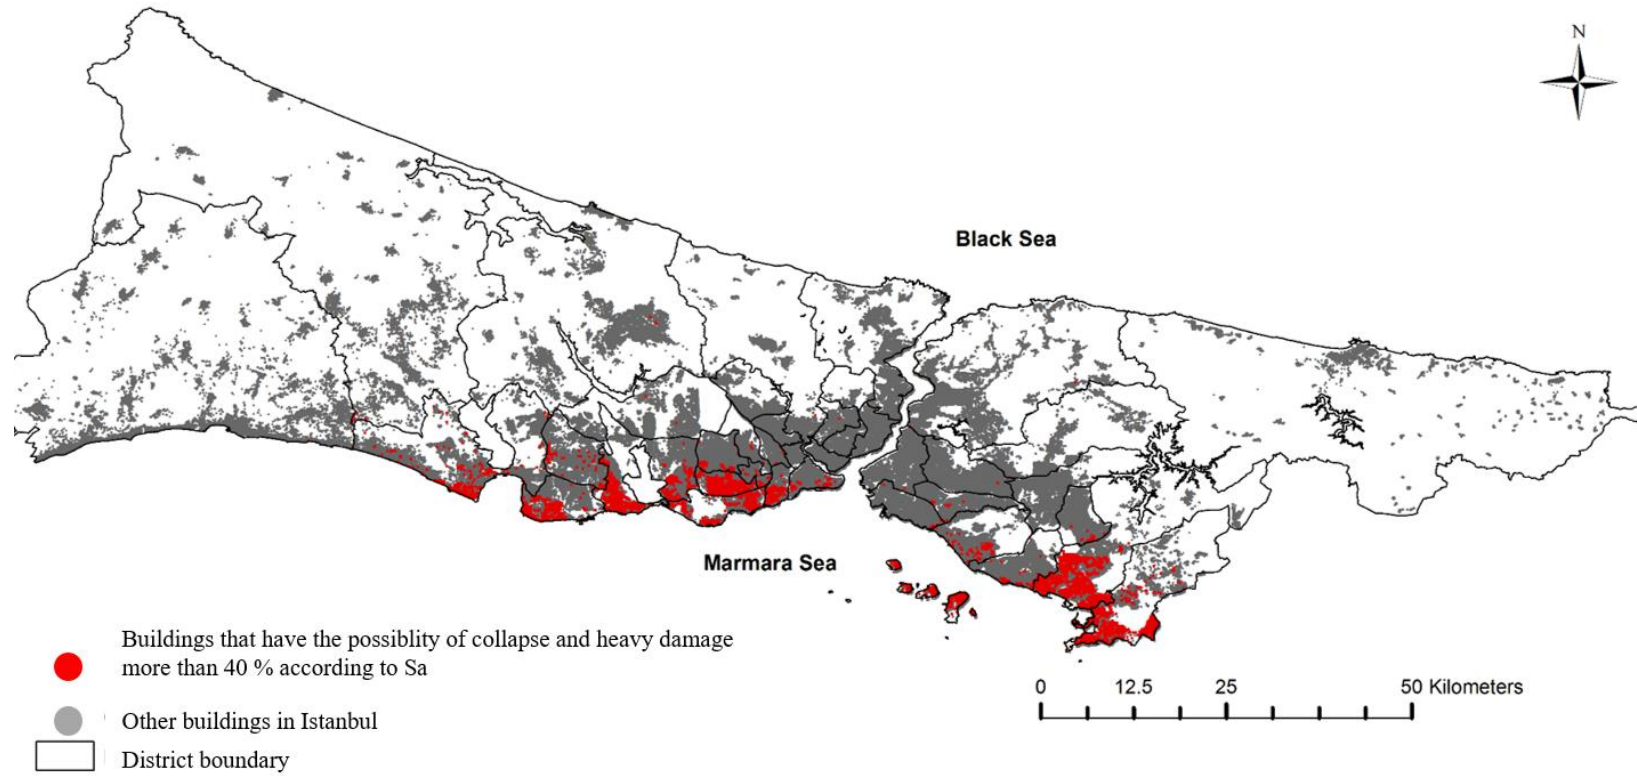
**Figure 6.9 :** Buildings in Istanbul that have the complete and heavy damage possibility more than 40% based on 0.2  $S_a$ .

There are 19,679 buildings in Istanbul that may have complete and heavy damage with a possibility greater than 40% according to 0.2 sec Sa. As it is shown in Figure 6.9, most of those buildings are located at the southern shore lines of Istanbul.

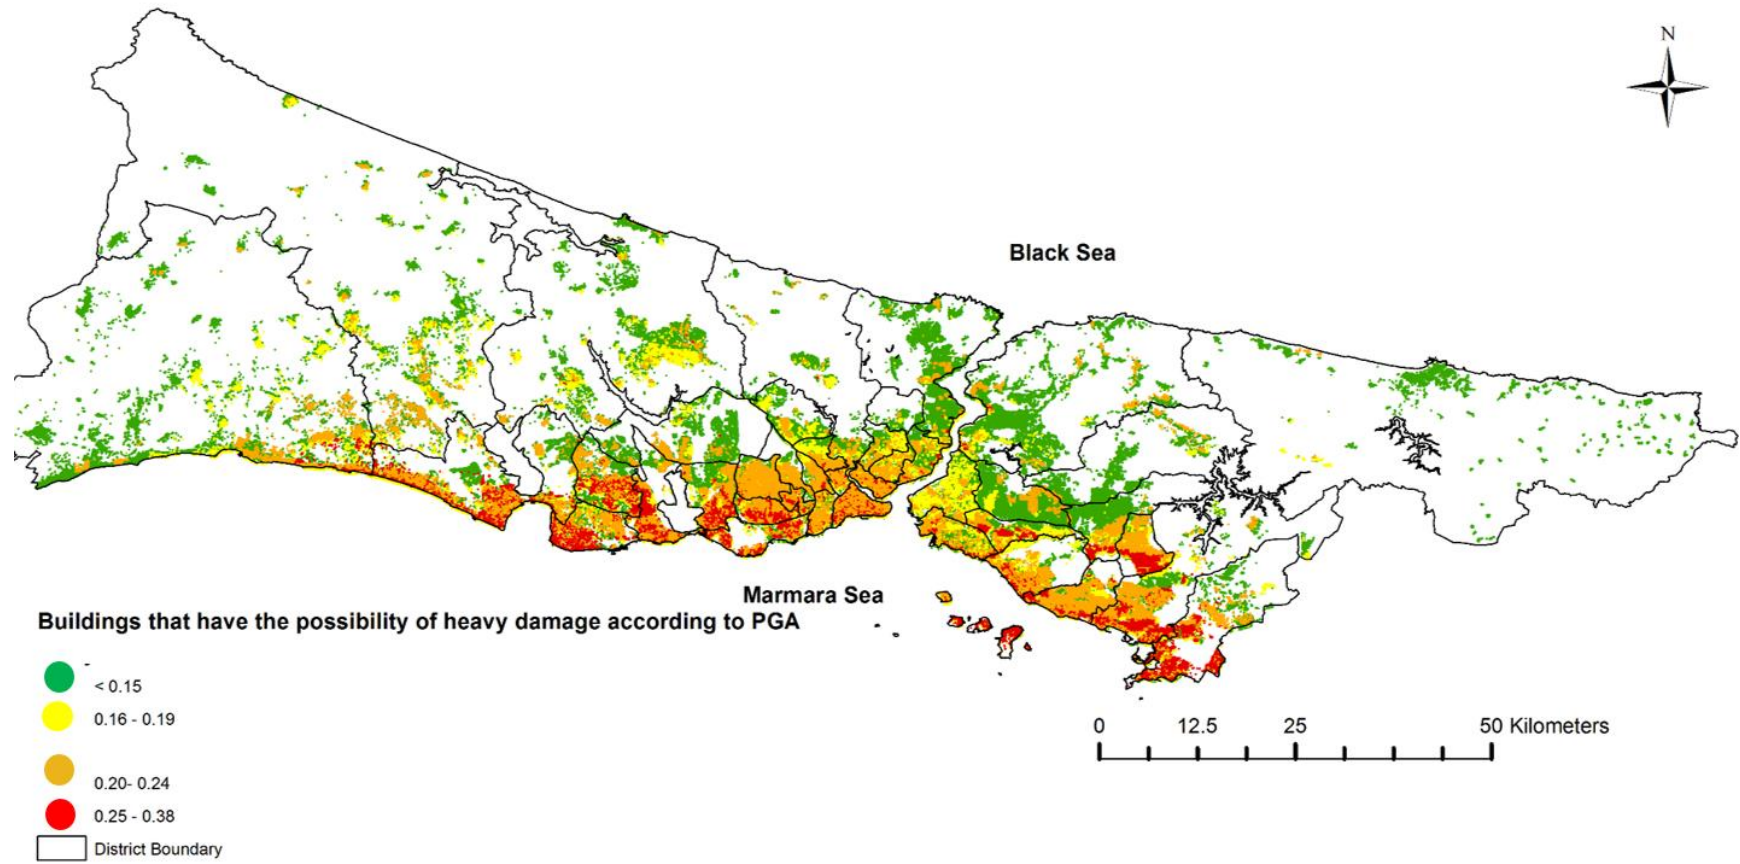
PGA based complete damage distribution of the Istanbul buildings illustrated in Figure 6.10. The heavy damage distribution of the same inventory is also represented in Figure 6.11 based on PGA.

**Figure 6.11 :** Heavy damage possibility distribution of Istanbul buildings according to PGA.

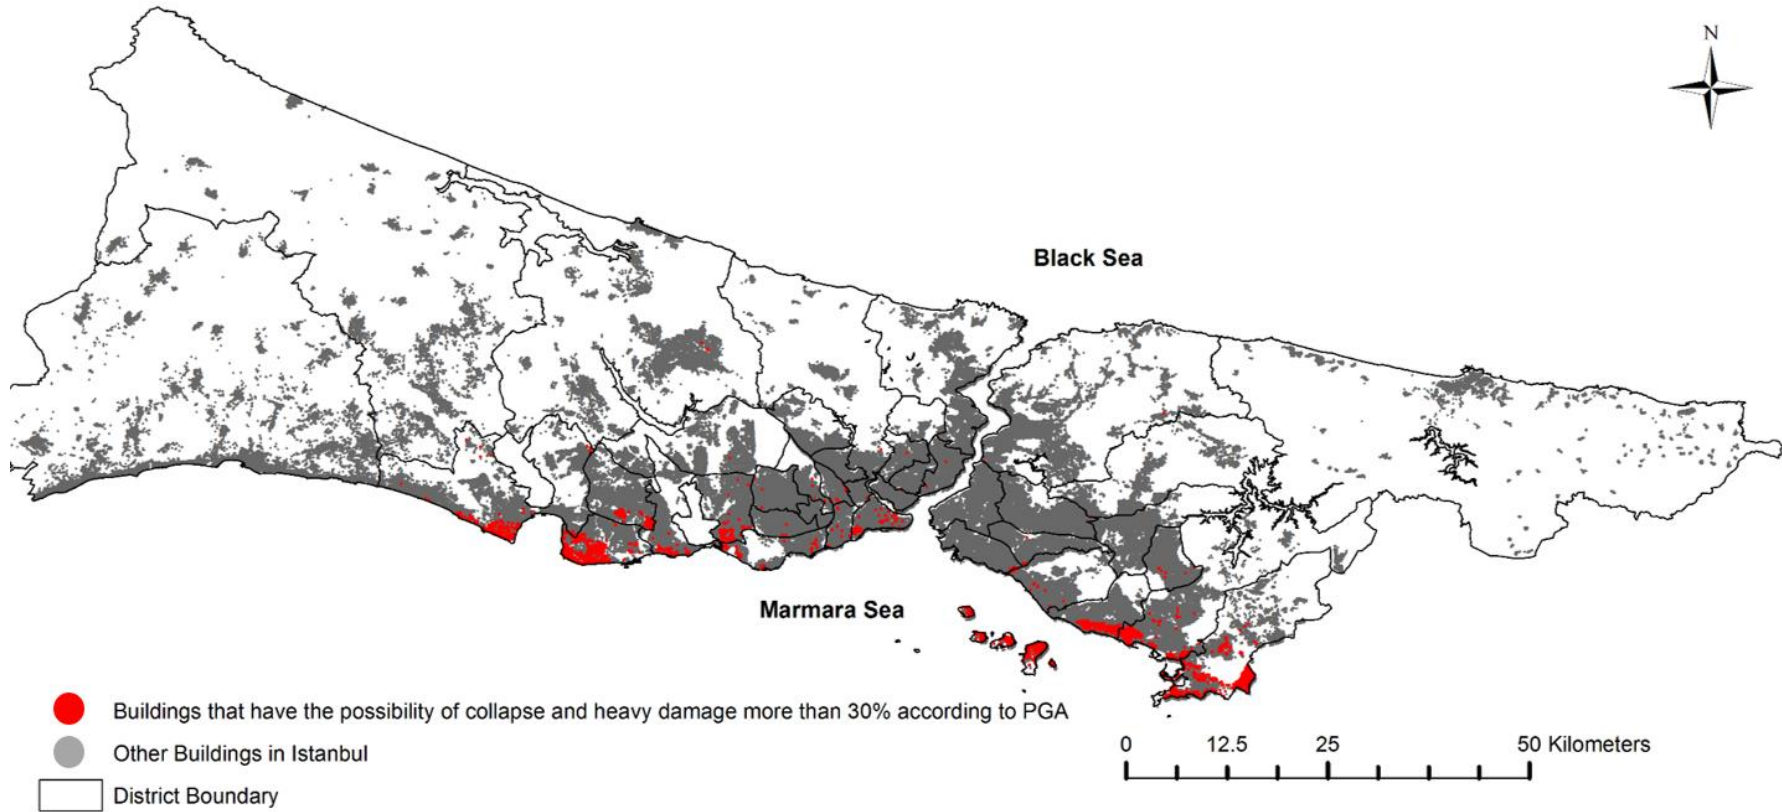
The damage possibilities of the Istanbul buildings based on PGA are less than the 0.2 sec  $S_a$ . While there were 19,679 buildings to have heavy and complete damage with a possibility more than 40%, there are 14,066 buildings that have the possibility of complete and heavy damage more than 30% due to PGA (Figure 6.12).

**Figure 6.12 :** Buildings in Istanbul that have the complete and heavy damage possibility more than 30% based on PGA.

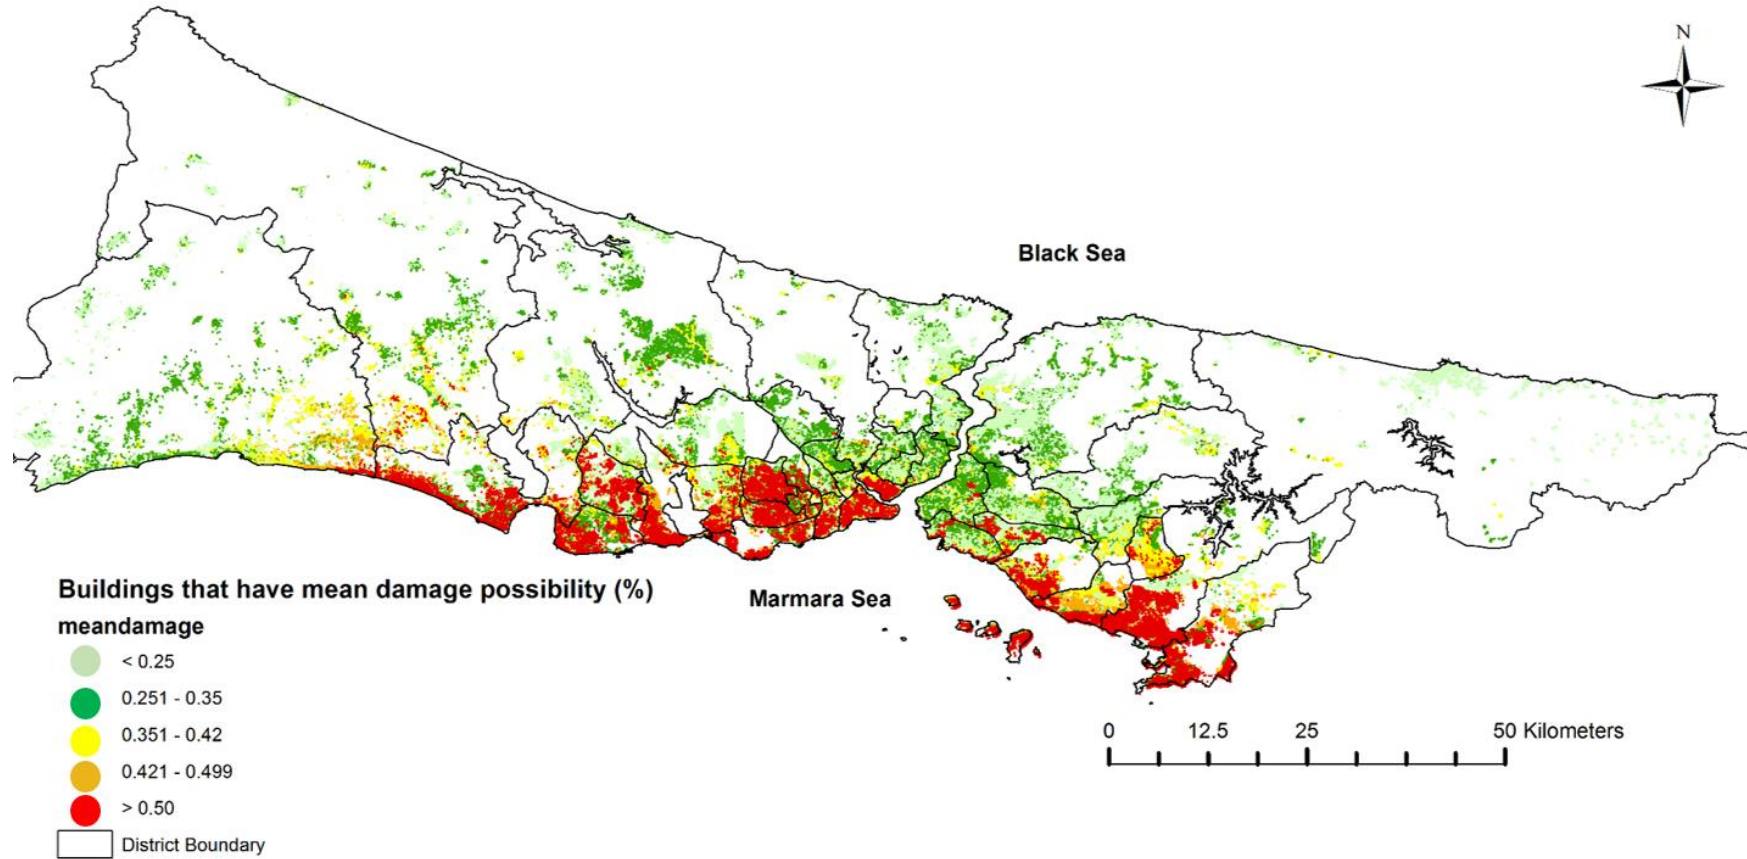
If the specific limit states are not taken into account and only the mean damage situation of all buildings considered, the mean damage possibility distribution of buildings in Istanbul according to 0.2 second Sa earthquake hazard map is determined as in Figure 6.13.

**Figure 6.13 :** Mean damage possibility distribution of Istanbul buildings according to 0.2 Sa.
