**EFFECTS OF BUILDING COLLAPSE DIRECTION  
AND BRIDGE FUNCTIONALITY ON ROAD  
NETWORKS FOLLOWING AN EARTHQUAKE**

**Ph.D. THESIS**

**Betül ERGÜN KONUKCU**

**Geomatics Engineering Department**

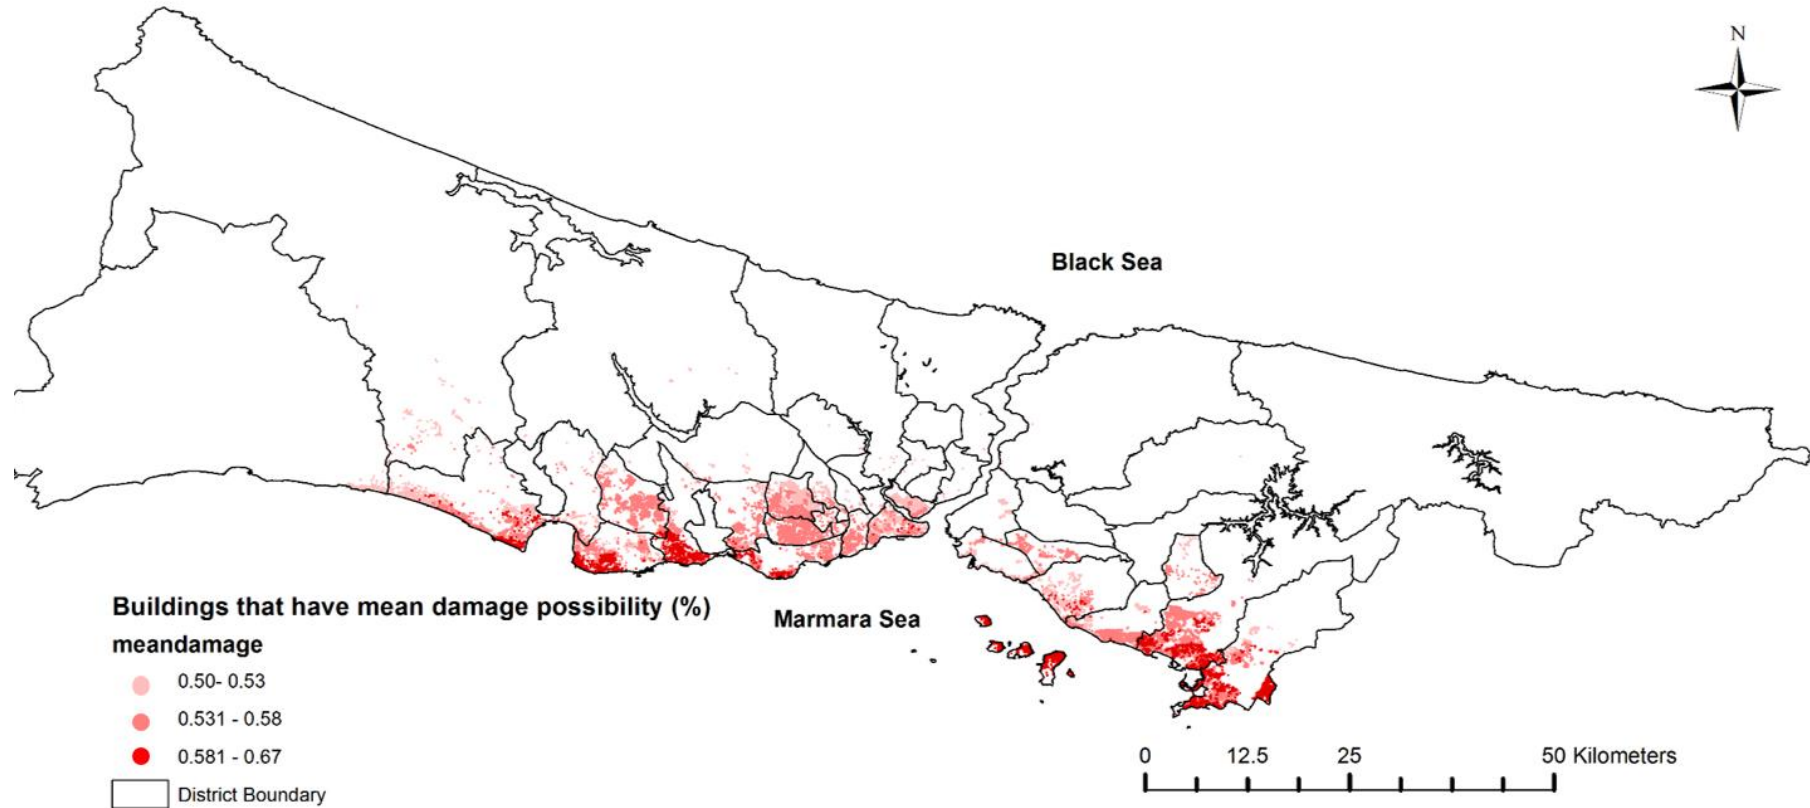
Based on the mean damage analysis, the number of buildings which have more than 50% mean damage possibility based on Sa demand type with 0.2 sec period is determined as 68,389 and represented in (Figure 6.14).

**Figure 6.14 :** More than 50% mean damage possibility distribution of Istanbul buildings based on 0.2 Sa.

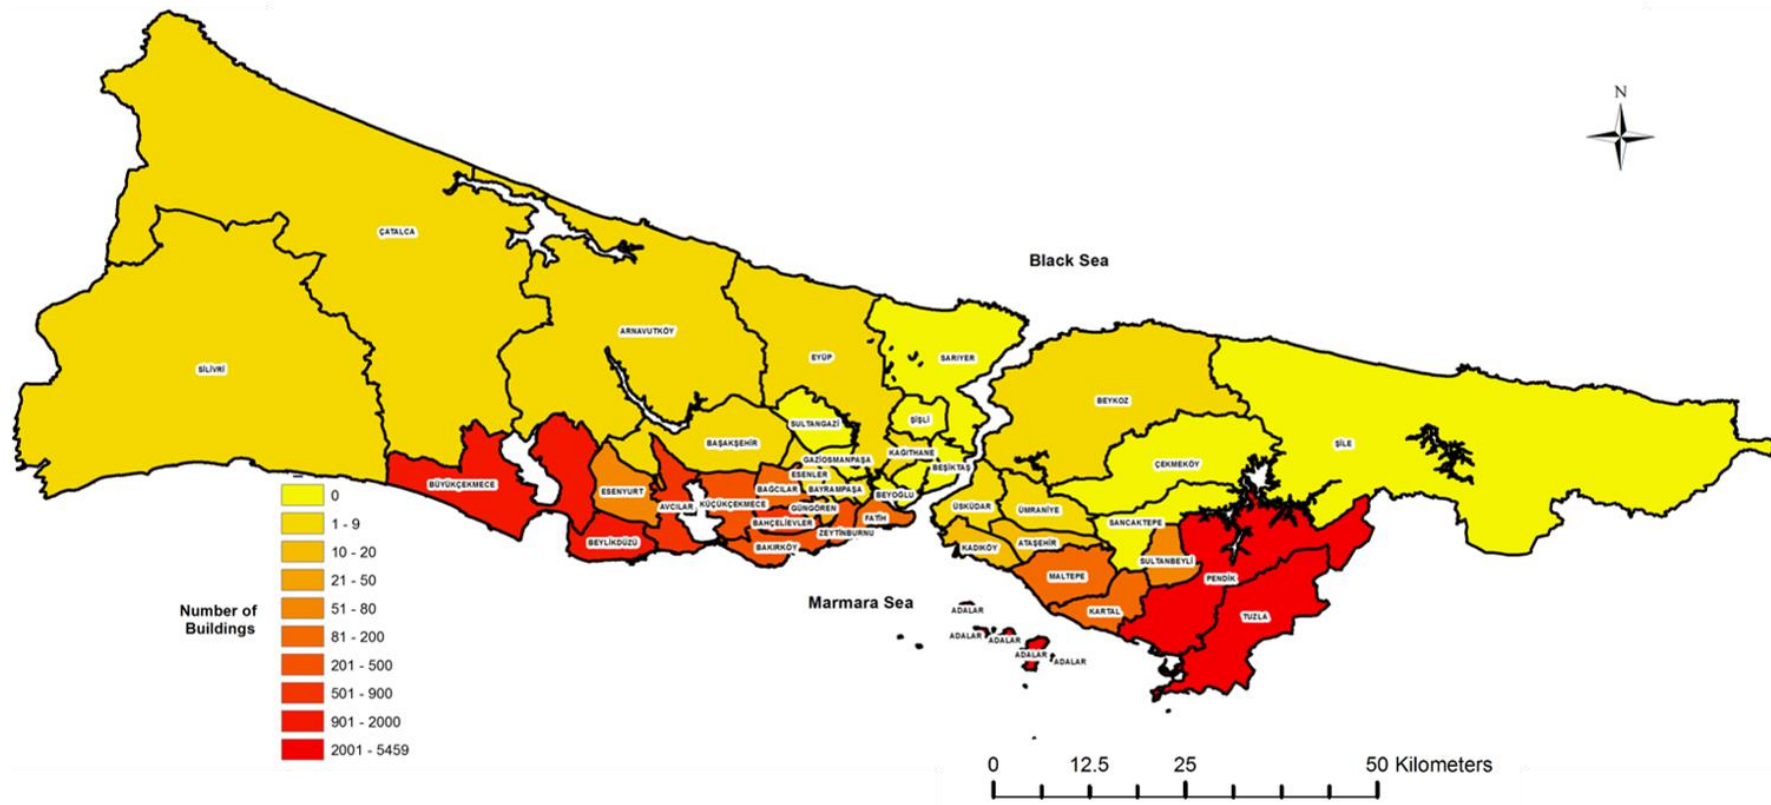
There are 39 districts and 936 sub-districts in Istanbul. According to the number of buildings that have possibility of complete and heavy damage more than 40% according to  $S_a$ , the earthquake damage for the buildings based on districts is shown in Figure 6.15. The 10 districts that have the highest heavy and complete damage risk are Tuzla, Pendik, Adalar, Beylikduzu, Bahcelievler, Avcilar, Zeytinburnu, Bakirkoy and Kucukcekmece respectively. If the sub-districts are taken into account for the highest heavy and complete damage risk the distribution of the districts are changed as followed Tuzla, Adalar, Pendik, Beylikduzu, Buyukcekmece, Bahcelievler, Avcilar, Kucukcekmece, Zeytinburnu, Kartal and Bakirkoy respectively (Figure 6.16).

**Figure 6.15 :** More than 40% Complete and heavy building damage possibility distribution of Istanbul districts based on 0.2 Sa.

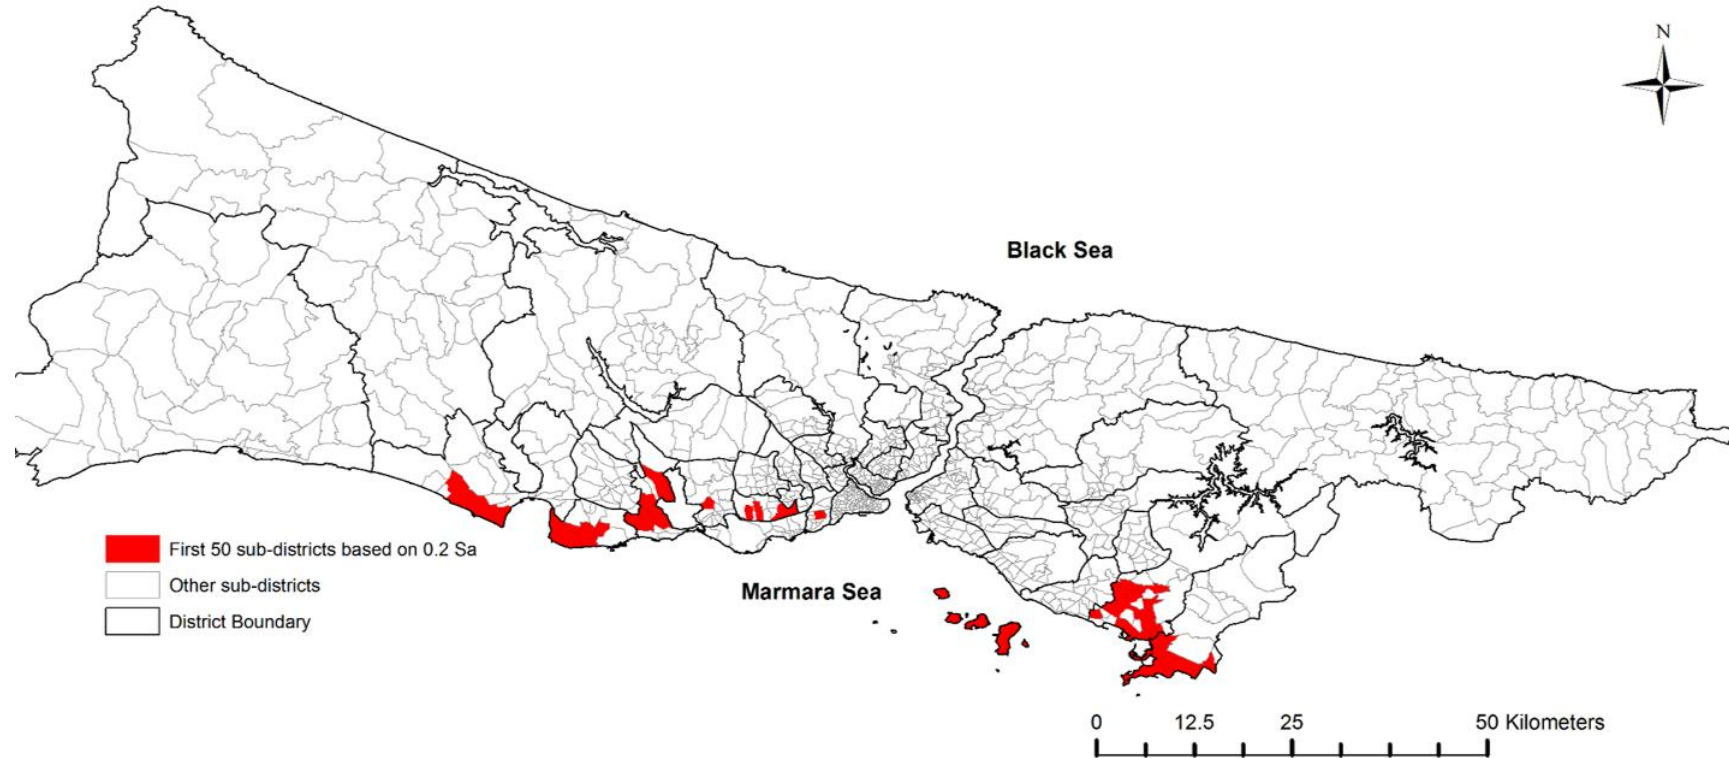
**Figure 6.16 :** More than 40% Complete and heavy building damage possibility distribution of Istanbul's first 50 sub-districts based on 0.2 Sa.

There are 2003 buildings in the Mimar Sinan Sub-district, which has the highest damage possibility, and there are 21,874 people living in that sub-district. According to this study's estimations, 1482 buildings in Mimar Sinan sub-district have more than 40% possibility of complete and heavily damage. This means that the damage could occur to more than 75% of buildings. In this case, approximately 15,000 people will be severely affected. The estimation numbers for the other sub-districts are also given at Table 6.21.

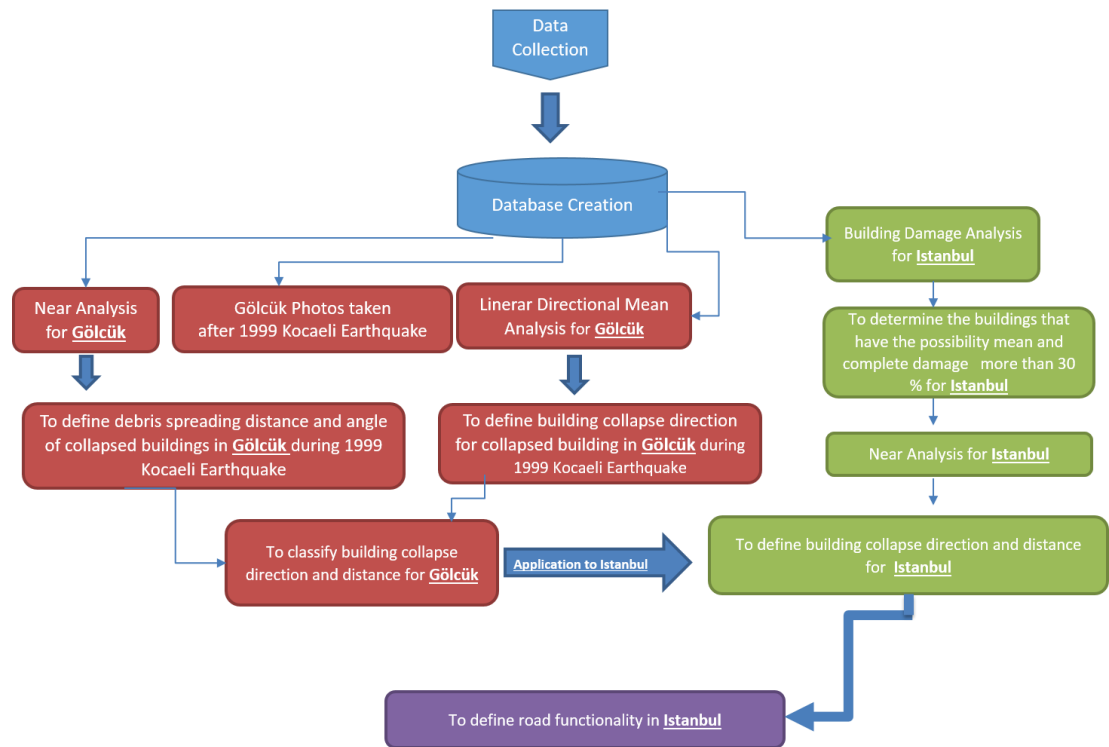
The collapse direction, distance and debris area estimation method of buildings in Istanbul is based on a potential Istanbul earthquake was obtained from collapsed building data in Gölçük, developed by using near and LDM (Linear Direction Mean) analysis on ArcGIS software. The conceptual workflow and the order of the analysis can be seen in Figure 7.1.

**Figure 7.1 :** Workflow and the order of the analysis for detecting road functionality based on building collapse direction.

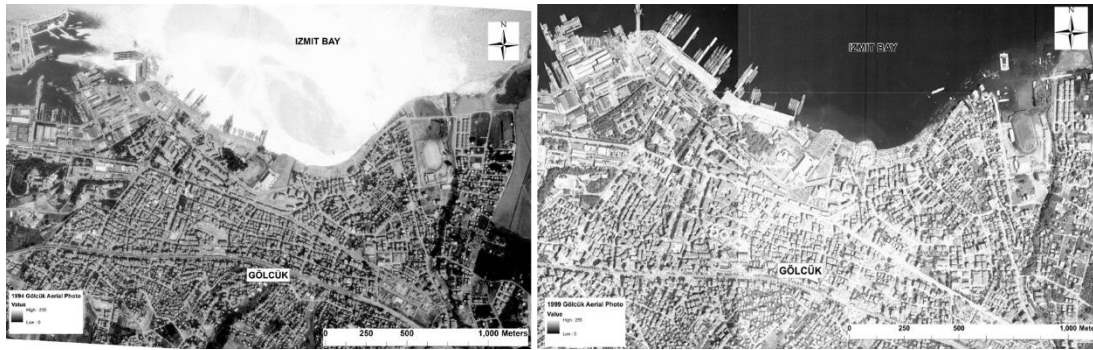
The first step of this study was to collect the data. Within the scope of this step, the Gölçük aerial photos taken before and after the 1999 Kocaeli Earthquake (in 1994 and September) were obtained from the General Command of Mapping (Figure 7.2).

**Figure 7.2 :** Gölcük aerial photos taken in 1994 and 1999.

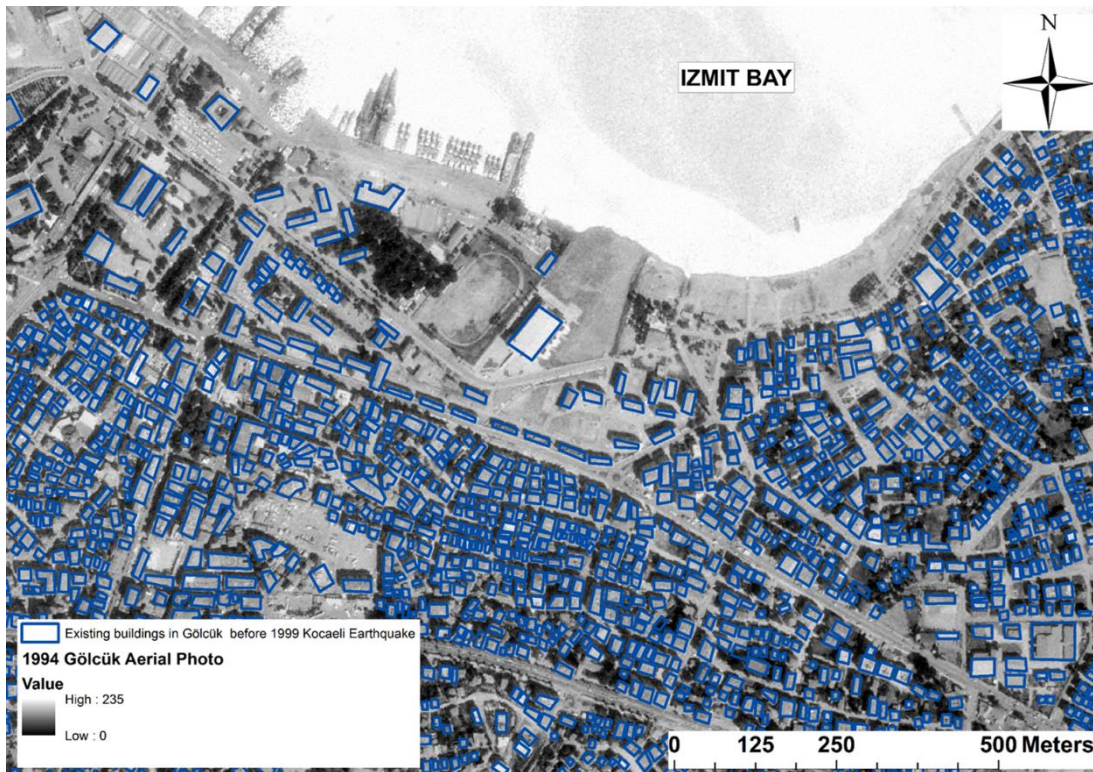
By using the 1994 aerial photo, 2157 building polygons were digitized for definition of the existing buildings in Gölcük before the 1999 earthquakes (Figure 7.3).

**Figure 7.3 :** The buildings that were built before 1994 in Gölcük.

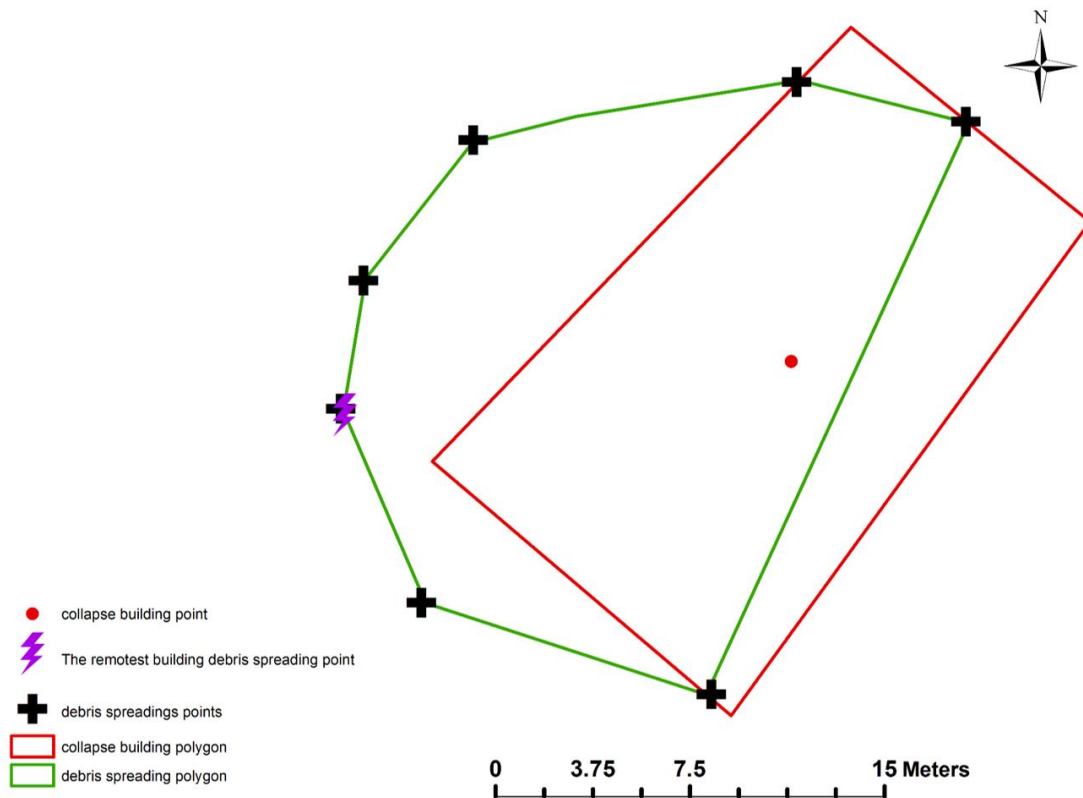
In order to define the remotest building debris spreading point that has the maximum distance from the collapsed building point, the points were created at different locations on the building debris spreading polygon data. These points were measured one by one from the centre of the collapsed buildings. Then the point that had the remotest distance from collapsed building was defined (Figure 7.5).

**Figure 7.5 :** To define the remotest debris spreading point.

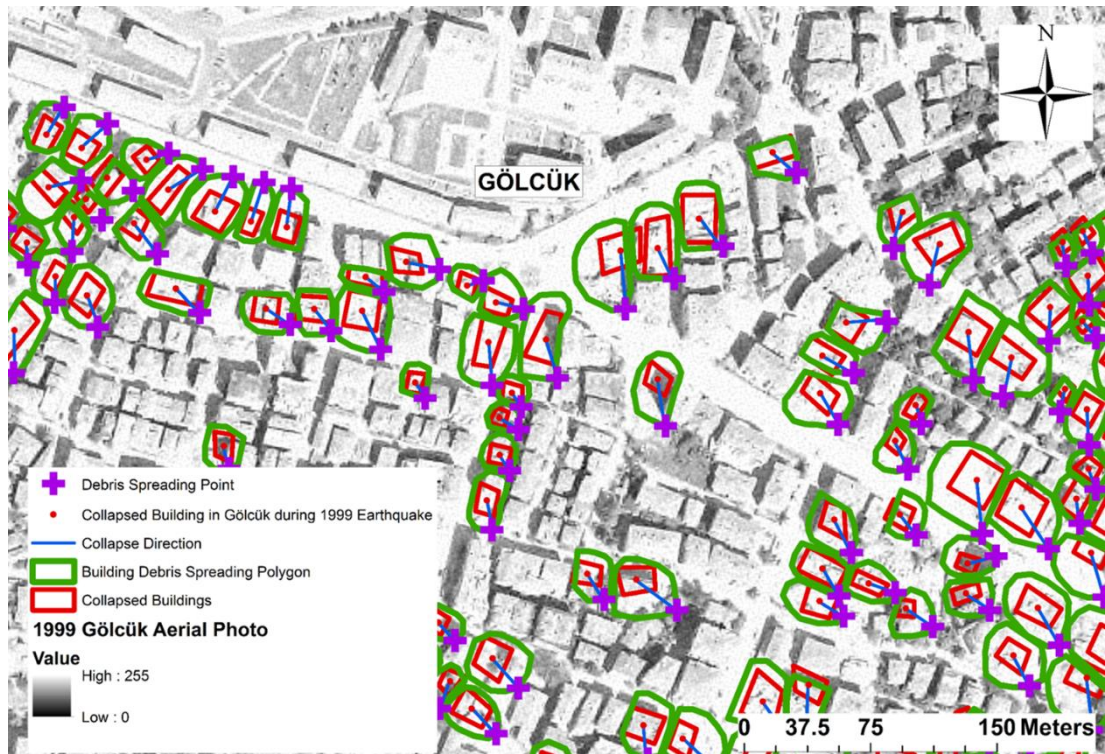
Thus “the remotest building debris spreading point data” was generated for every collapsed building on the building debris spreading polygon data according to the remotest point on the polygon circumference from the collapsed building point. Hereinafter it is referred to as a “debris spreading point”. Then “the remotest building debris spreading line data” was generated by crossing a line between the debris spreading data and the collapsed building point for every collapsed building. Hereinafter it is referred to as a “collapse direction” (Figure 7.6).

**Figure 7.6 :** Debris database from 1999 Gölcük aerial photo.

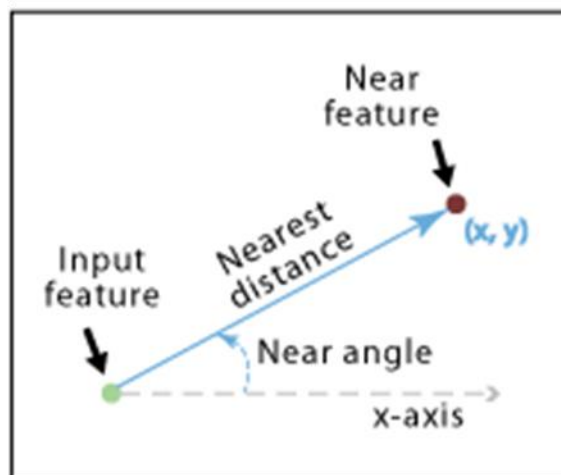
Near analysis on ArcGIS was used to find out the digital connection between the collapsed building location, debris spreading point and fault location (Figure 7.7). This analysis was repeated twice and the results were merged based on the building id number.

**Figure 7.7 :** Near analysis illustration on ArcGIS (ArcGIS Help File).

For the first Near analysis, collapsed building points were used as Input features and debris spreading points were used as Near feature (Figure 7.7). Near analysis needs another point in that its location should be farther than the debris spreading point from the collapsed building centre to calculate the near angle and distance. For this reason,

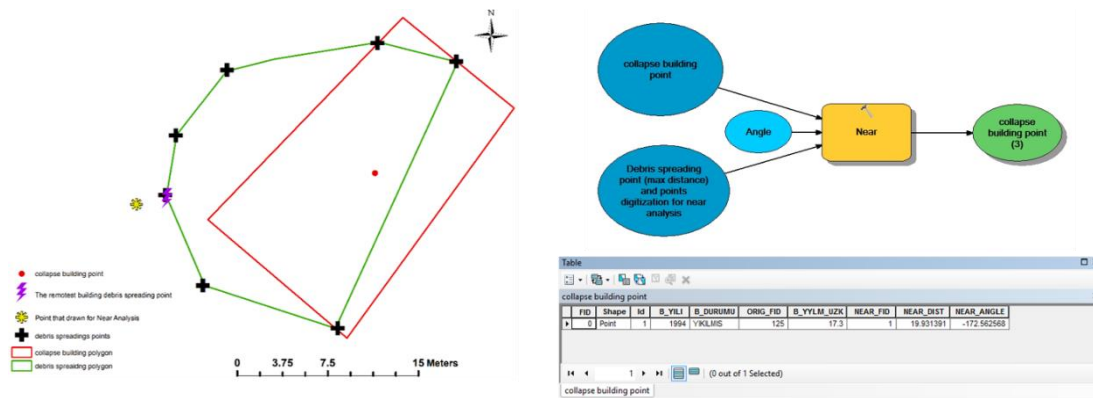
another point was digitized manually far from the debris spreading point in order to make a near analysis with the debris spreading point. This process was repeated for every 254 collapsed buildings. To decrease the process time, the model builder was created on ArcGIS. The Near analysis was repeated for every collapsed building in Gölcük individually by using this model builder. When running the model, the angle and distance between the collapsed building point and debris spreading point were obtained (Figure 7.8). After finishing the analysis the result tables were merged.

**Figure 7.8 :** Model builder for near analysis.

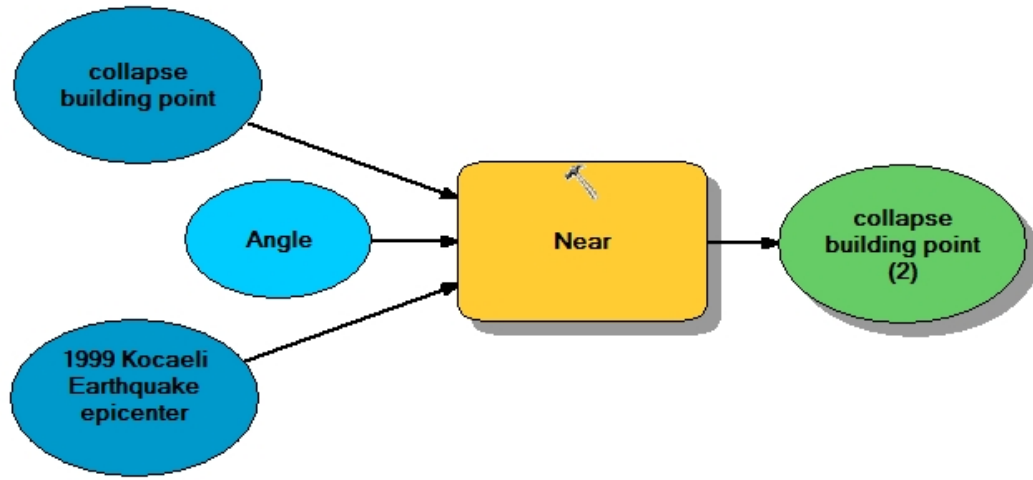
Model builder was created on ArcGIS and this model was run for every collapsed building individually (Figure 7.9). After finishing the analysis the result tables were merged.

**Figure 7.9 :** The second model builder for near analysis.

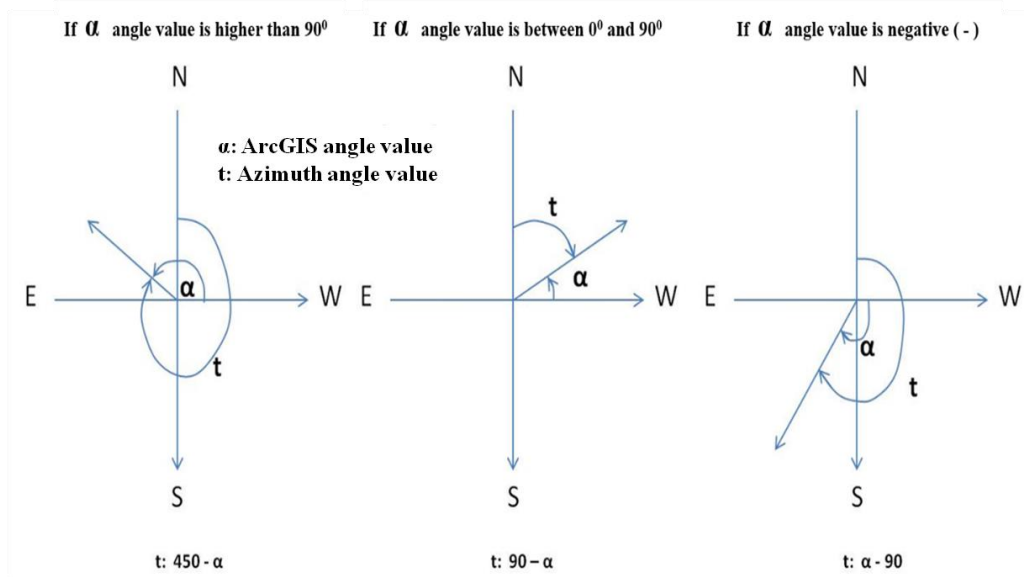
In order to calculate the Azimuth angle ( $t$ ) of the Near analysis angle values ( $\alpha$ ), the following calculations, were made. If the angle value was higher than  $90^\circ$ , the angle value was subtracted from  $450^\circ$ . If the angle value was between  $0$  and  $90^\circ$ , the angle value was subtracted from  $90^\circ$ . If the angle value was  $(-)$ , the angle value was subtracted from  $90^\circ$  (Figure 7.10).

**Figure 7.10 :** How to obtain azimuth angle value from near analysis angle value.

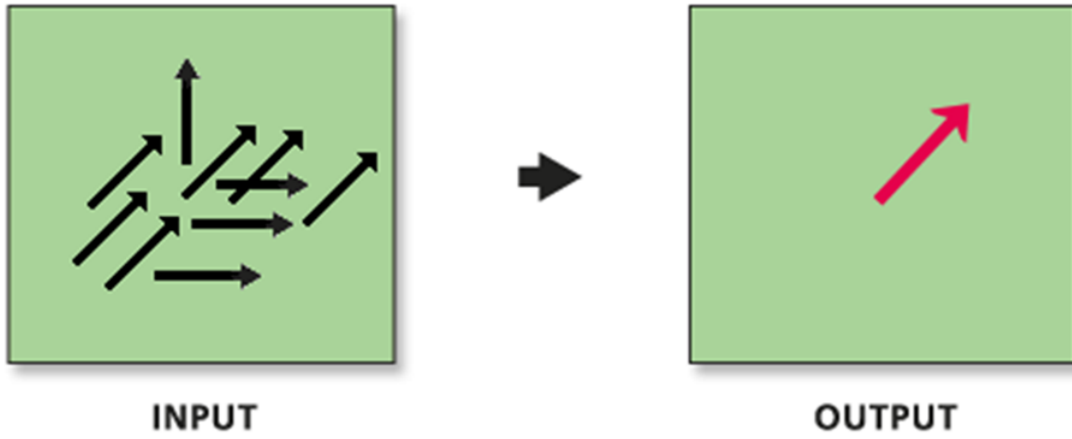
**Figure 7.11** : LDM analysis illustration on ArcGIS (ArcGIS Help File).

To determine the average spreading direction of the collapsed building in Gölcük, a LDM Analysis (Linear Directional Mean) on ArcGIS was used (Figure 7.11). In this analysis, the collapse direction was used as an input variable. At the end of the analysis, the average spreading direction of the collapsed building was achieved.

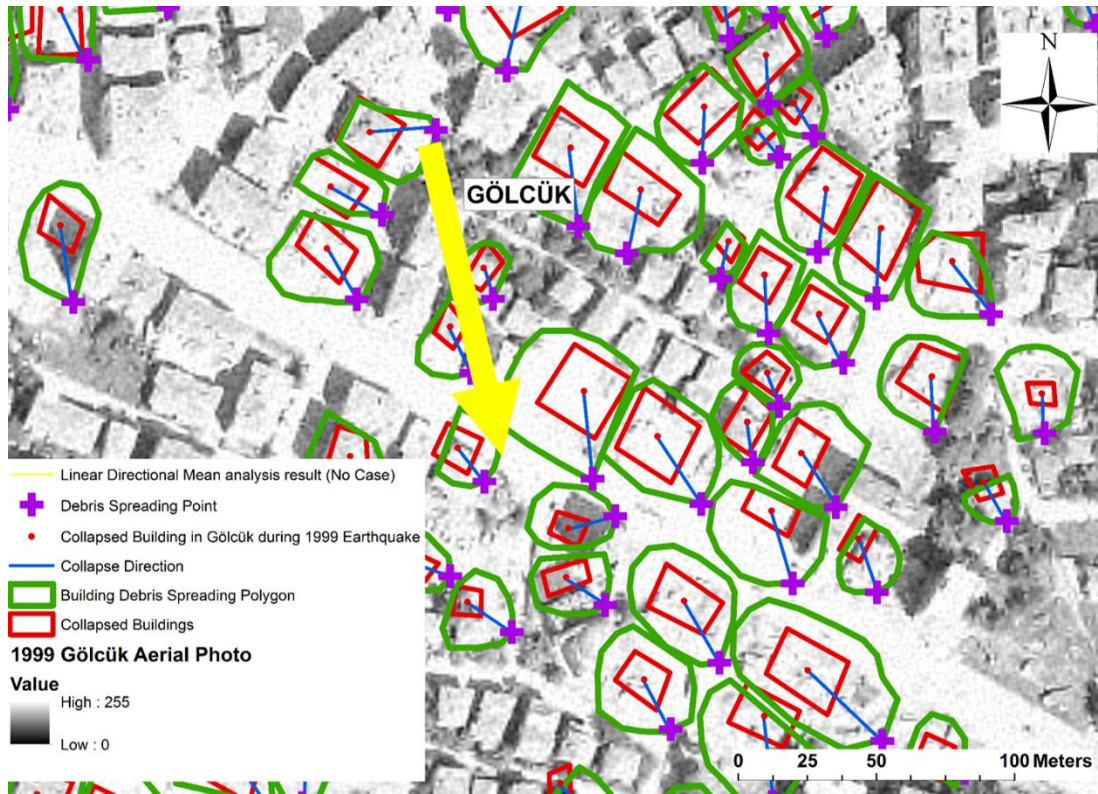
**Figure 7.12** : LDM analysis (field case: empty).

When LDM analysis was performed for first time, the case field was not filled in. Regarding this analysis, it is determined that the average direction of collapsed building spreading in Gölcük is approximately south (Figure 7.12).

Collapsed buildings cause debris around them; this was seen easily in the 1999 aerial photo due to the fact that it had a high resolution (Figure 7.12).

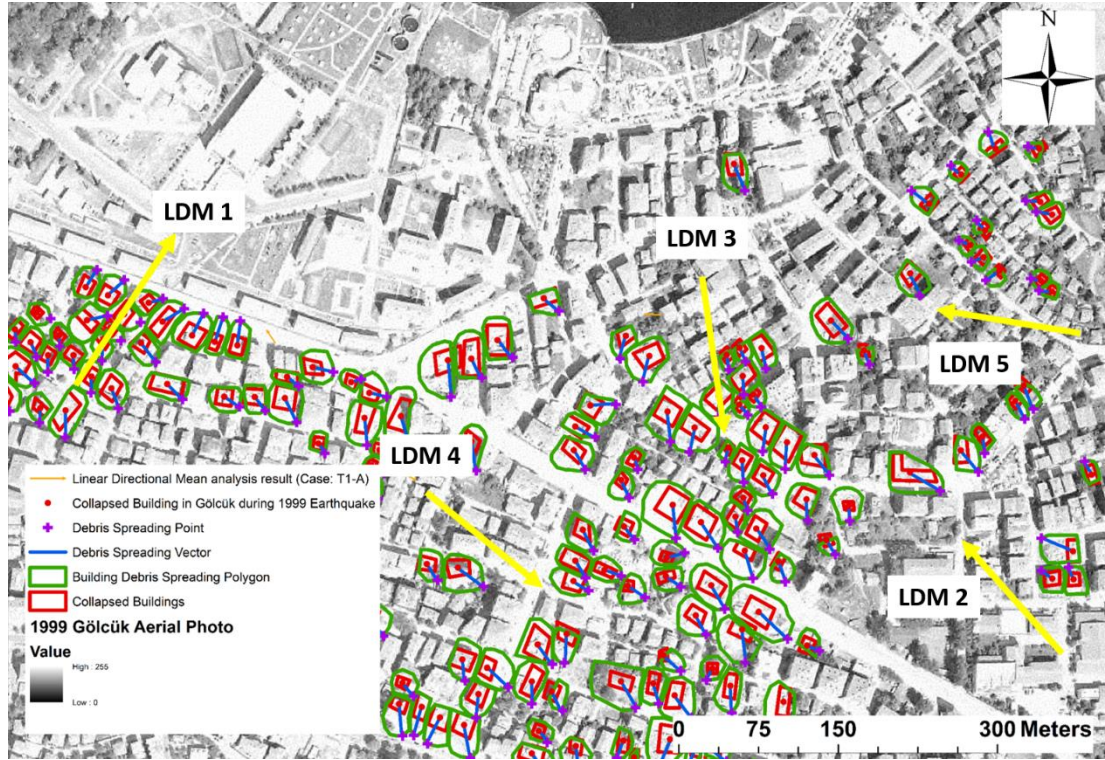
**Figure 7.13 : LDM analysis (field case: T<sub>1-A</sub>).**

When the LDM analysis was repeated for a second time and  $T_{1t}$  was chosen as the case field. The spreading direction of the collapsed buildings was distributed in five directions. The spreading direction was classified as: approximately north east as LDM1; approximately north west as LDM2; approximately south LDM3; approximately south east LDM4; and approximately west as LDM5 (Figure 7.13). The

appropriate direction from this classification was defined for every collapsed building in Gölcük by using the collapsed direction.

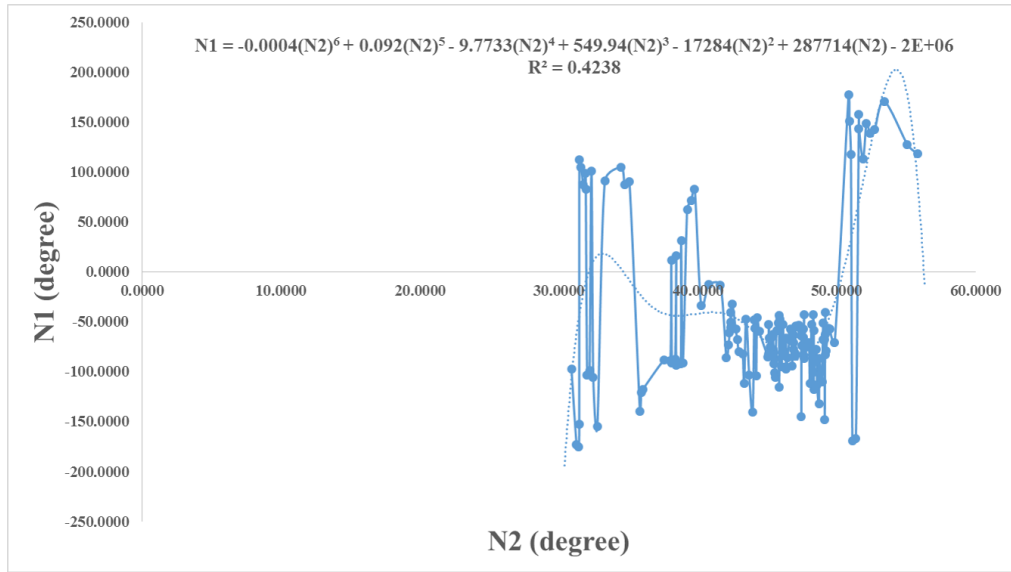
**Figure 7.14 :** The formula between  $N_2$  and  $N_1$  obtained from collapsed buildings in Gölcük.

When all the collapsed buildings in Gölcük were assessed according to  $N_2$  (x) and  $N_1$  (y), in order to reveal the relationship between them, the formula given in Figure 7.14 was obtained. The horizontal axis show the  $N_2$  angle and the vertical axis shows the  $N_1$  angle.

When all the collapsed buildings in Gölcük were assessed according to  $N_2$  (x) and  $N_1$  (y), in order to reveal relationship between them, the formula given in the Figure 5.23 was obtained. The horizontal axis shows the  $N_2$  angle and vertical axis shows the  $N_1$  angle. In order to obtain from  $N_2$  to  $N_1$ , we tried to find a formula by formatting the trendline option on Excel. Trendlines are used to graphically display trends in data and to help analyze problems of prediction. When a chart is added, a trendline can be generated in Microsoft Office Excel. Polynomial trendlines were chosen in this study. A trendline is most accurate when its R-squared value is at, or near, 1. Excel automatically calculates its R-squared value. Within the context of this study, five formulas were obtained, in order to apply the test to Istanbul. But because R-squared value was not near 1, these formulas were not used for Istanbul's buildings (Figure 7.14, Figure 7.15, Figure 7.16, Figure 7.17).

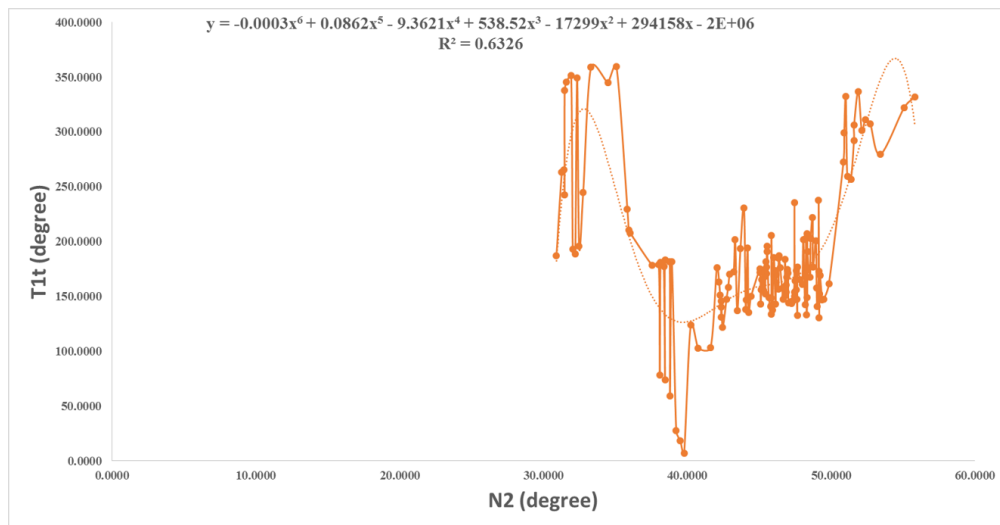
**Figure 7.15 :** The formula between  $N_2$  and  $T_{1t}$  obtained from collapsed buildings in Gölcük.

When all the collapsed buildings in Gölcük were assessed according to  $N_2$  (x) and  $T_{1t}$  (y), in order to reveal the relationship between them, the formula given in Figure 7.15 was obtained. The horizontal axis shows the  $N_2$  angle and the vertical axis shows the  $T_{1t}$  angle.

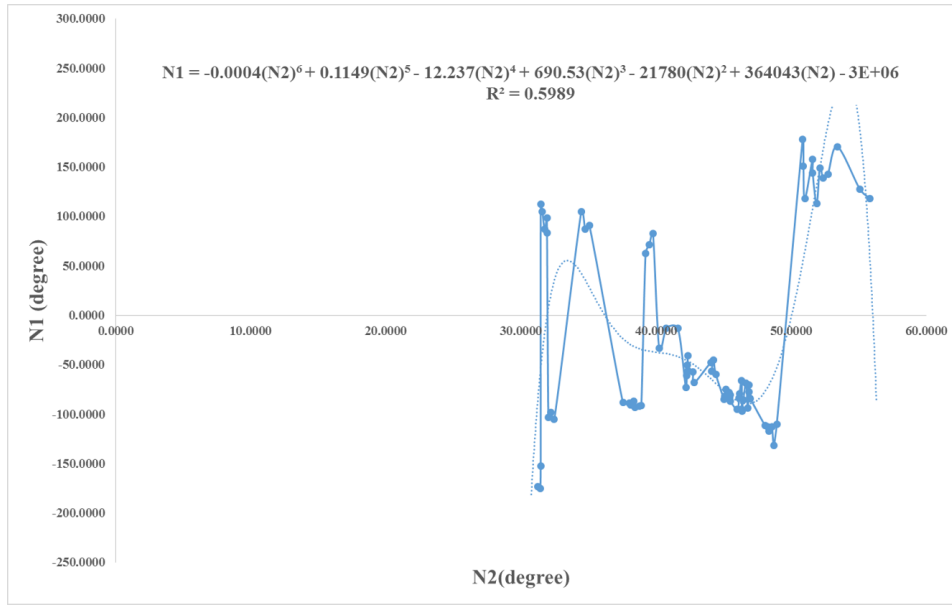
**Figure 7.16 :** The formula between  $N_2$  and  $N_1$  obtained from building classes in Gölcük.

When the building classes in Gölcük were assessed according to  $N_2$  (x) and  $N_1$  (y) in order to reveal the relationship between them, the formula given in Figure 7.16 was obtained. The horizontal axis shows the  $N_2$  angle and the vertical axis shows the  $N_1$  angle.

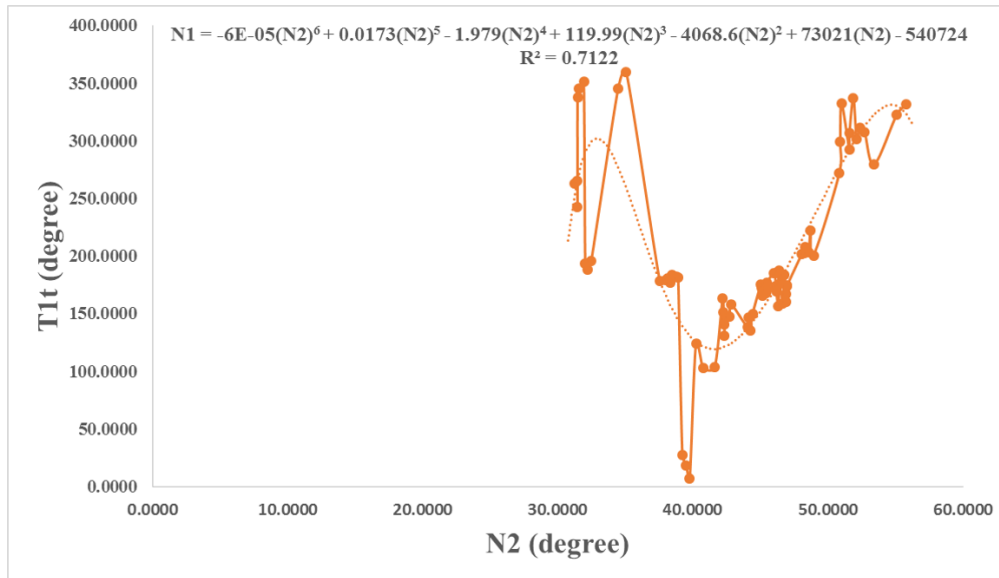
**Figure 7.17 :** The formula between  $N_2$  and  $T_{1t}$  obtained from building classes in Gölcük.

When the building classes in Gölcük were assessed according to  $N_2$  (x) and  $T_{1t}$  (y) in order to reveal the relationship between them, the formula given in Figure 7.17 was obtained. The horizontal axis shows the  $N_2$  angle and the vertical axis shows the  $T_{1t}$  angle.

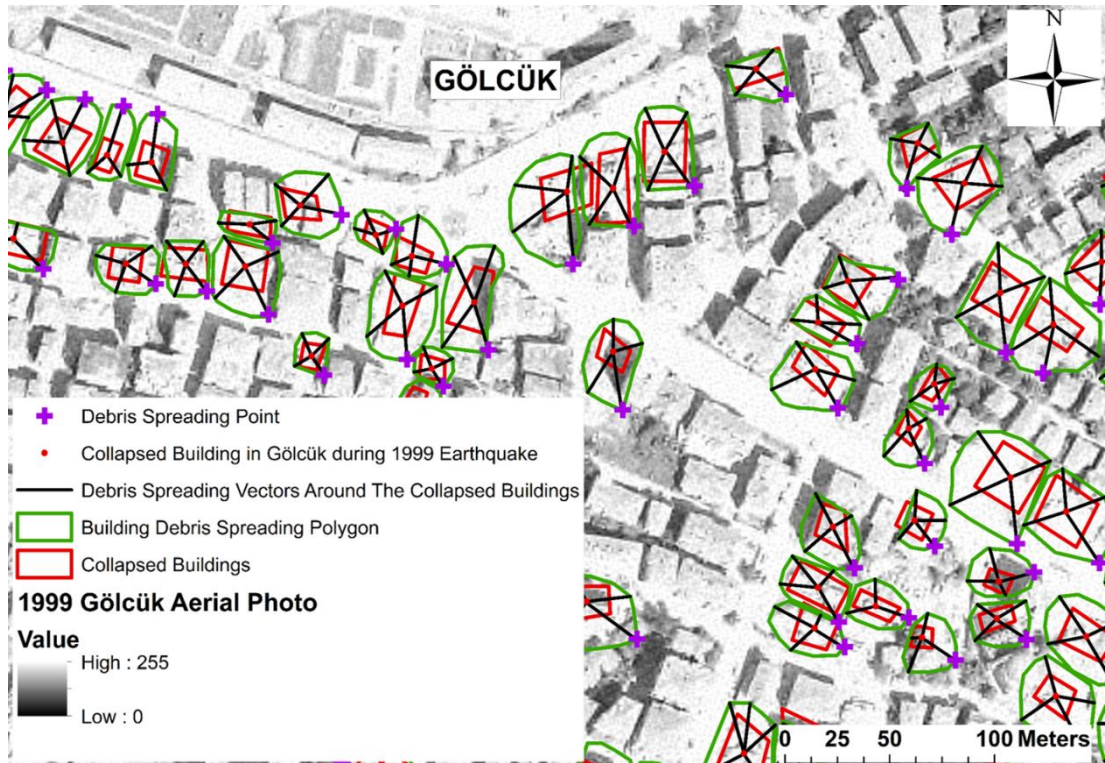
**Figure 7.18 :** Debris spreading vectors around the collapsed buildings in Gölcük.

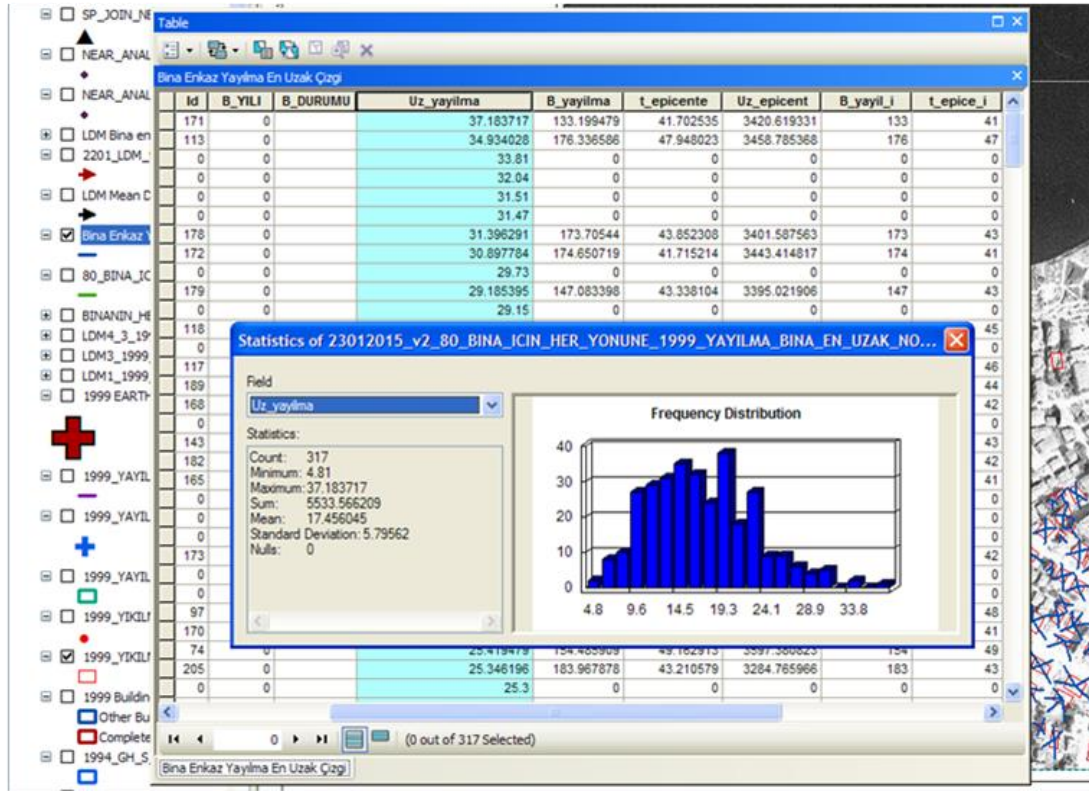
Figure 7.19 : Determination of average collapsed building spreading.

According to the statistical process between 317 debris spreading vectors in every direction, the maximum distance of the debris of the collapsed buildings in Gölcük was 37.18m, the average distance of the debris of the collapsed buildings in Gölcük was 17.45m and the least distance of the debris of the collapsed buildings in Gölcük is 4.81m (Figure 7.19).

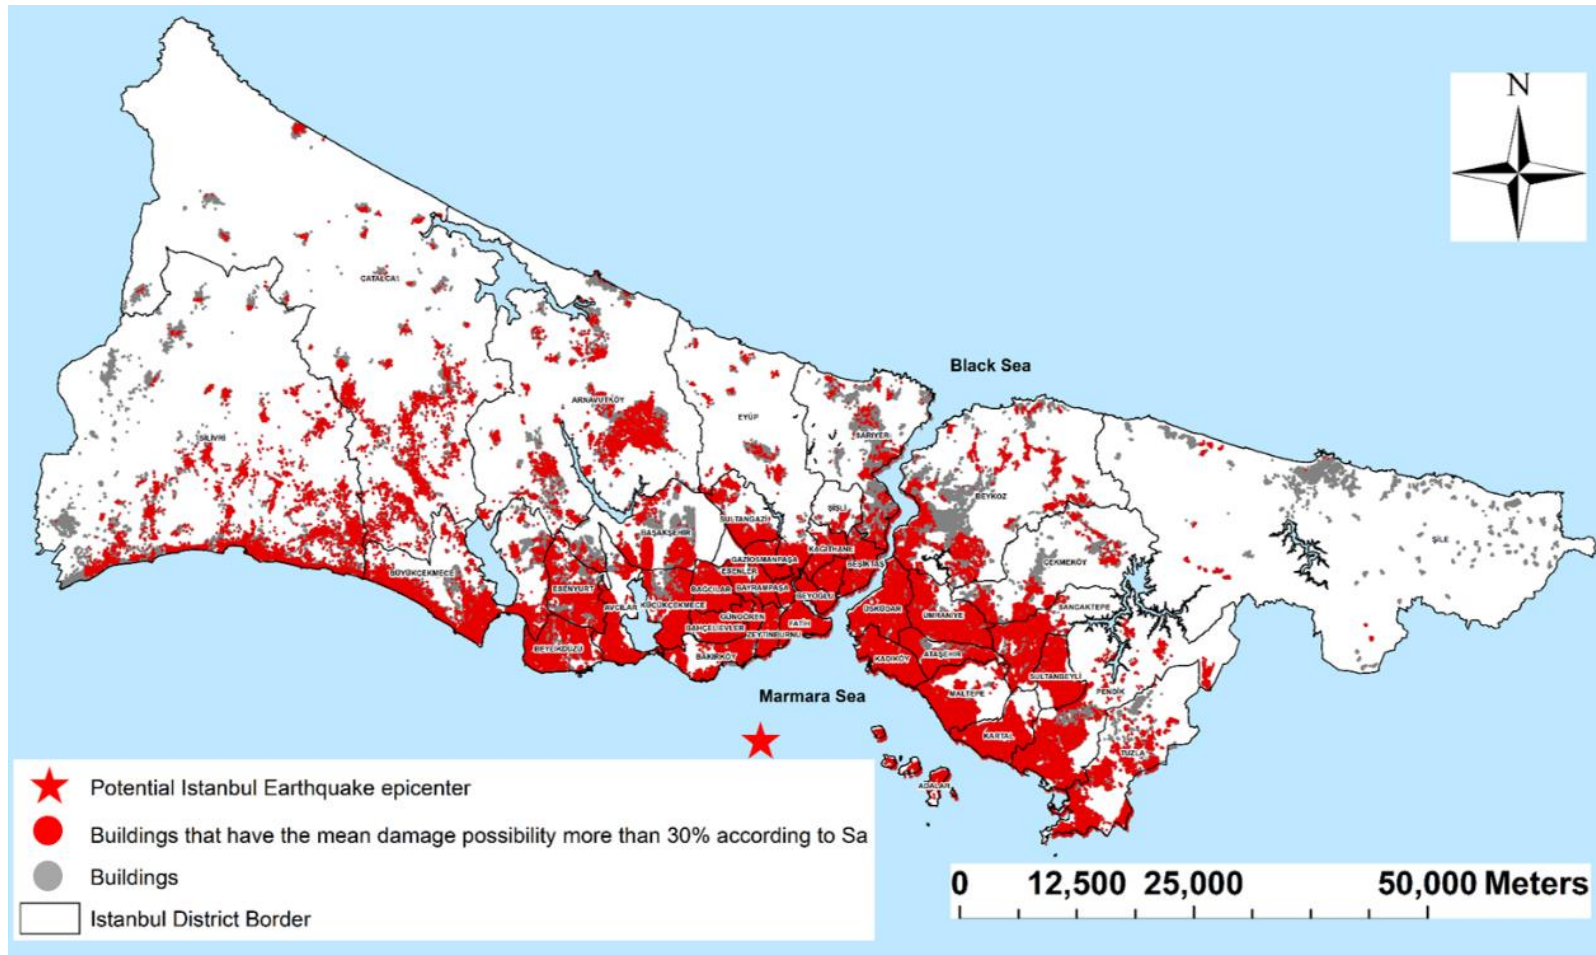
**Figure 7.20 :** The buildings in Istanbul that have the mean damage possibility more than 30% .

According to building damage analysis using HAZTURK software, there are 680817 buildings in Istanbul that have the possibility for mean damage of more than 30% against to  $S_a$  (Figure 7.20).

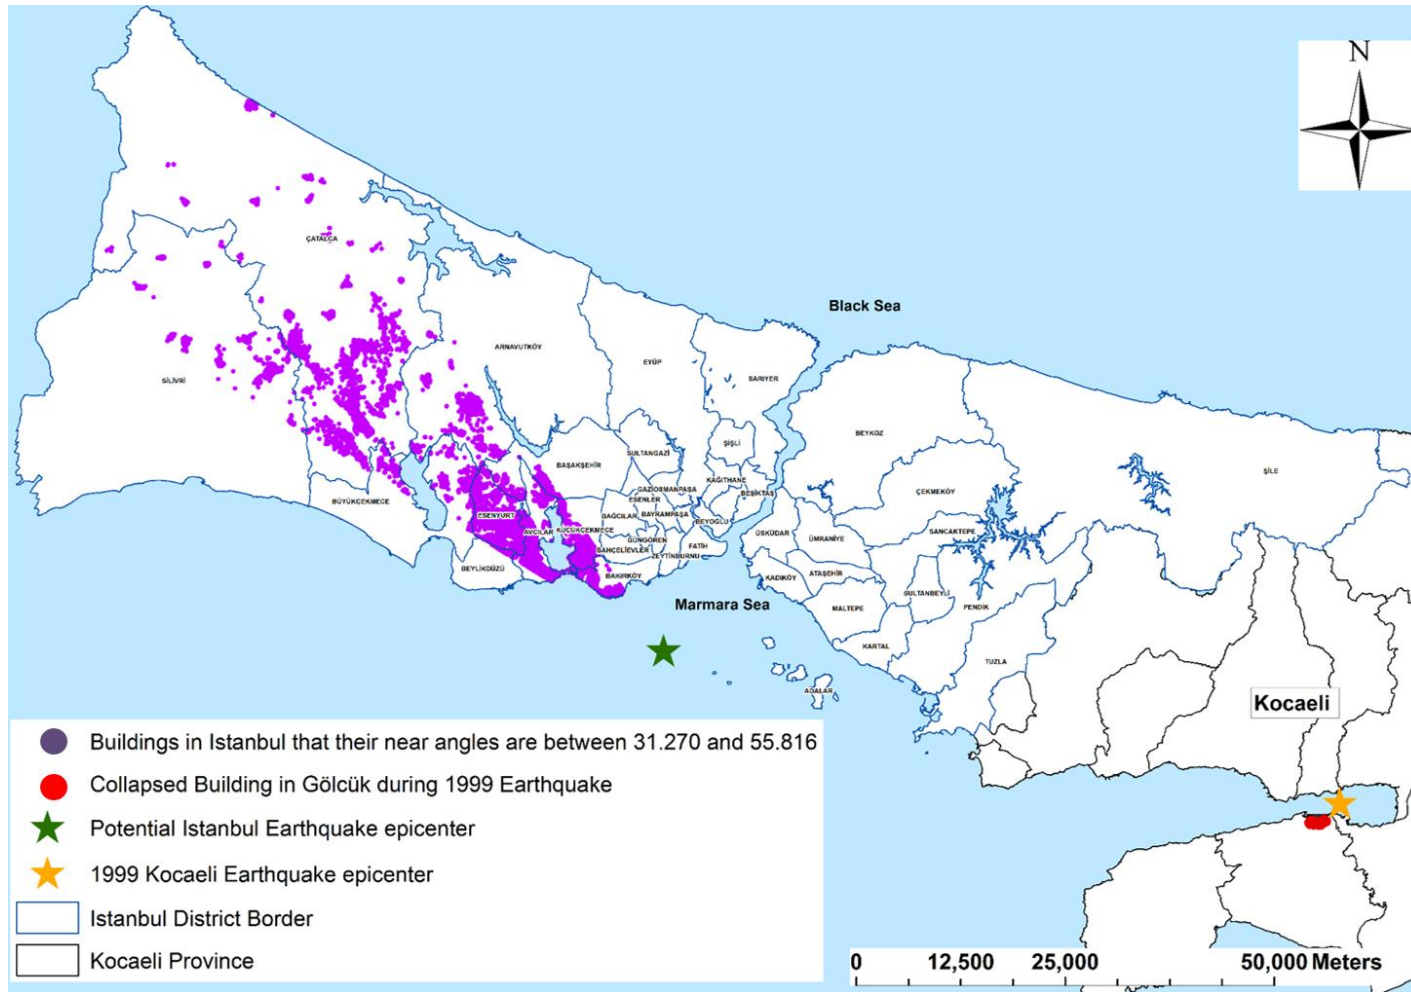
**Figure 7.21 :** The buildings in Istanbul that their near angles are between 31.2700 – 55.8160.

In this step, the  $N_1$  angles of buildings in Istanbul were assigned by using  $N_2$ . In Gölcük, the  $N_2$  angle values changed between 31.2700 and 55.8160. So the classification tables were created between these values. For this reason, the buildings whose Near angle values in Istanbul lay outside of the range 31.2700 and 55.8160 were deleted. After deleting buildings that have the inappropriate  $N_2$  values, there were 44642 buildings in Istanbul whose Near angles were between 31.2700 and 55.8160 (Figure 7.21).
