**EFFECTS OF BUILDING COLLAPSE DIRECTION  
AND BRIDGE FUNCTIONALITY ON ROAD  
NETWORKS FOLLOWING AN EARTHQUAKE**

**Ph.D. THESIS**

**Betül ERGÜN KONUKCU**

**Geomatics Engineering Department**

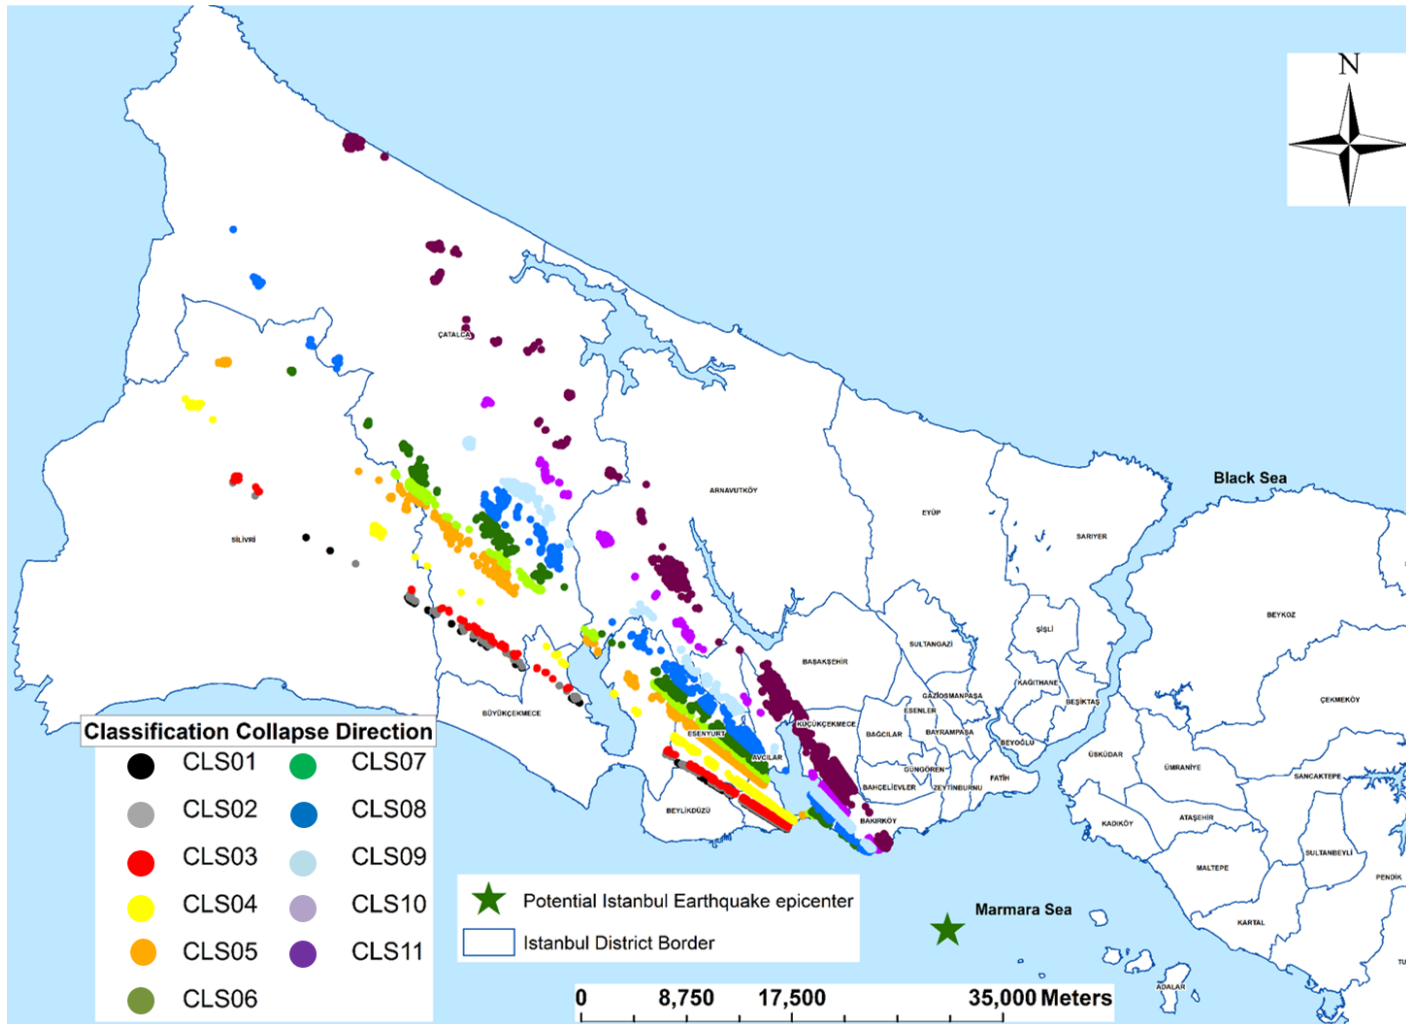
**Figure 7.22 :** The distribution of collapse direction classification in Istanbul.

Regarding classification of the spreading direction of the collapsed building tables in Istanbul, there were 630 buildings belonging to CLS01, 1214 buildings belonging to CLS02, 1208 buildings belonging to CLS03, 2267 buildings belonging to CLS04, 6513 buildings belonging to CLS05, 2011 buildings belonging to CLS06, 5381 buildings belonging to CLS07, 7098 buildings belonging to CLS08, 2929 buildings belonging to CLS09, 1421 buildings belonging to CLS10, and 13970 buildings belonging to CLS11. It is expected that the collapse direction of CLS01 buildings would be LDM5 (approximately east), the collapse direction of CLS02, CLS04, CLS06 buildings would be LDM1 (north east), the collapse direction of CLS03, CLS05, CLS09, CLS10 buildings would be LDM3 (south), the collapse direction of CLS07, CLS08 buildings would be LDM4 (south east), the collapse direction of CLS11 buildings would be LDM2 (north west) (Figure 7.22).

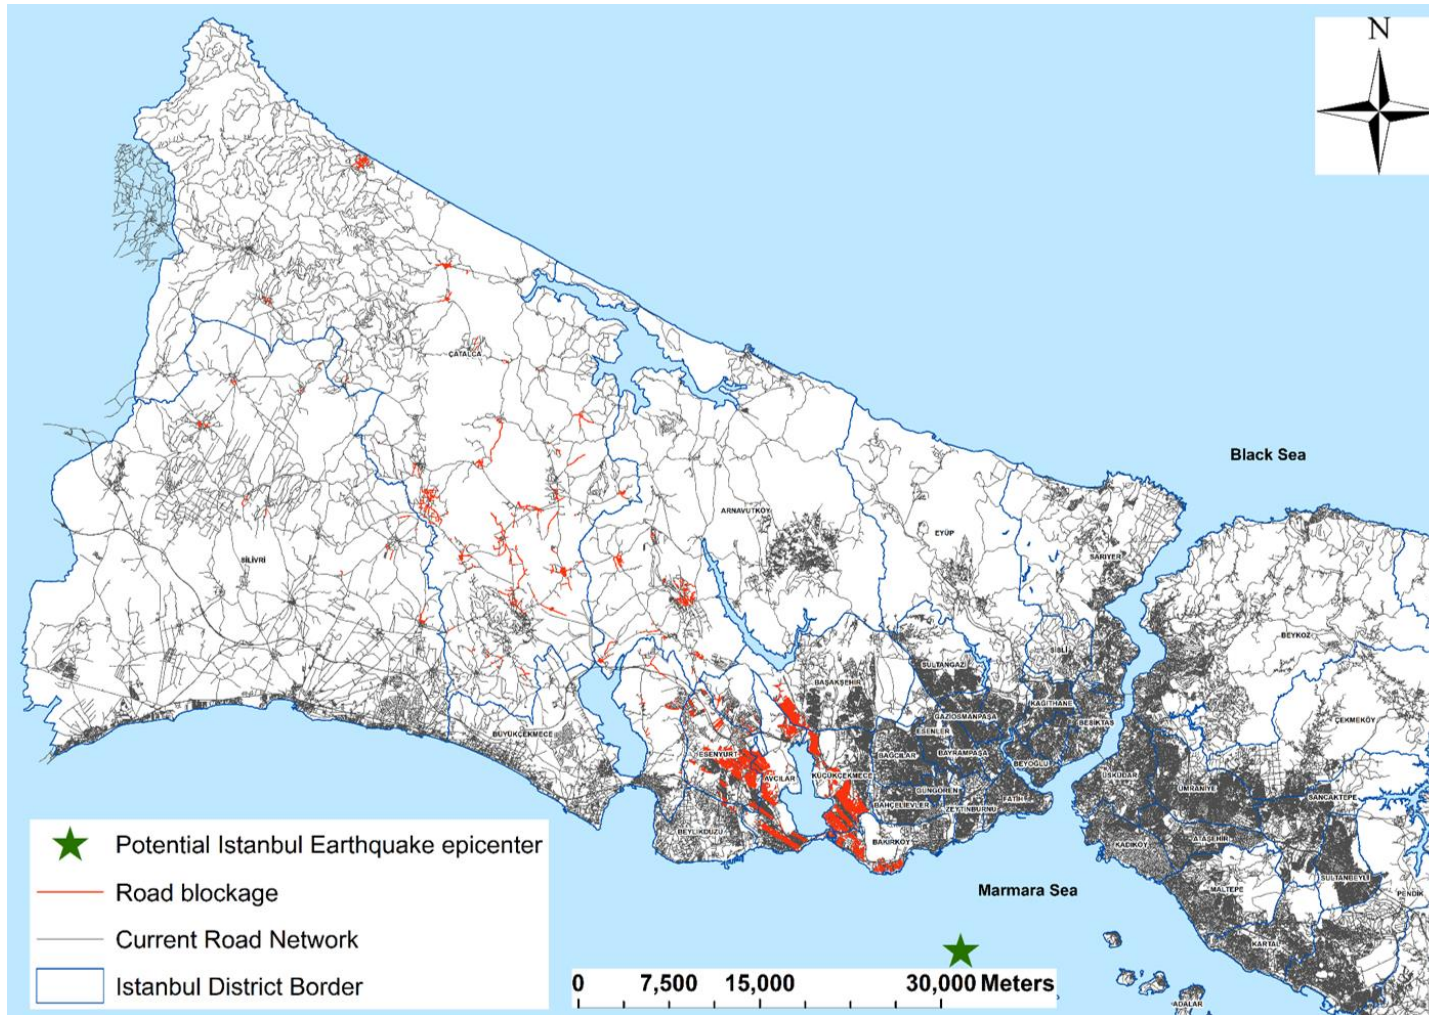
**Figure 7.23 :** Road blockage in Istanbul because of the building collapse direction.

By using the average  $S_s$  for every class value given in Table 4 and taking into account the LDM class (collapsed buildings spreading direction), the possible road blockages were determined for these areas in Istanbul. The current road network in Istanbul is approximately 30325 km, of which, according to the road blockage analysis, approximately 888 kms of road could decrease its functionality (Figure 7.23). As seen in Figure 7.24, possible non-functional roads in Istanbul are located in the most populated area in Istanbul.

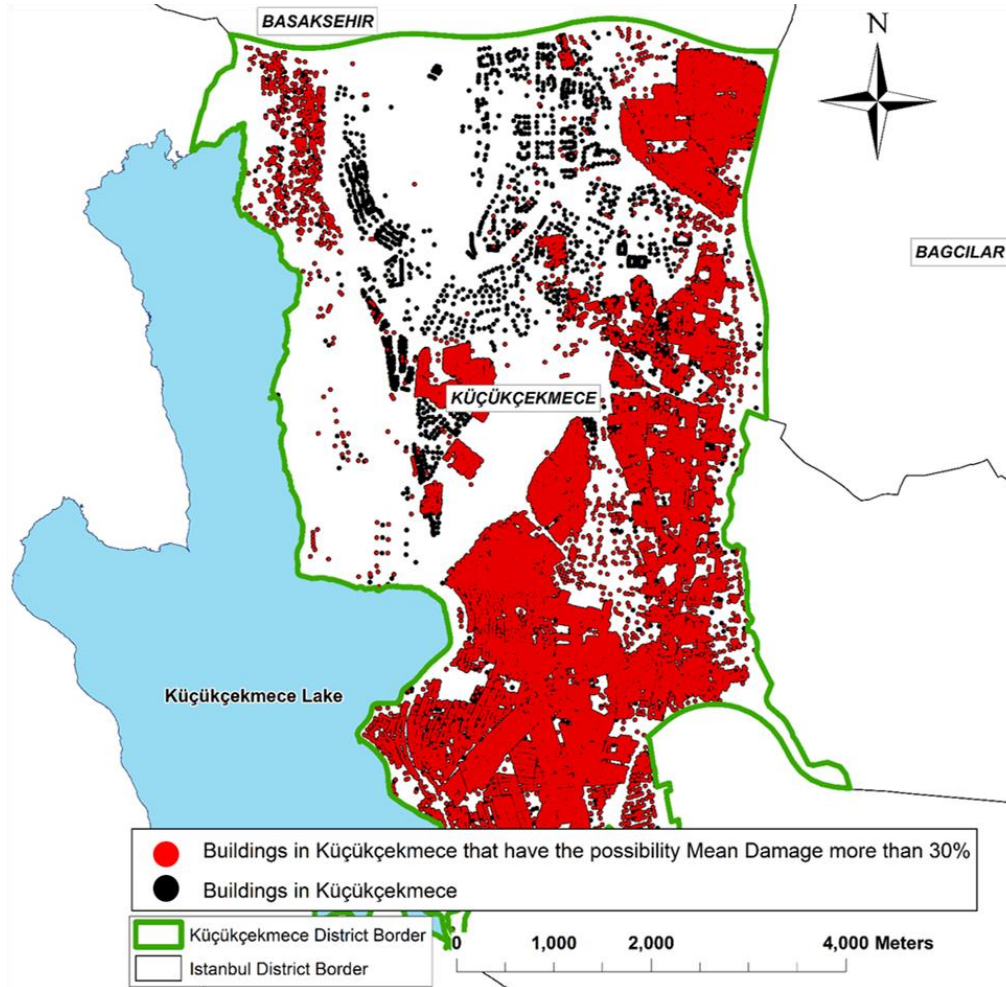
**Figure 7.25 :** Buildings in Küçükçekmece with more than 30% mean damage possibility.

According to building damage analysis calculated by using HAZTURK software, there are 31061 buildings that have the possibility of more than 30% mean damage (Figure 7.25).

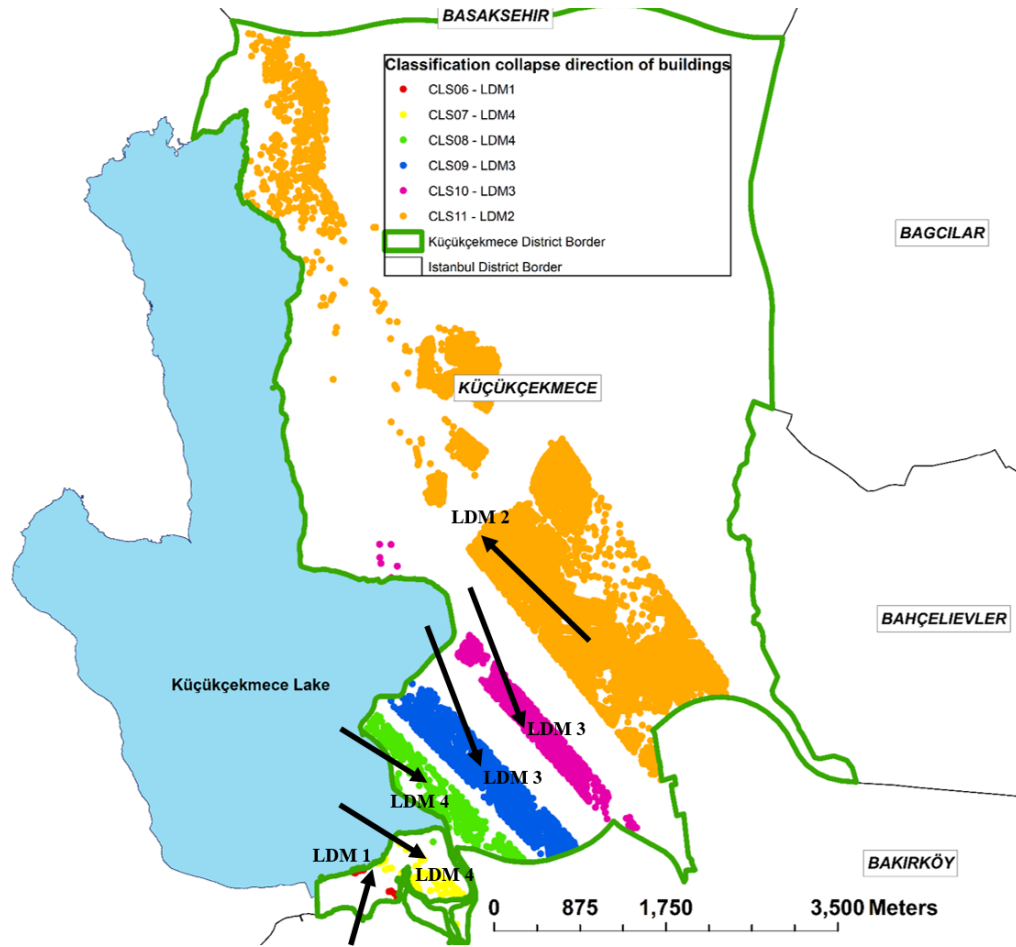
**Figure 7.26 :** Classification of spreading direction of collapsed buildings in Küçükçekmece.

When the buildings were deleted which had the  $N_2$  angles which were not between 31.2700 - 55.8160, there were 12292 buildings in Küçükçekmece that were suitable for classification of possible spreading direction and distance of collapsed buildings as obtained from the Gölcük study. Regarding this classification, there were 10 buildings belonging to CLS06, 91 buildings belonging to CLS07, 439 buildings belonging to CLS08, 1346 buildings belonging to CLS09, 955 buildings belonging to CLS10, 9451 buildings belonging to CLS11 in Küçükçekmece. These buildings will cause debris in directions LDM1, LDM4, LDM3 and LDM2 (Figure 7.26).

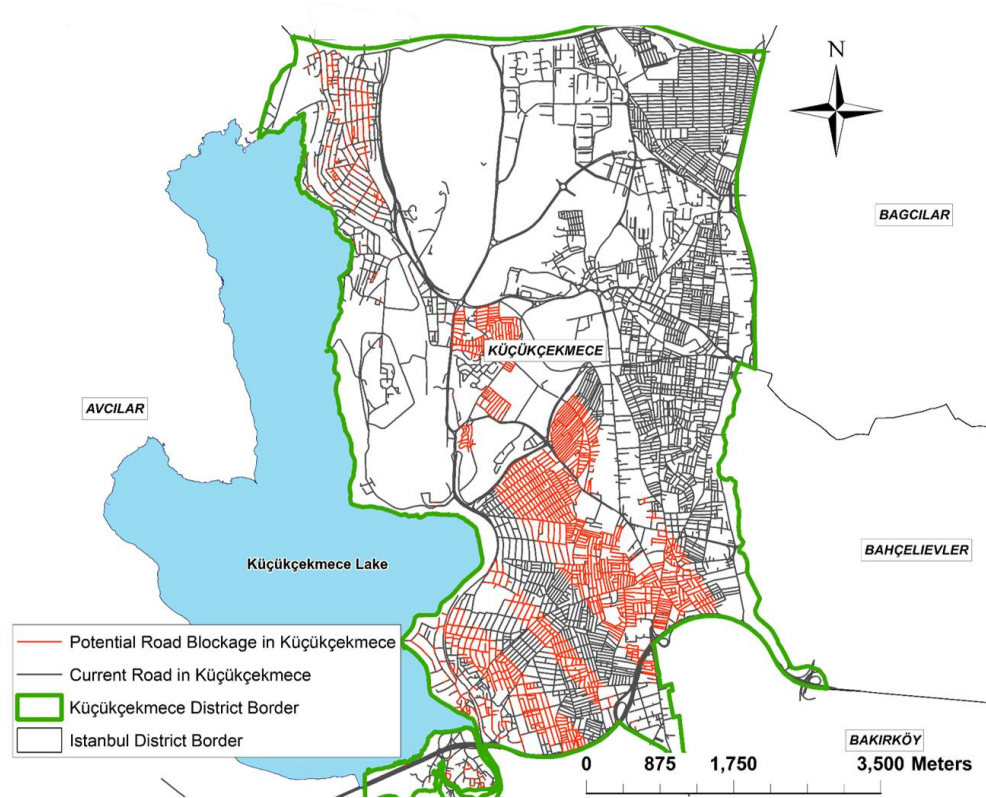
**Figure 7.27 :** Road blockage in Küçükçekmece because of the building collapse direction.

Regarding the spreading direction and spreading distance of collapsed buildings, the estimation of possible road blockages in Küçükçekmece is given in Figure 6.26. The current road network in Küçükçekmece is approximately 624 km; according to road blockage analysis, approximately 210 km of these roads could decrease in functionality (Figure 7.27).

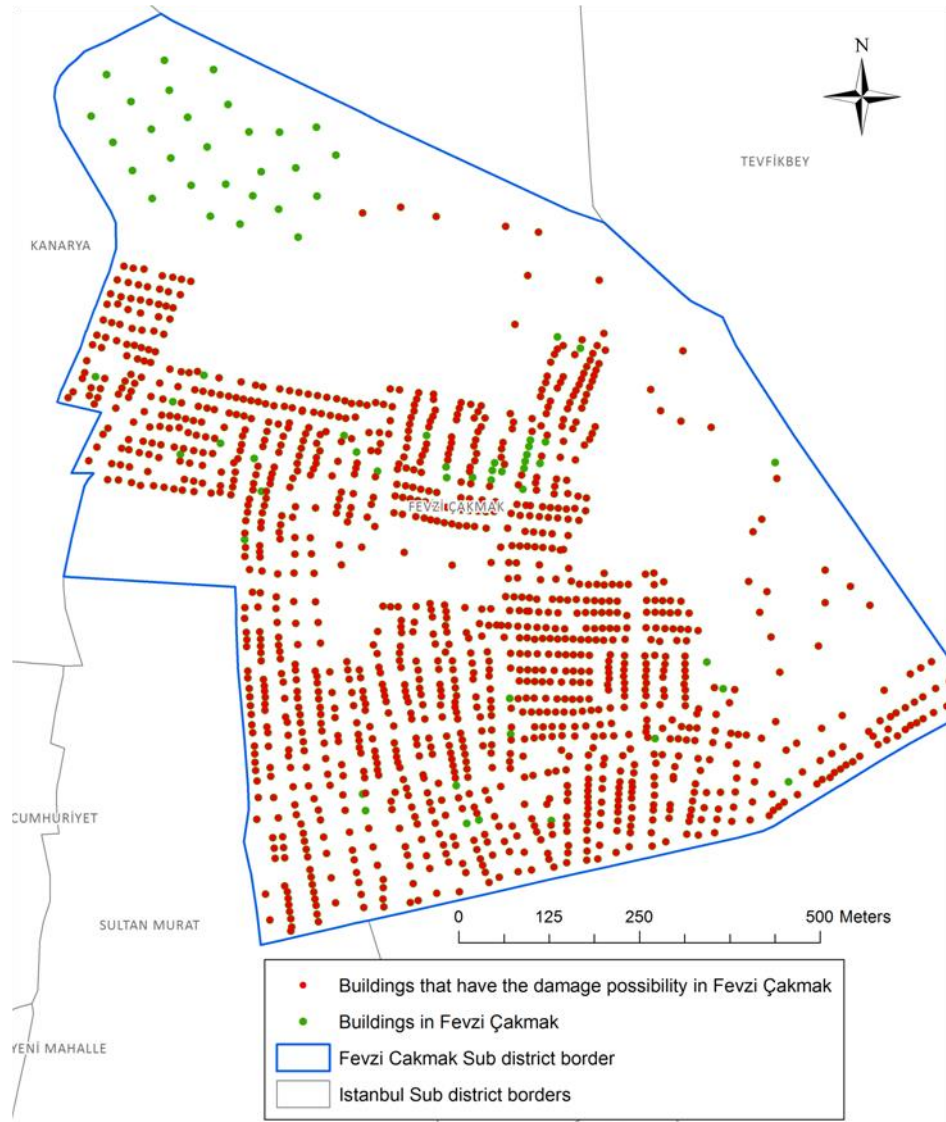
**Figure 7.30 :** Buildings in Fevzi Çakmak sub district that mean damage possibility more than 30%.

Of these, 1354 had the possibility of mean damage of more than 30% in a potential Istanbul earthquake (Figure 7.30).

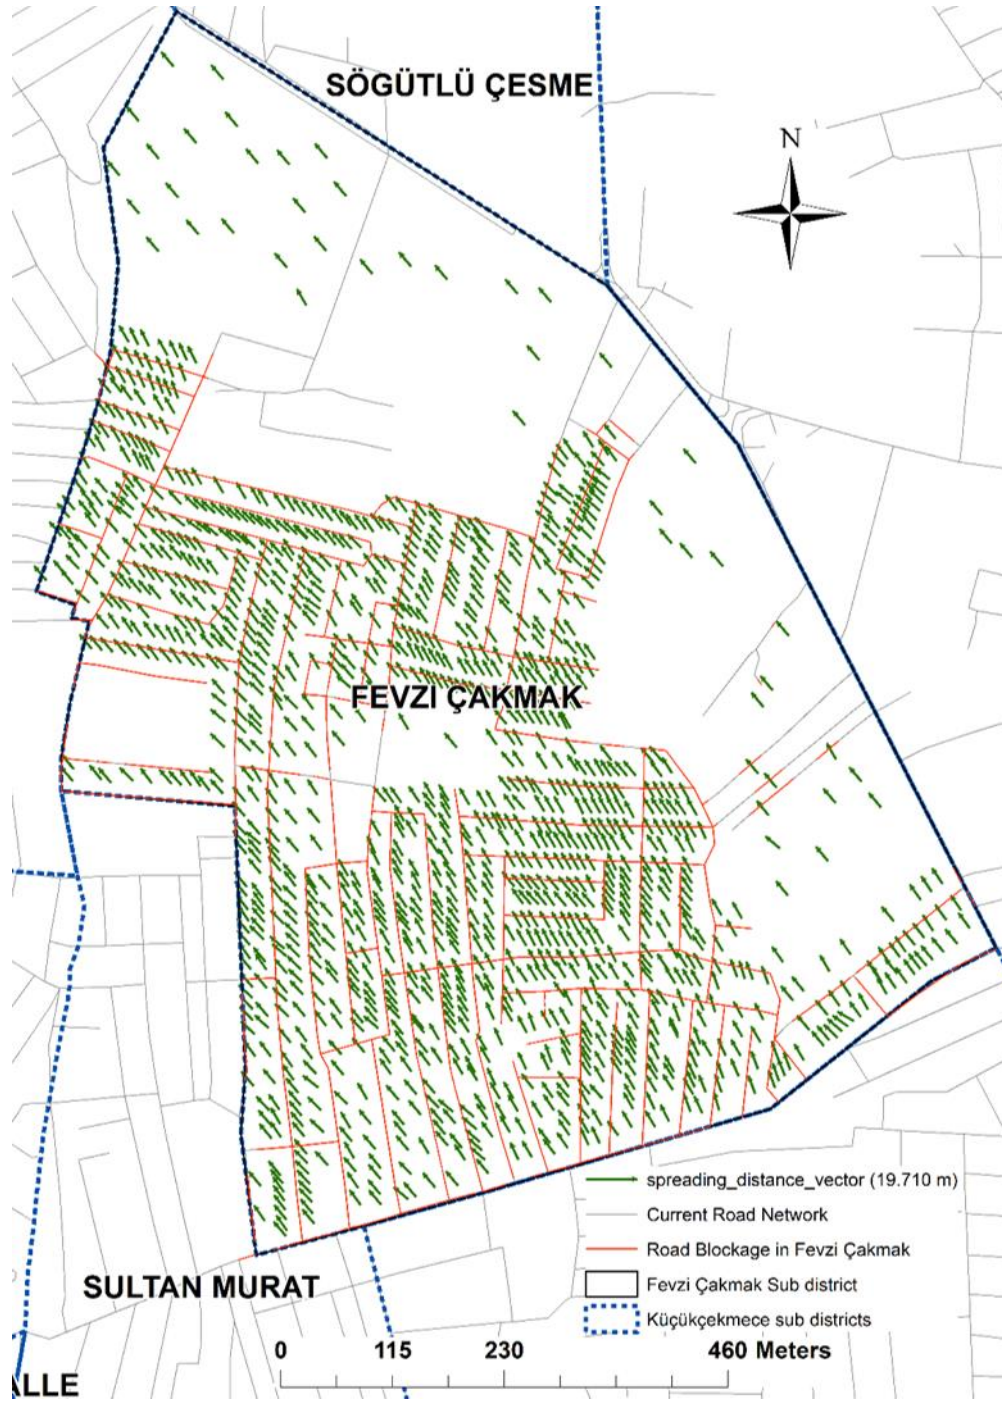
**Figure 7.31 :** Classification of spreading direction of collapsed buildings in Fevzi Çakmak.

The collapse classification of these 1354 buildings was CLS11 and it is expected that these buildings will collapse in the direction of LDM2 (approximately north east) with an average debris spreading distance of 19.710m (Figure 7.31).

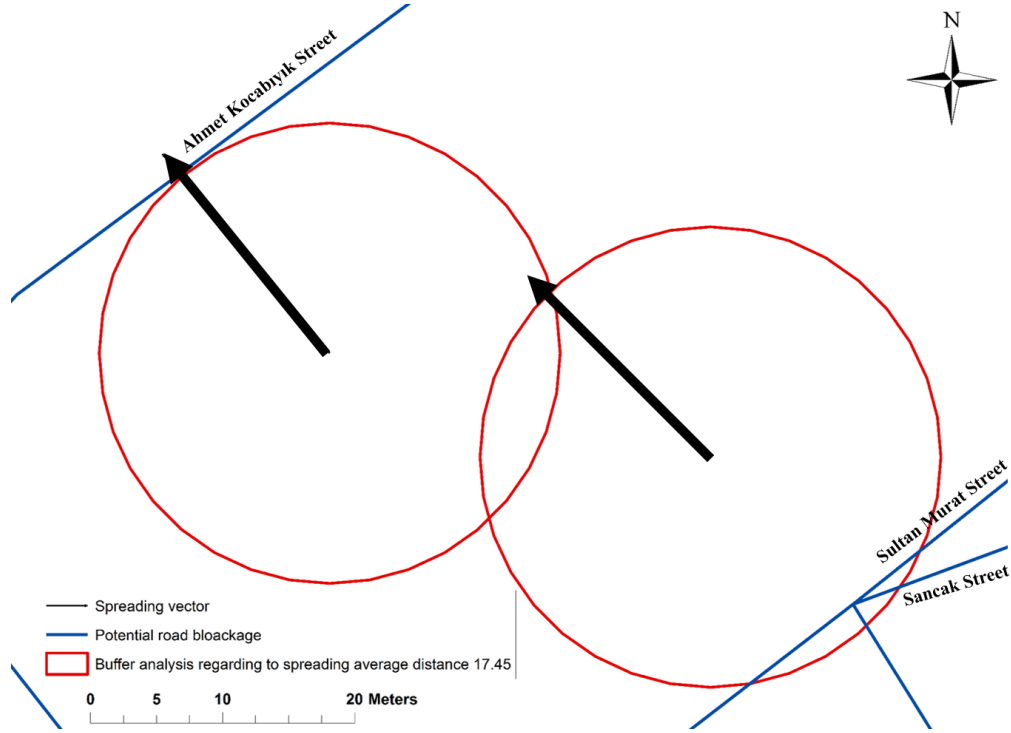
**Figure 7.33 :** Road blockage in Fevzi Çakmak because of the building collapse direction.

Possible road blockages due to the debris of collapsed buildings in Fevzi Çakmak is shown in Figure 31. Road blockages do cause the loss of road functionality. Currently, the sub-district of Fevzi Çakmak has, 18745m of roads. If the potential earthquake in Istanbul occurs, it is estimated that the functional road length will decrease to 7004 m (Figure 7.33). If the anticipated earthquake occurs in Istanbul, most of the roads in Fevzi Çakmak will lose their functionality.

As seen in Figure 34, if it is accepted that the estimated debris spreading distance would be 19.710 m regarding Near and LDM analysis, then Ahmet Kocabıyık street will be closed, but if it is accepted that the average debris spread would be 17.40 m, then it is thought that Ahmet Kocabıyık street will not be closed (Figure 7.34). When we look at Sultan Murat Street, if it is accepted that the spread of debris would be

17.40 m, then this road could be closed. But regarding the collapse direction, it may not be closed.

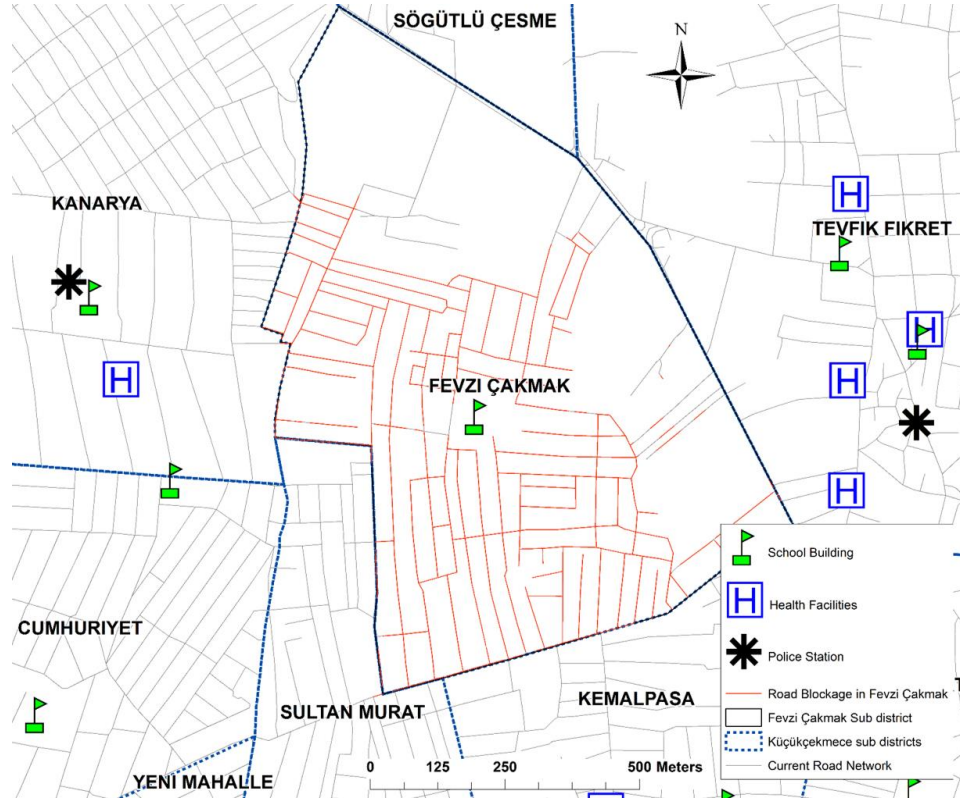
**Figure 7.34 :** Accessibility of critical facilities around Fevzi Çakmak sub district.

If the road functionality length decreases, the accessibility to critical facilities from Fevzi Çakmak district decreases, making the response stage difficult (Figure 7.34).

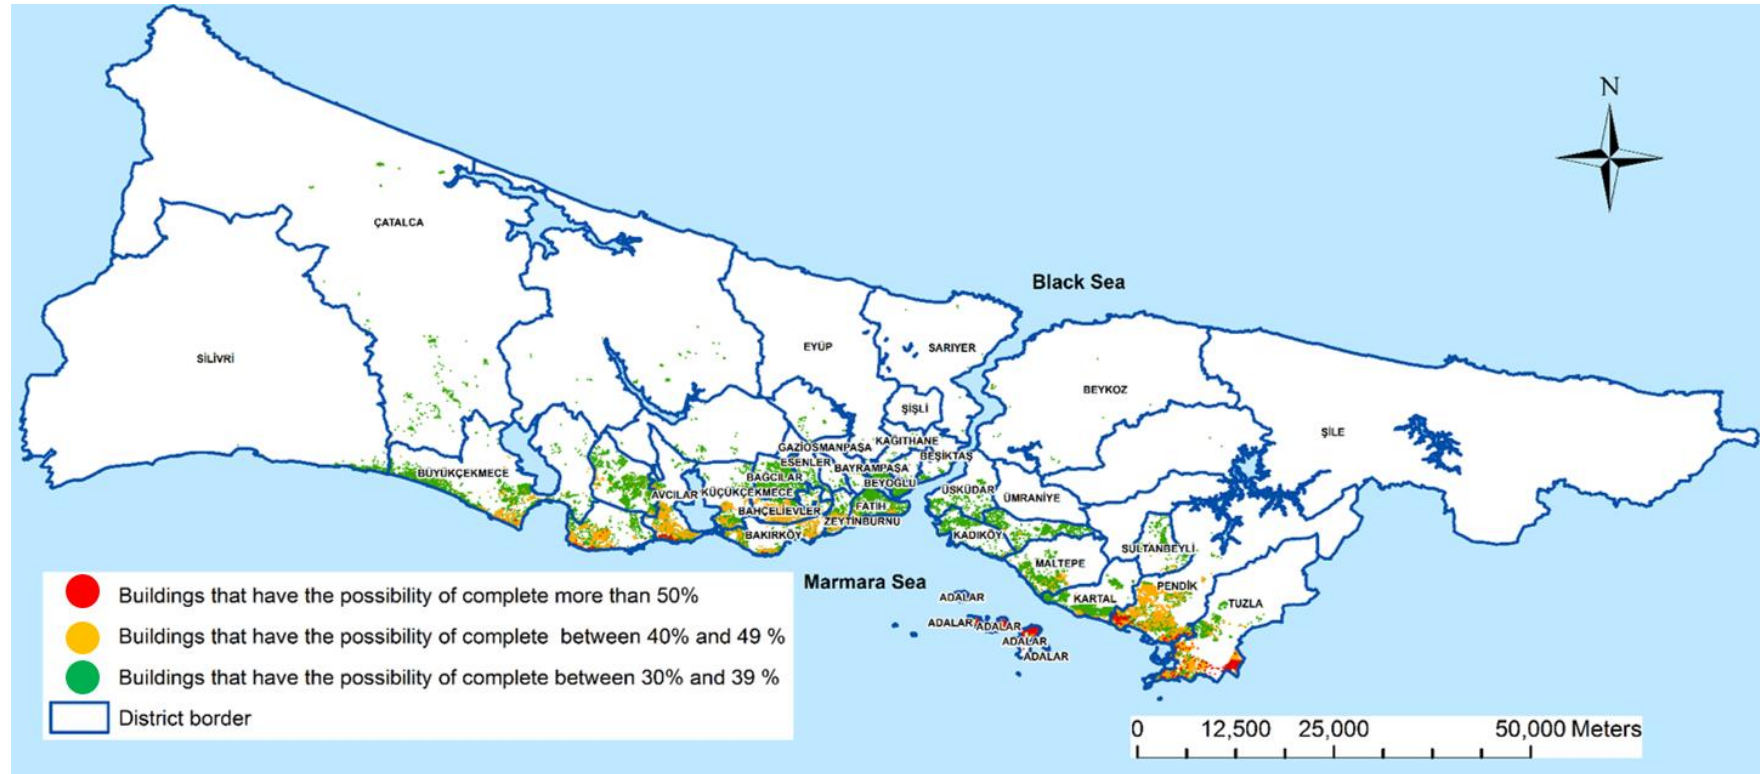
**Figure 7.35 :** Buildings that have the complete possibility more than 30%.

There are 3646 buildings that have the possibility of complete damage of more than 50%, while there are 15863 buildings that have the possibility of complete damage of between 40% and 50%, and 53999 buildings that have the possibility of complete damage of between 30% and 40% (Figure 7.35).

According to the building damage analysis performed by calculating HAZTURK software, there are 73508 buildings that have a collapse possibility of more than 30%. The buffer analysis was made by using these buildings and it was accepted that these collapsed buildings would create a 17.45 m debris site around them.

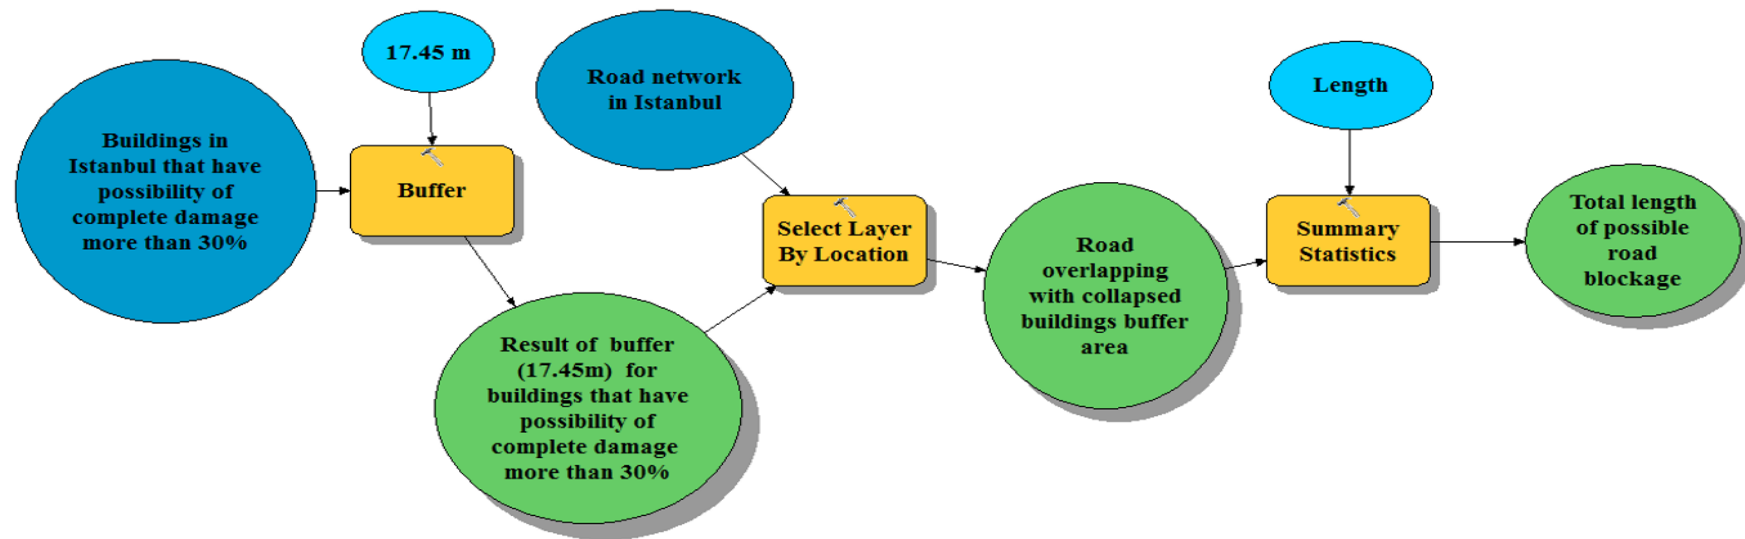
**Figure 7.36 :** Model builder for defining road blockage in Istanbul by using average debris value (17.45 m).

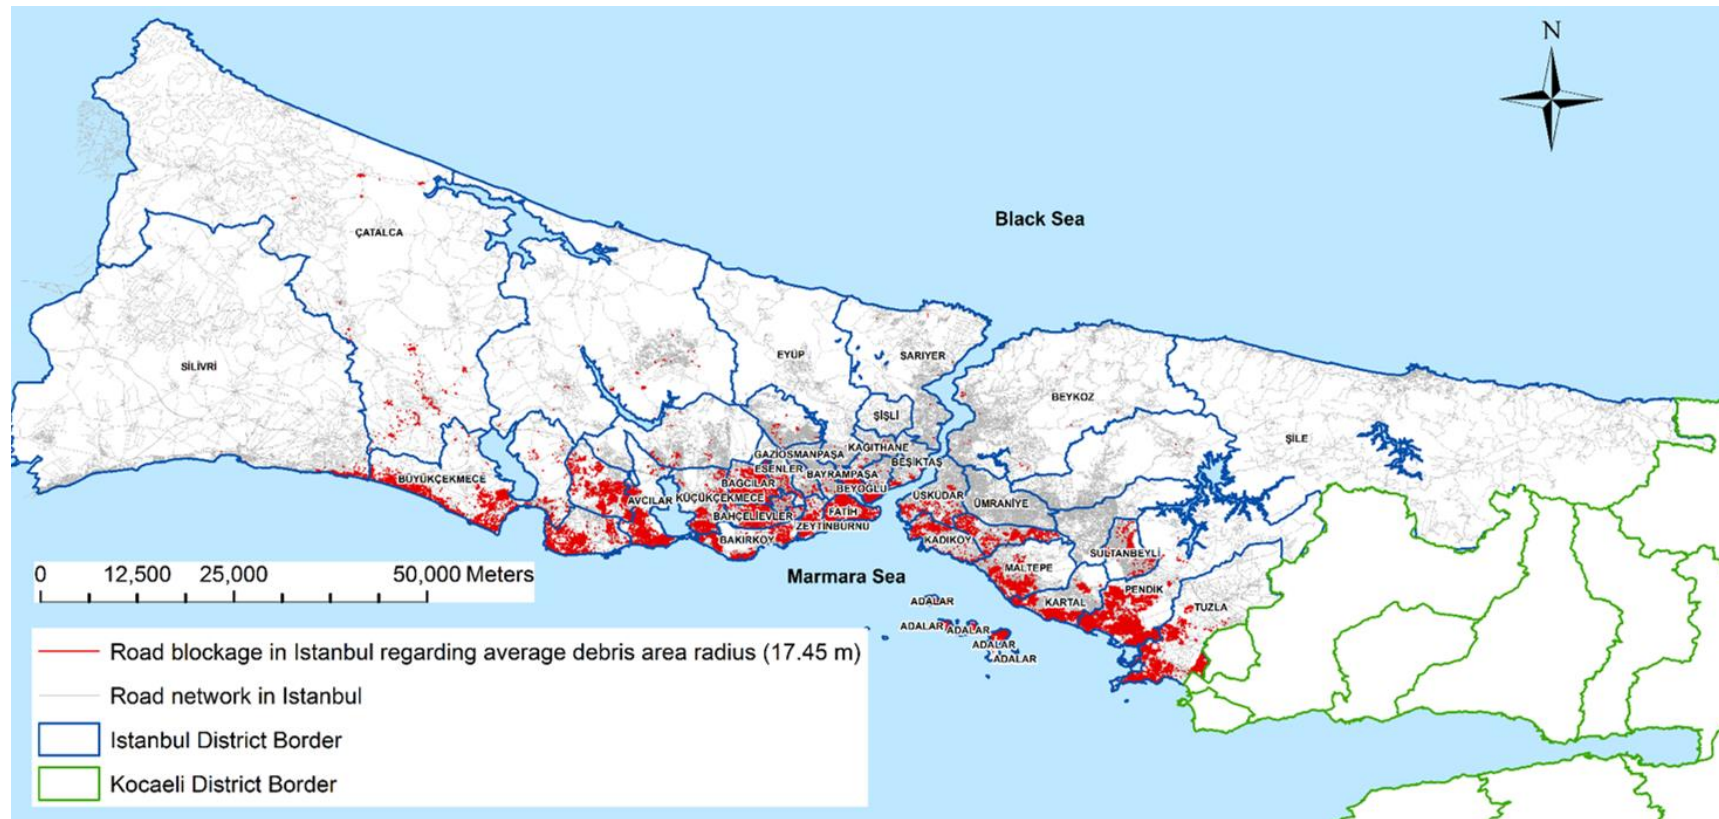
**Figure 7.37 : Road blockage in Istanbul.**

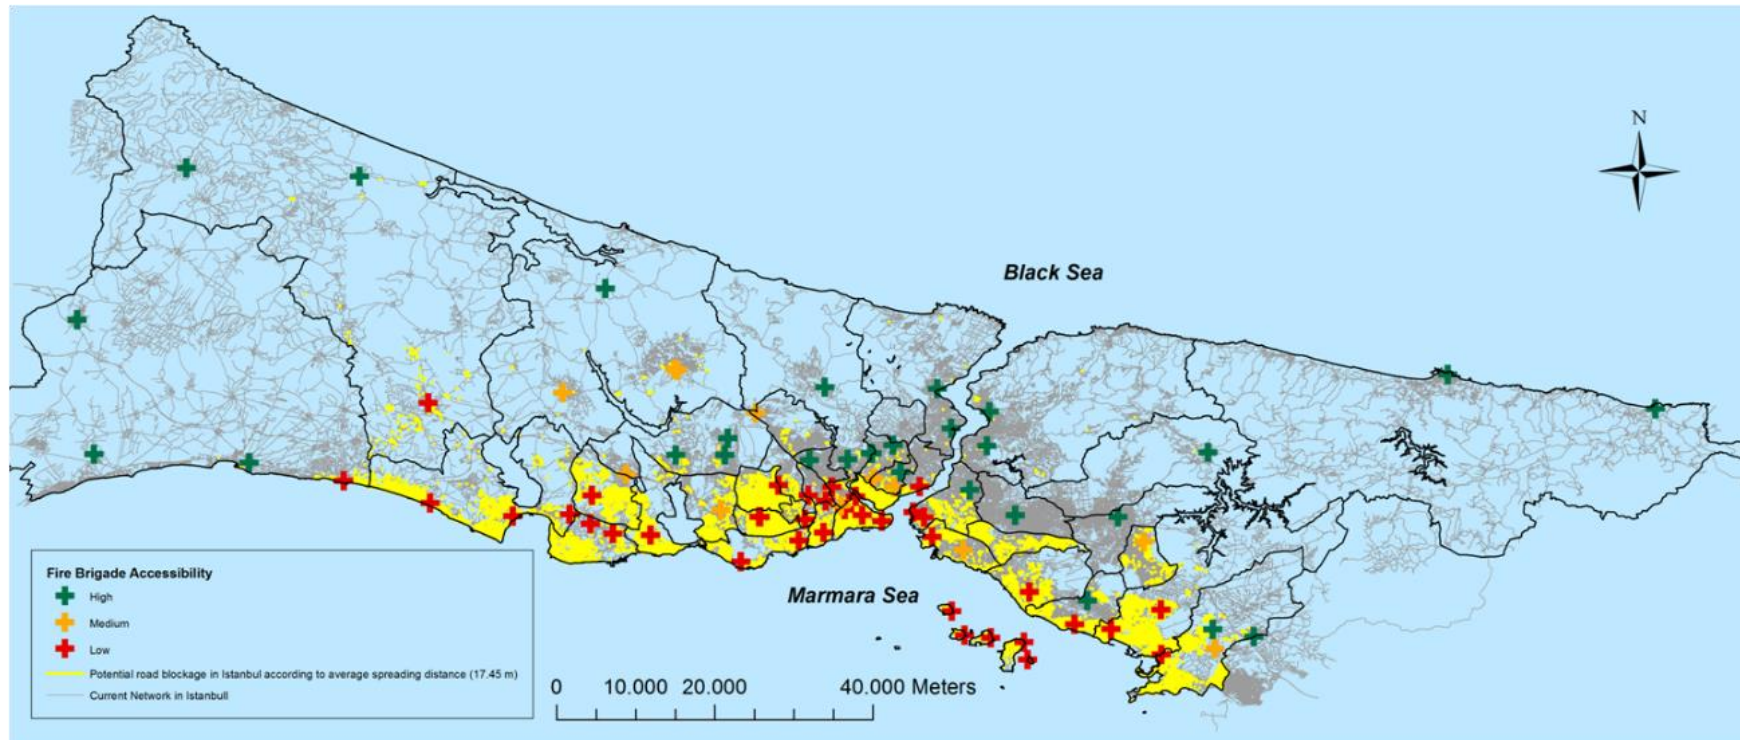
**Figure 7.38 :** Accessibility of fire stations in Istanbul

One of the most important critical facilities in a disaster is the fire service. Figure 7.38 shows the location of the fire station and their accessibility after a potential earthquake. It is seen that the accessibility of the fire station, which is located in the northern part of Istanbul is very high. In contrast to the northern part, the accessibility of the fire station, which is located in the south is very low. This shows that if there was a fire in the southern part of Istanbul during or after an earthquake, it would be impossible for them to respond to the fire. Therefore, the secondary disaster may occur.

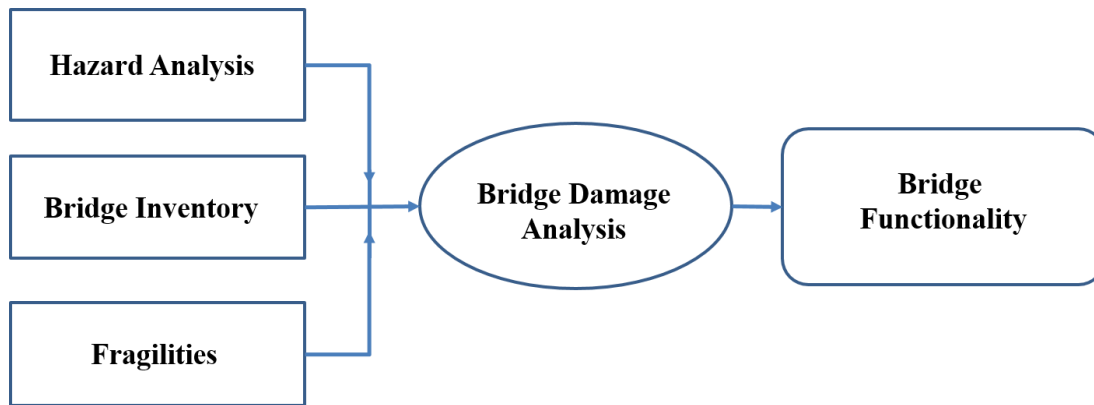
**Figure 8.1 :** Methodology of bridge functionality.

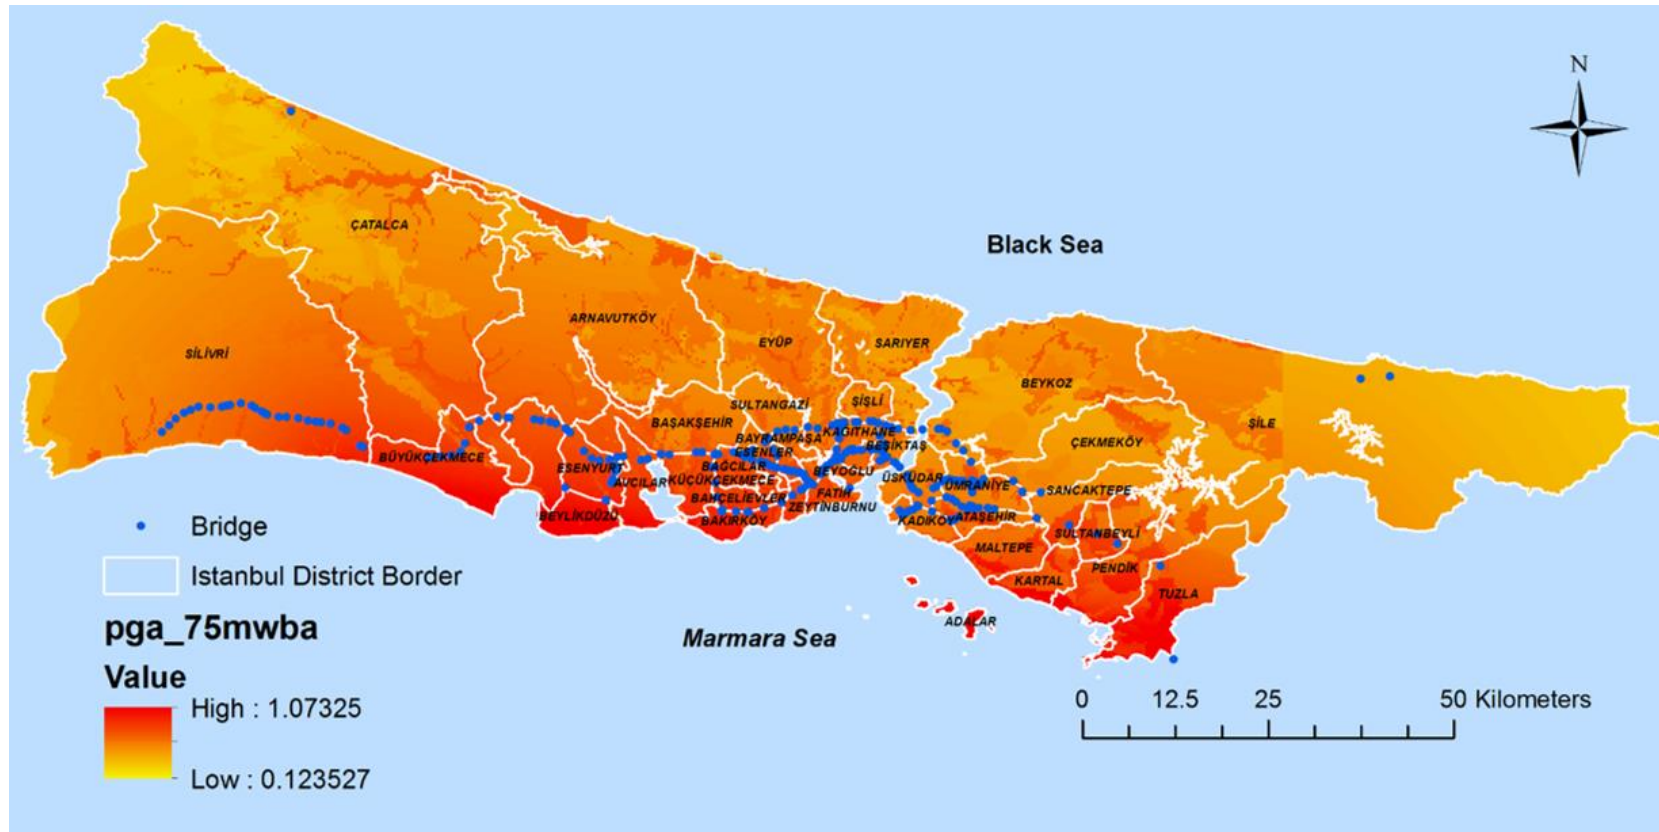
**Figure 8.2 :** Distribution of bridge locations on Istanbul Earthquake Hazard Map according to Boore & Atkinson (2008) PGA.

Peak ground acceleration (PGA) for each transportation structure was used for this calculation by using fragility curves and the hazard definition (Figure 8.2). By using PGA with the related fragility curves, the damage, retrofitting cost and the functionality analysis were obtained for each of the transportation structures.

A deterministic hazard map was used in the seismic risk analyses. For the deterministic hazard, Model A of the JICA and IMM (2002) was used with an epicenter of 28.9 N, 40.9 W, which is approximately in the south eastern part of Istanbul.

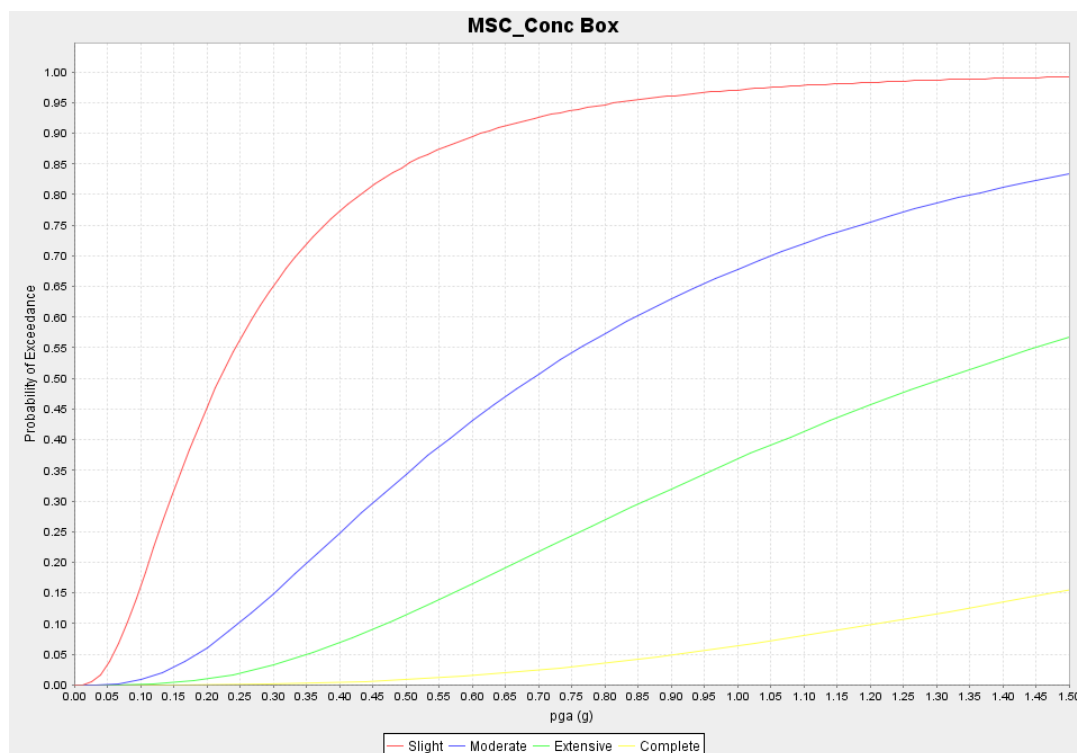
**Figure 8.3 :** Fragility curves for the continuous bridge classes: MSC\_Conc Box.

For transportation structures, fragility curves are defined in terms of PGA (Figure 8.3, Figure 8.4, Figure 8.5, Figure 8.6).

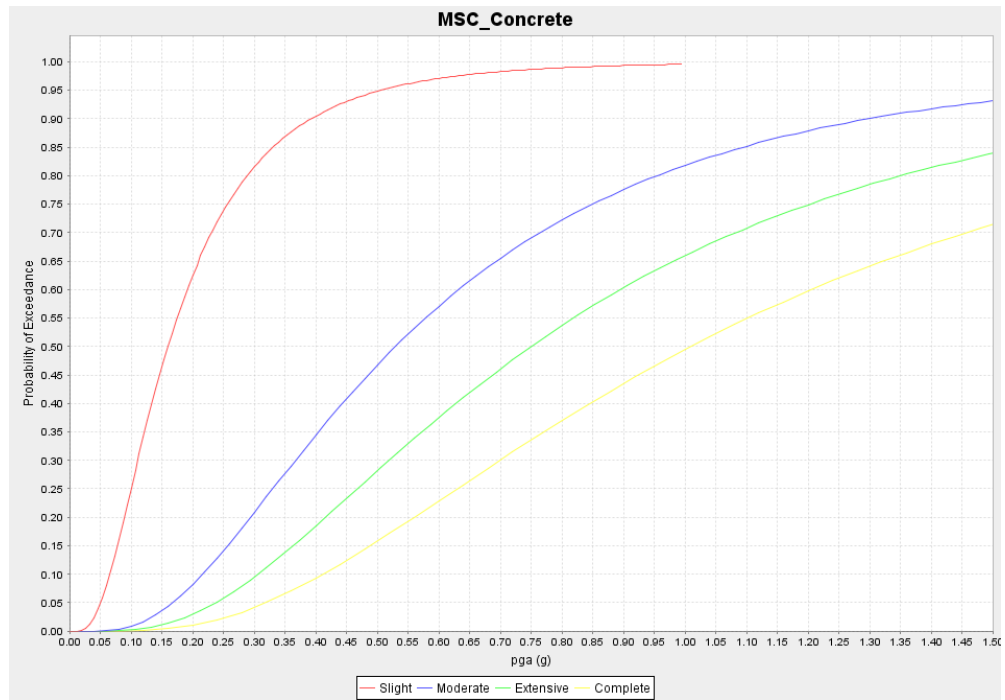
**Figure 8.4 :** Fragility curves for the continuous bridge classes: MSC\_Concrete.

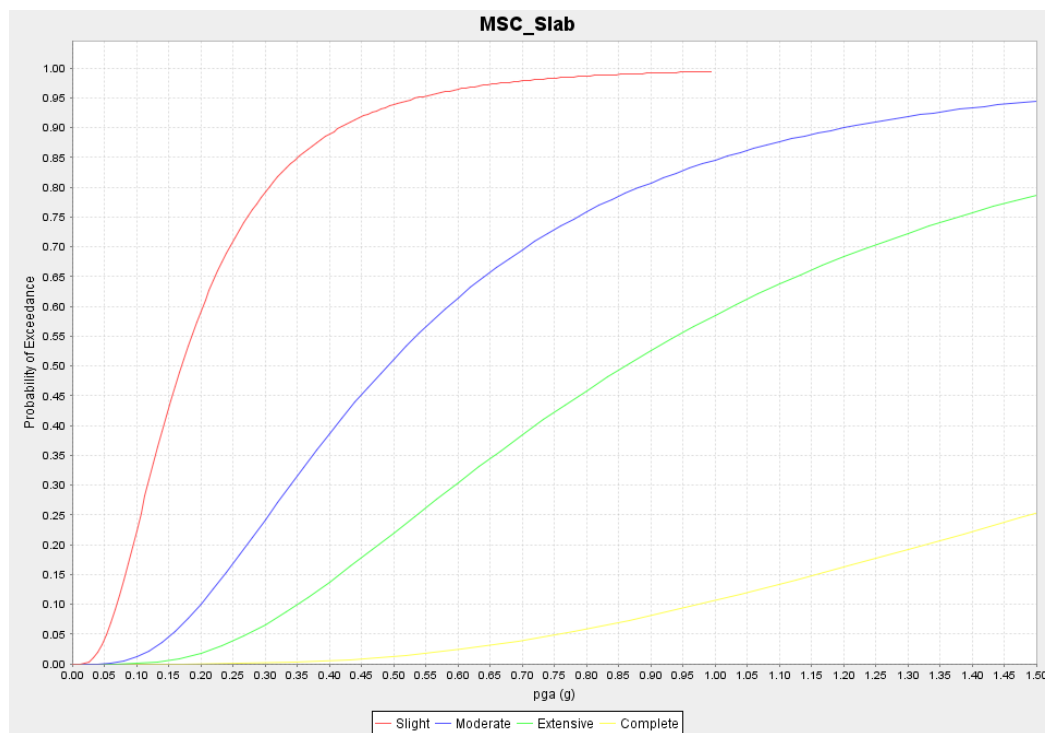
**Figure 8.5 :** Fragility curves for the continuous bridge classes: MSC\_Slab.

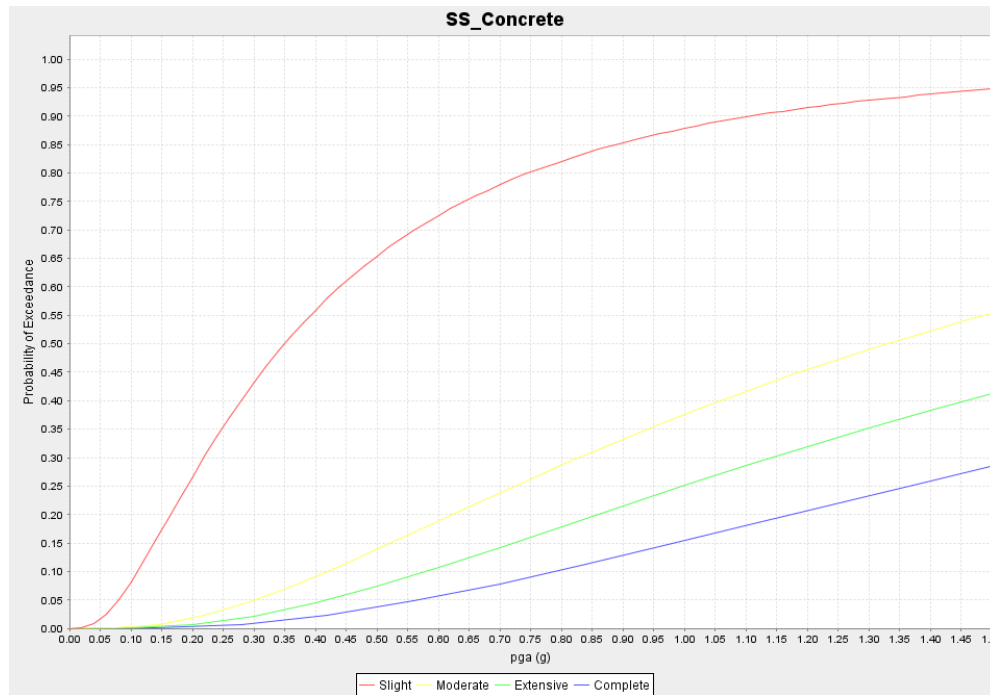
**Figure 8.6 :** Fragility curves for the single span simply supported bridge classes: SS Steel.

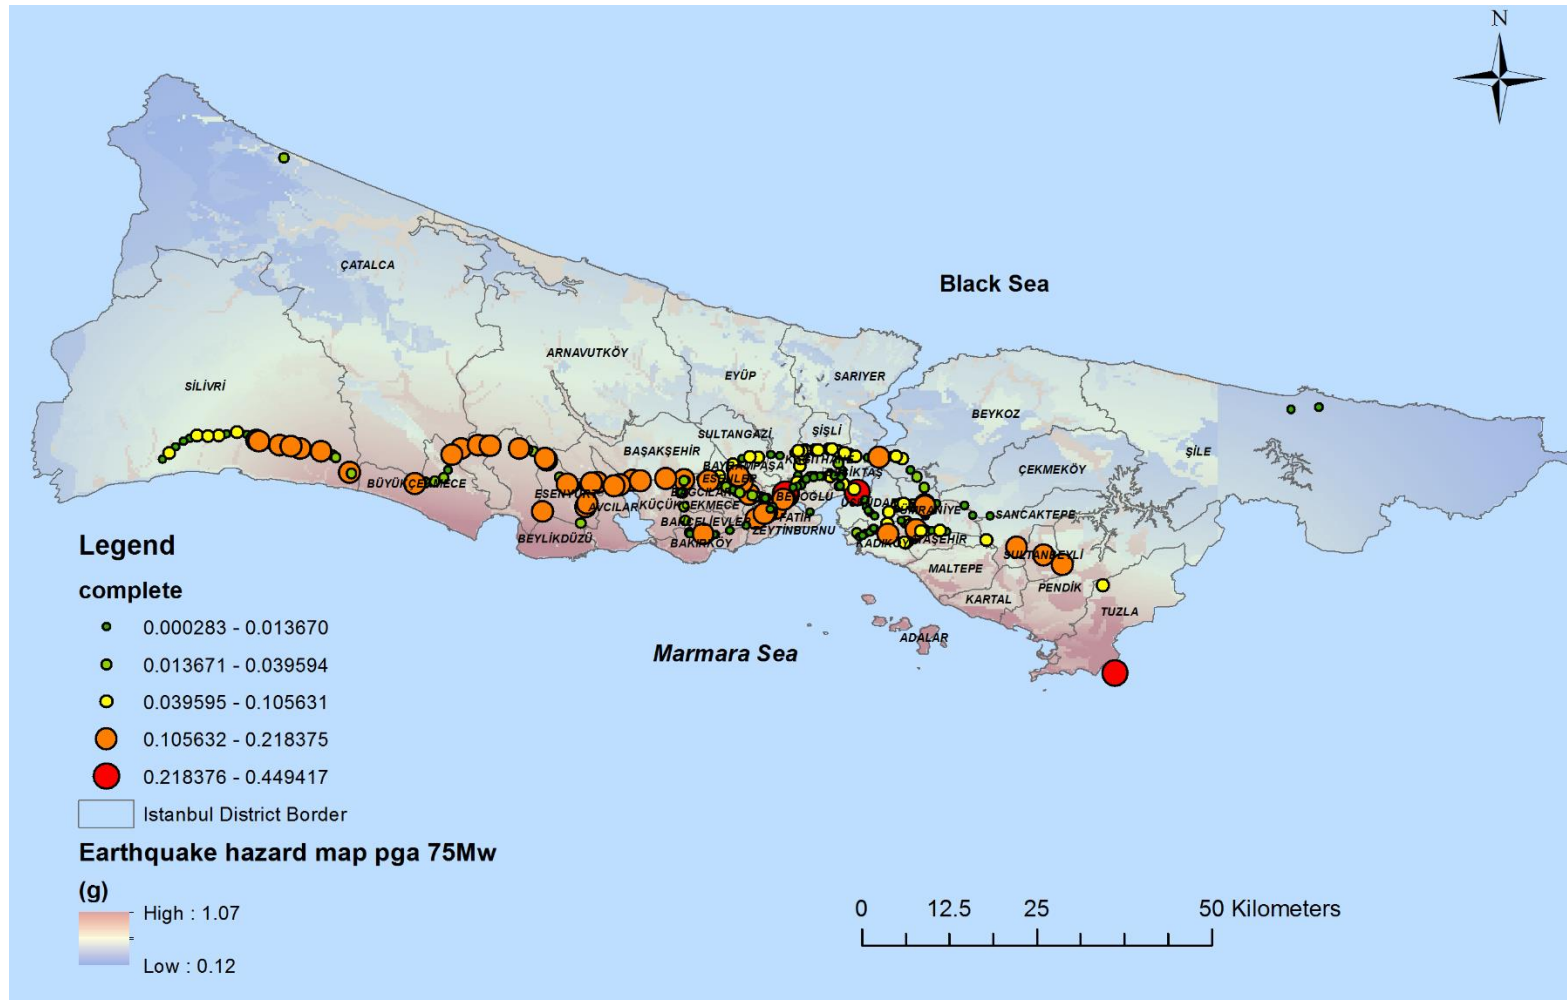
**Figure 8.7 :** Distribution of complete damage possibility of bridges in Istanbul.
