**EFFECTS OF BUILDING COLLAPSE DIRECTION  
AND BRIDGE FUNCTIONALITY ON ROAD  
NETWORKS FOLLOWING AN EARTHQUAKE**

**Ph.D. THESIS**

**Betül ERGÜN KONUKCU**

**Geomatics Engineering Department**

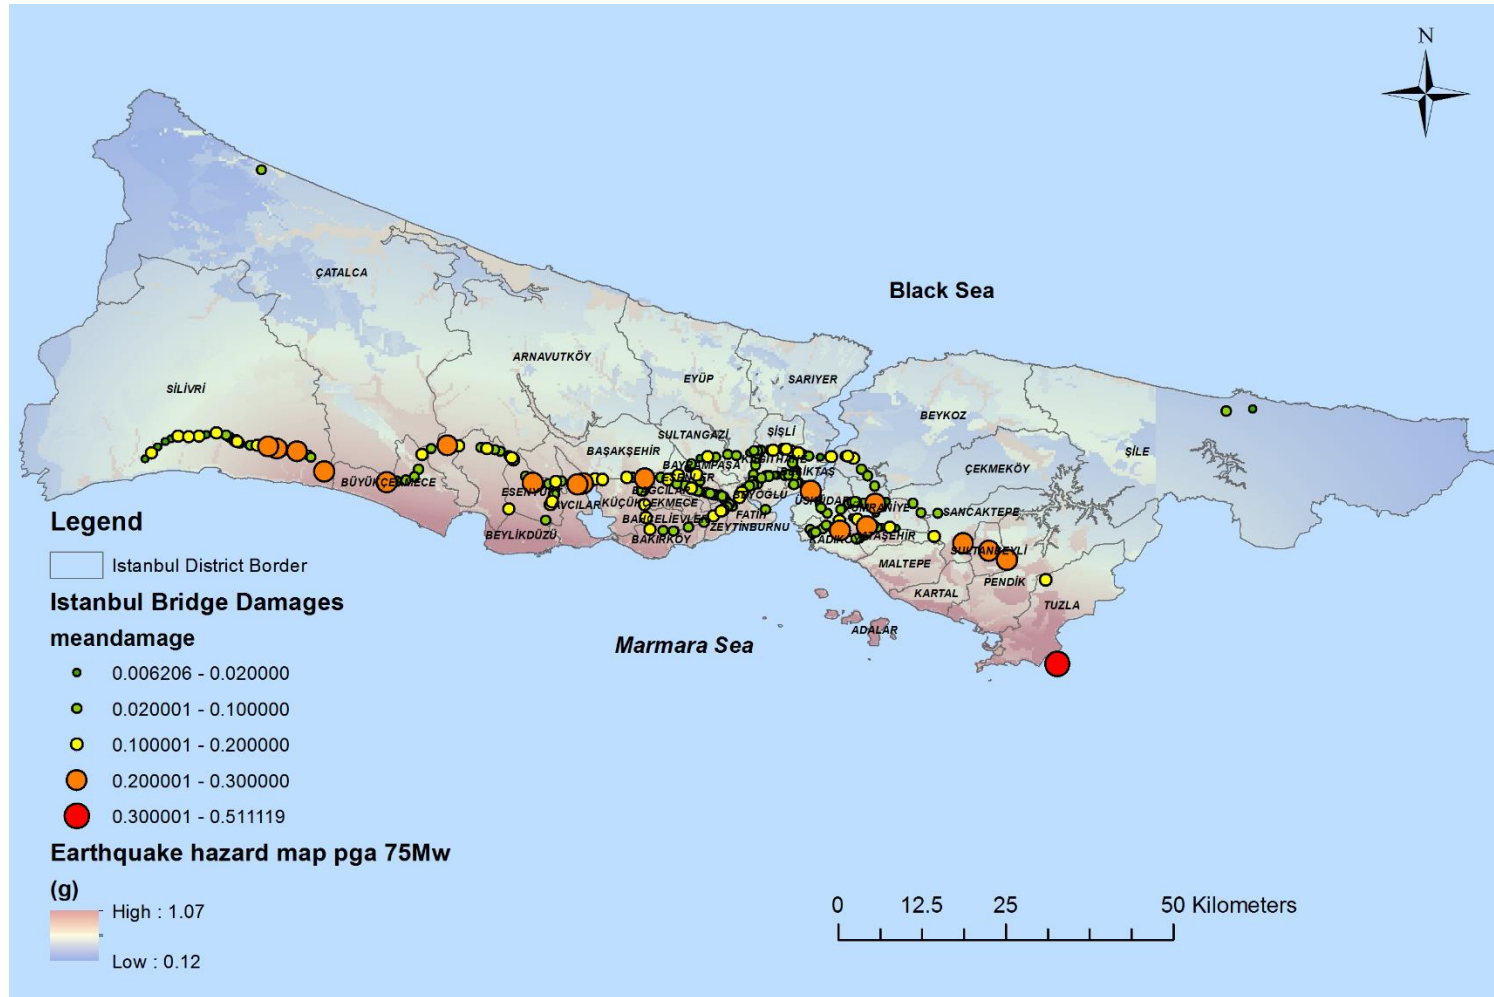
**Figure 8.8 :** Distribution of mean damage possibility of bridges in Istanbul.

Complete damage distribution of the transportation structure based on PGA, is represented in Figure 8.7, while the mean damage distribution according to PGA is shown in Figure 8.8.

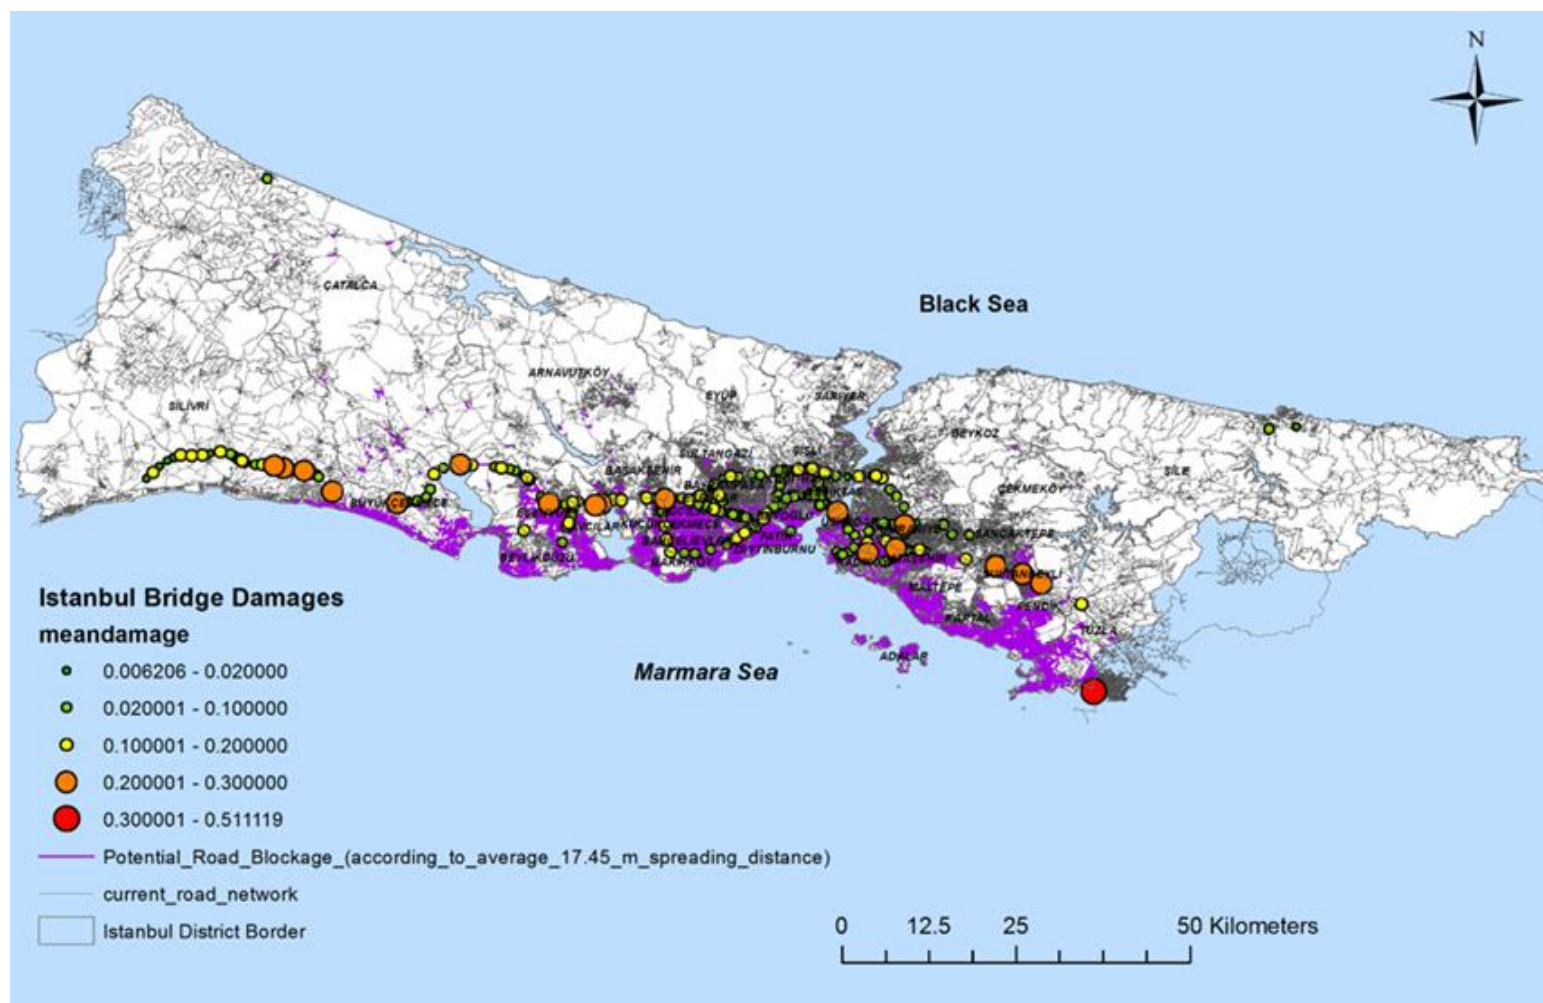
**Figure 8.9 :** Non functional roads and bridge damage distribution in Istanbul.

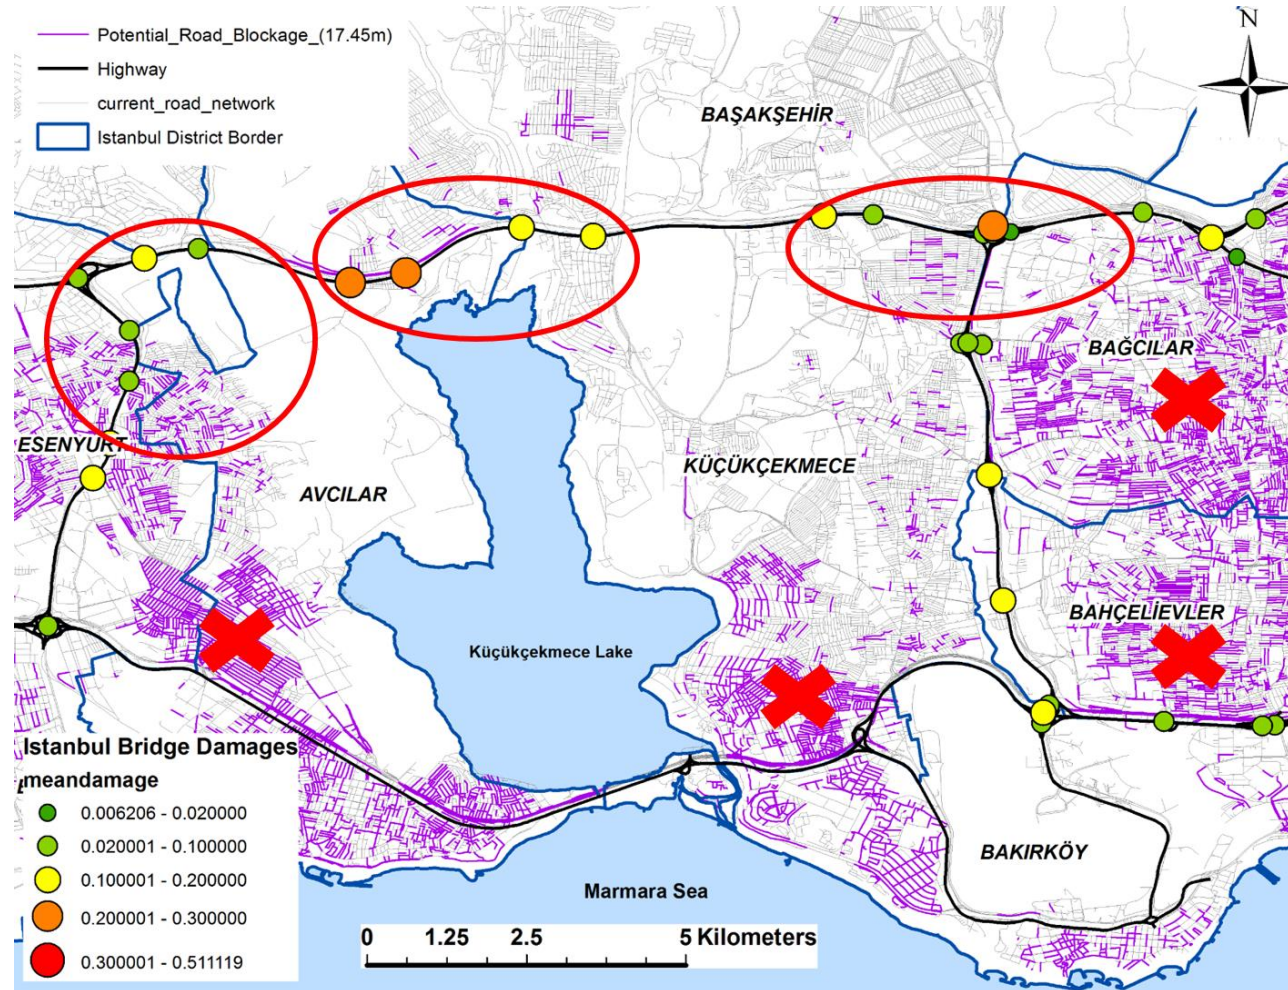
**Figure 8.11 :** Large scale representation of non functional roads and bridge damage distribution in Küçükçekmece and Avcılar Districts.

In the regions that were highlighted with the red polygons and with red x marks, the traffic flow would be impossible following an earthquake due to the debris from collapsed buildings and the damage to transportation structures (Figure 8.11).

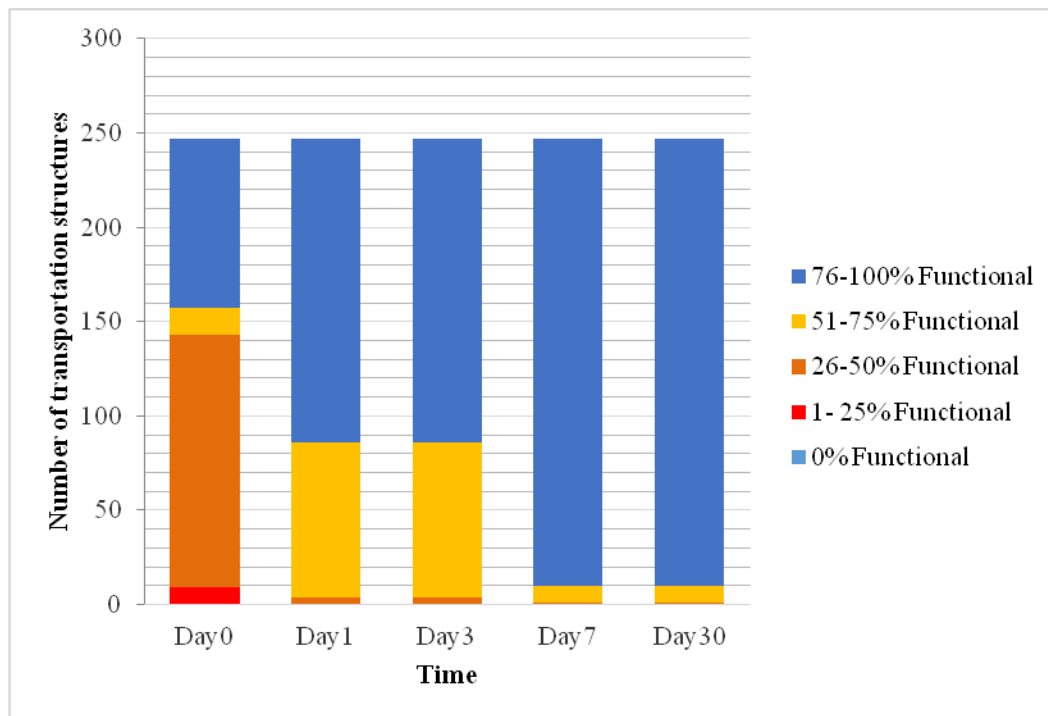
**Figure 8.12 :** Continuous functionality analysis for bridge in Istanbul.

Continuous functionality analysis results estimate that 9 bridges would have 1 to 25% functionality, while there would be 134 bridges with 26 to 50% functionality, 14 bridges with 51 to 75% functionality and 90 bridges with 76 to 100% functionality possibilities, as it can be recognized in Figure 8.12.

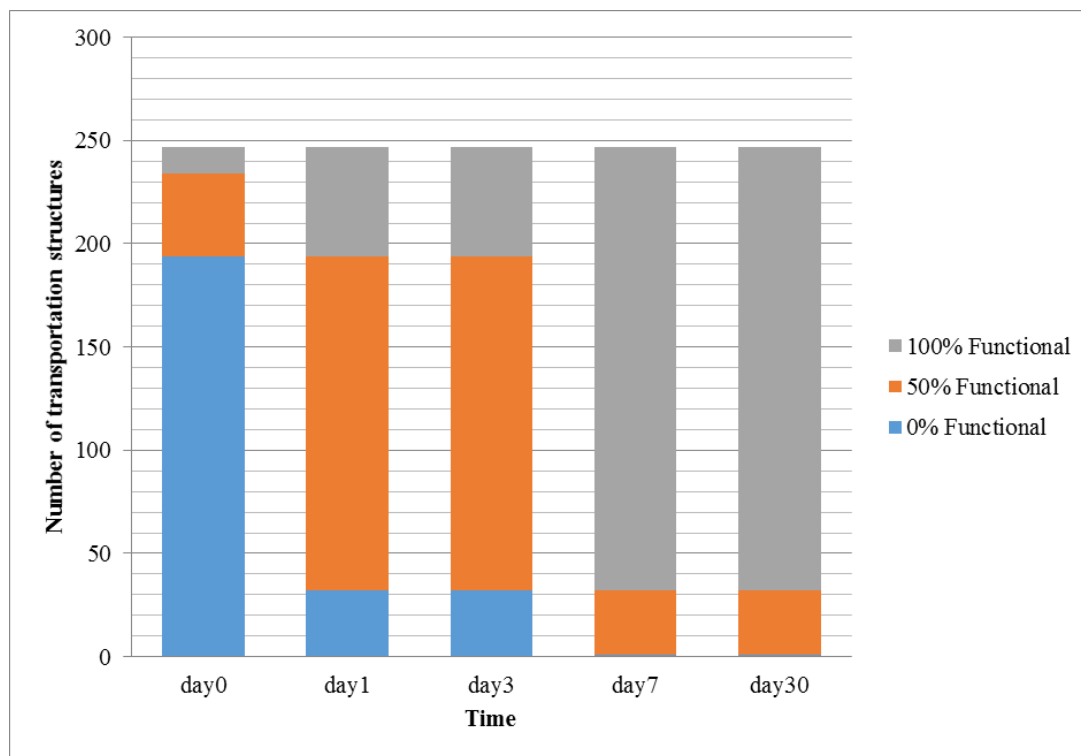
**Figure 8.13 :** Step functionality analysis for bridge in Istanbul.

The functionality analysis results according to the step analysis are given in Figure 8.13. According to step functionality analysis, 194 bridges would have 0 % functionality, 40 bridges would have 50 % functionality and, 13 would have 100 %

functionality immediately after an earthquake. It was estimated that 32 bridges would be non-functional 3 days after the earthquake (Figure 8.13).

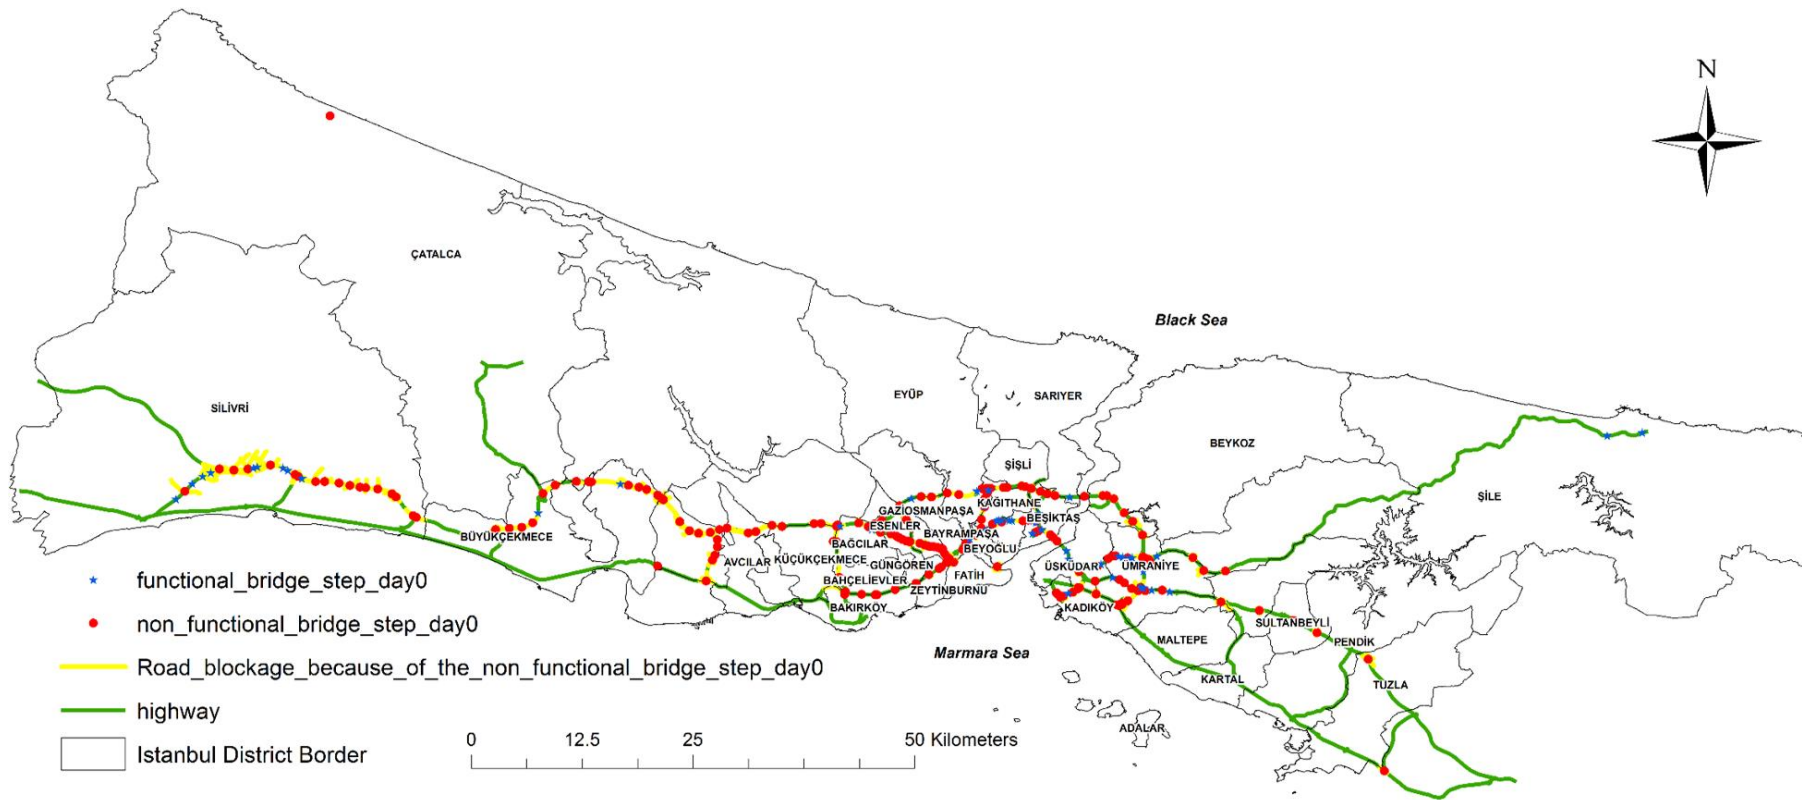
**Figure 8.14 :** Functional and non functional bridge distribution in Istanbul following potential Istanbul Earthquake (Step Functionality).

Figures 8.14 and 8.15 represent the functional and non functional bridges in Istanbul immediatelly following an earthqauke and 3 days after an earthquake, respectively.

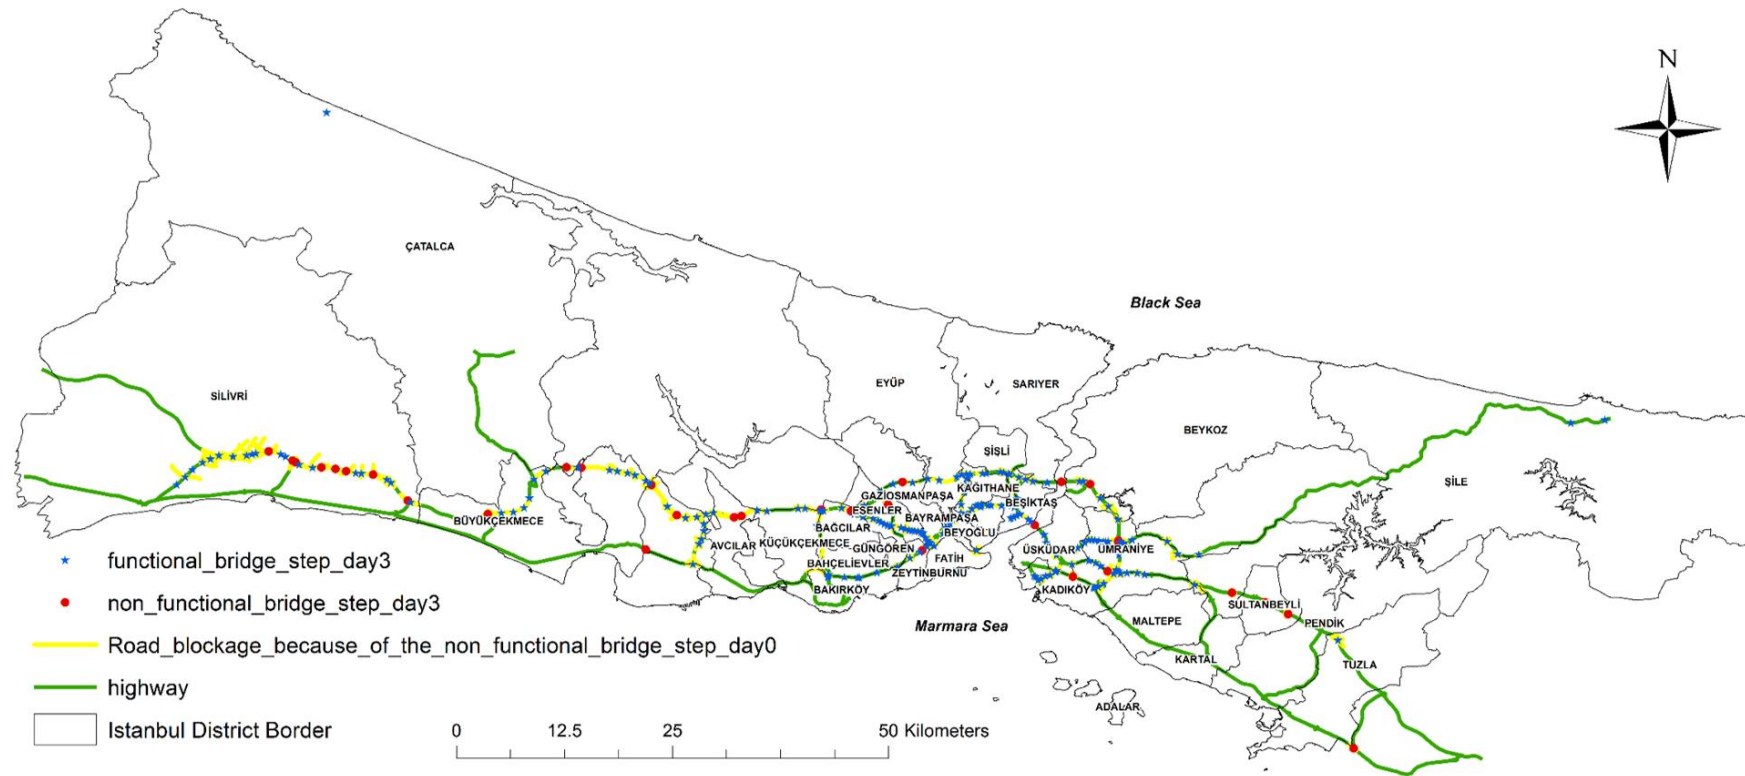
**Figure 8.15 :** Functional and non functional bridge distribution in Istanbul after 3 days from potential Istanbul Earthquake (Step Functionality).

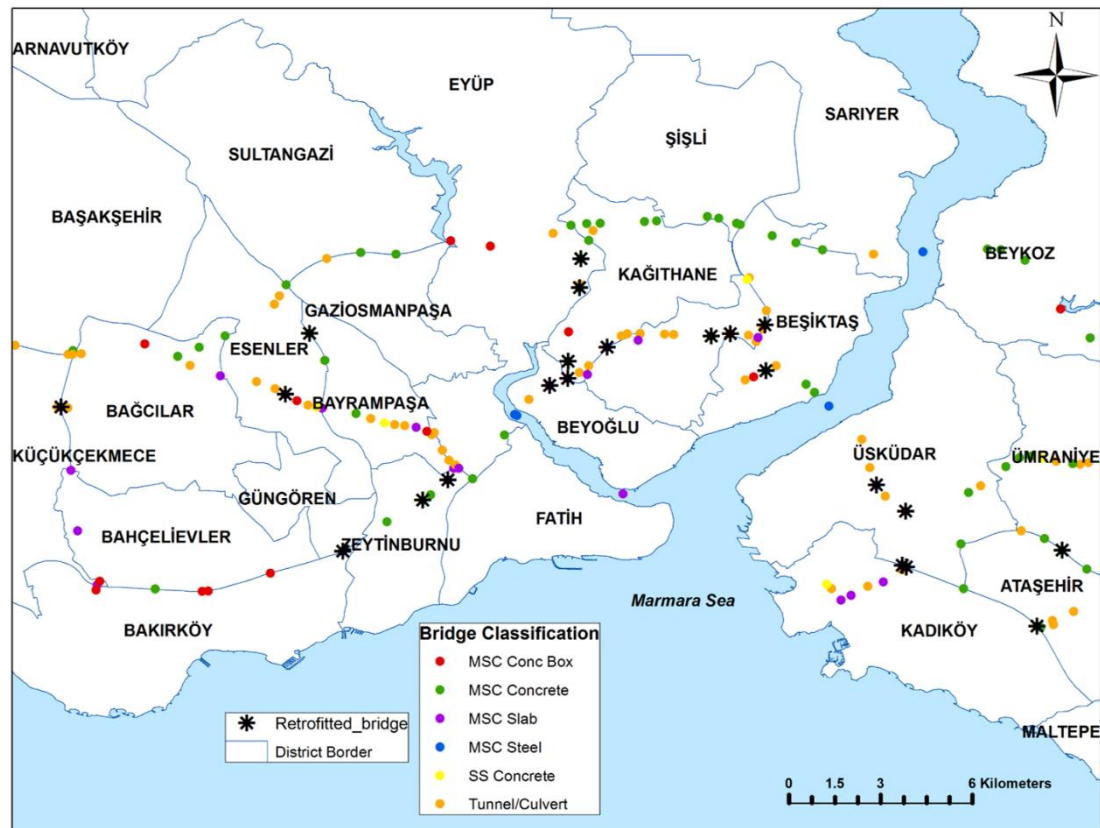
**Figure 8.16 : Distribution of Retrofitted bridges in Istanbul.**

The locations and the distributions of the aforementioned bridges can also be seen in Figure 8.16.

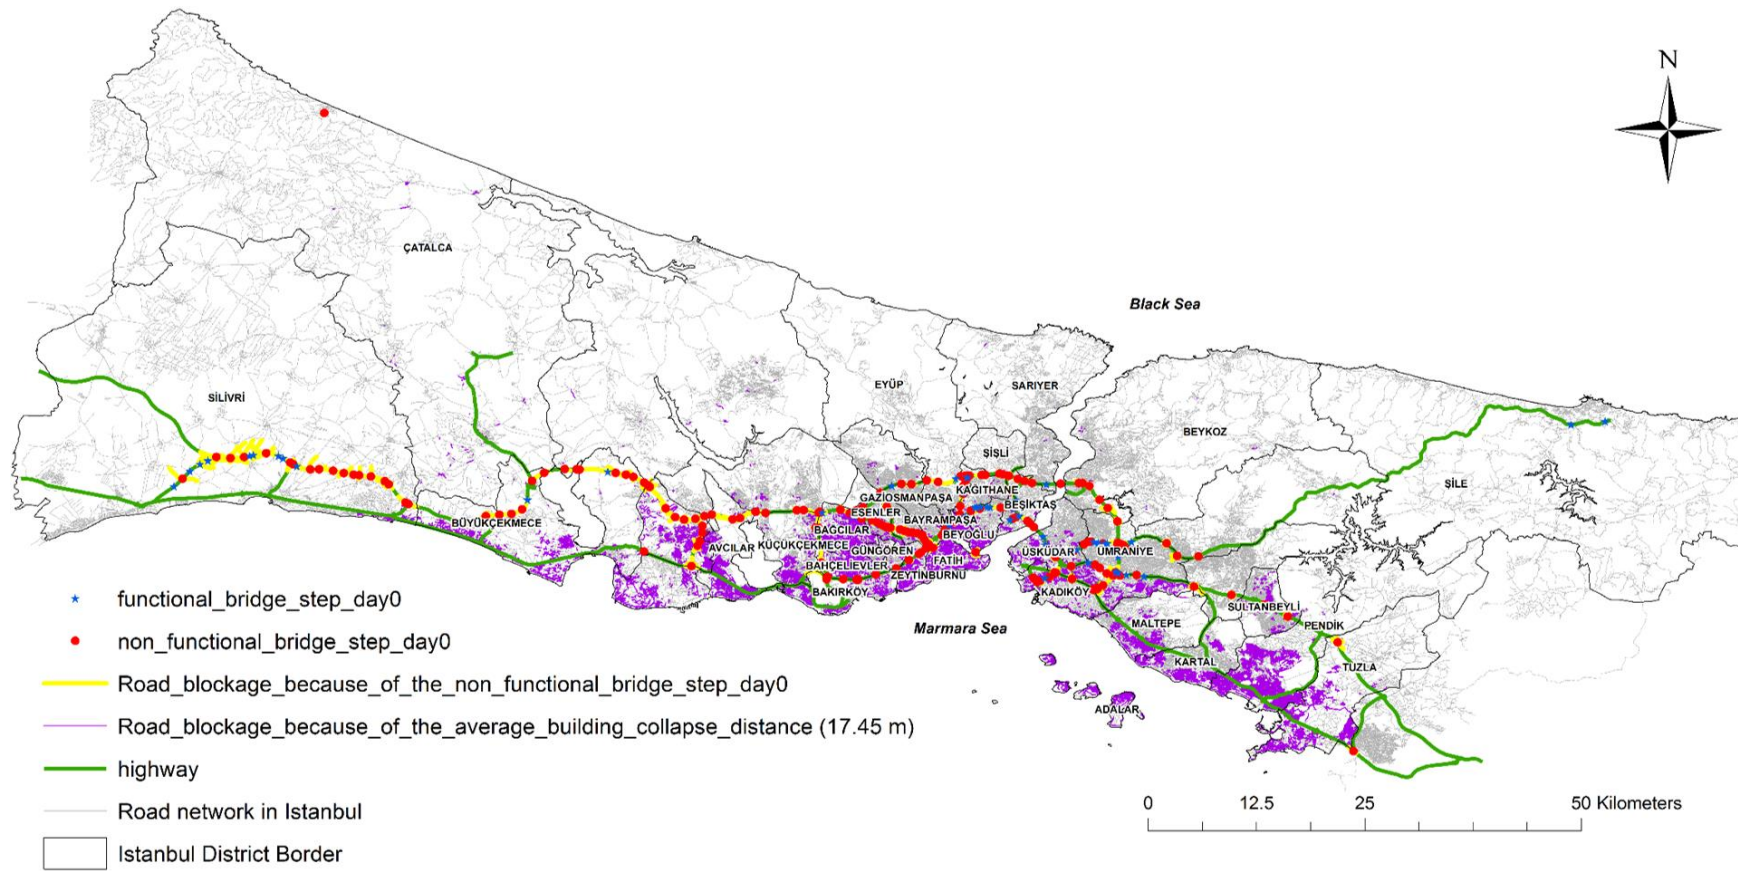
**Figure 9.1 :** Road blockage in Istanbul immediately after a potential earthquake.

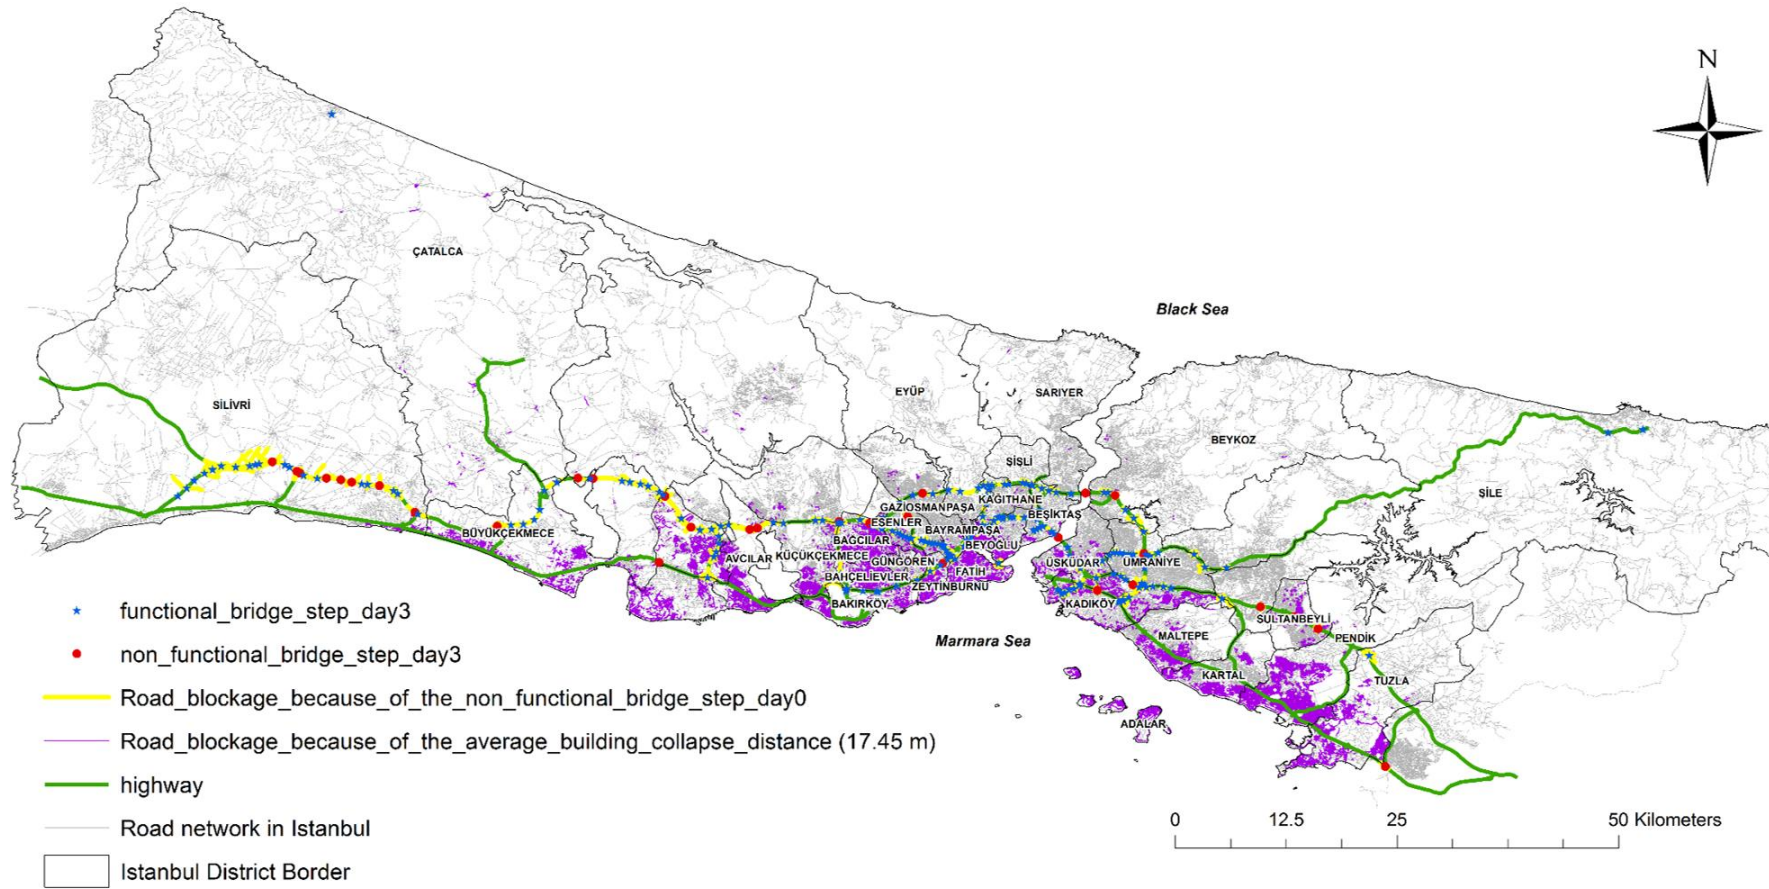
**Figure 9.2 :** Road blockage in Istanbul immediately after 3 days a potential earthquake.

Figures 9.1 and 9.2 show the potential road blockages according to the assessment of the buildings collapse distance and bridge step functionality immediately after an earthquake and 3 days after an earthquake, respectively.

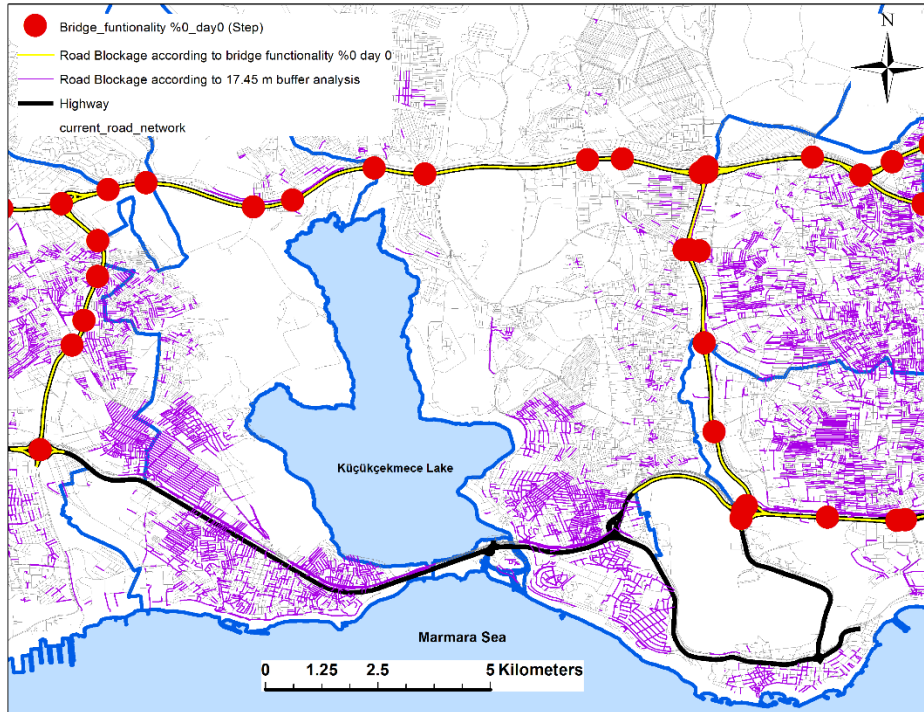
**Figure 9.3 :** Large scale representation of road blockage for day 0.

Figures 9.3 and 9.4 show the results on a larger scale with a randomly selected region. Figure 9.3 displays the road and bridge functionality on the day of the earthquake and Figure 9.4 shows the same situation 3 days after the earthquake.

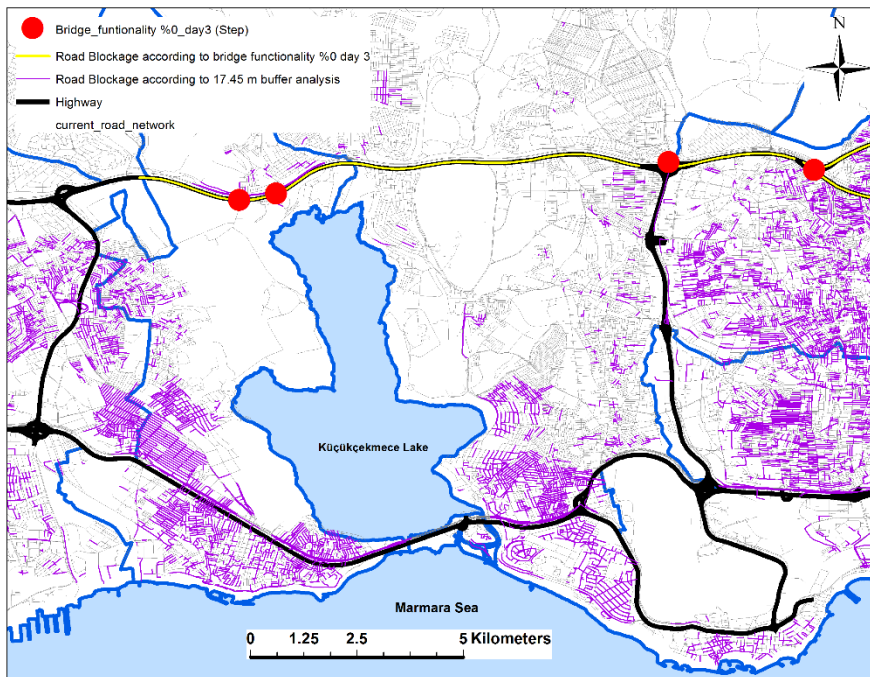
**Figure 9.4 :** Large scale representation of road blockage for day 3.

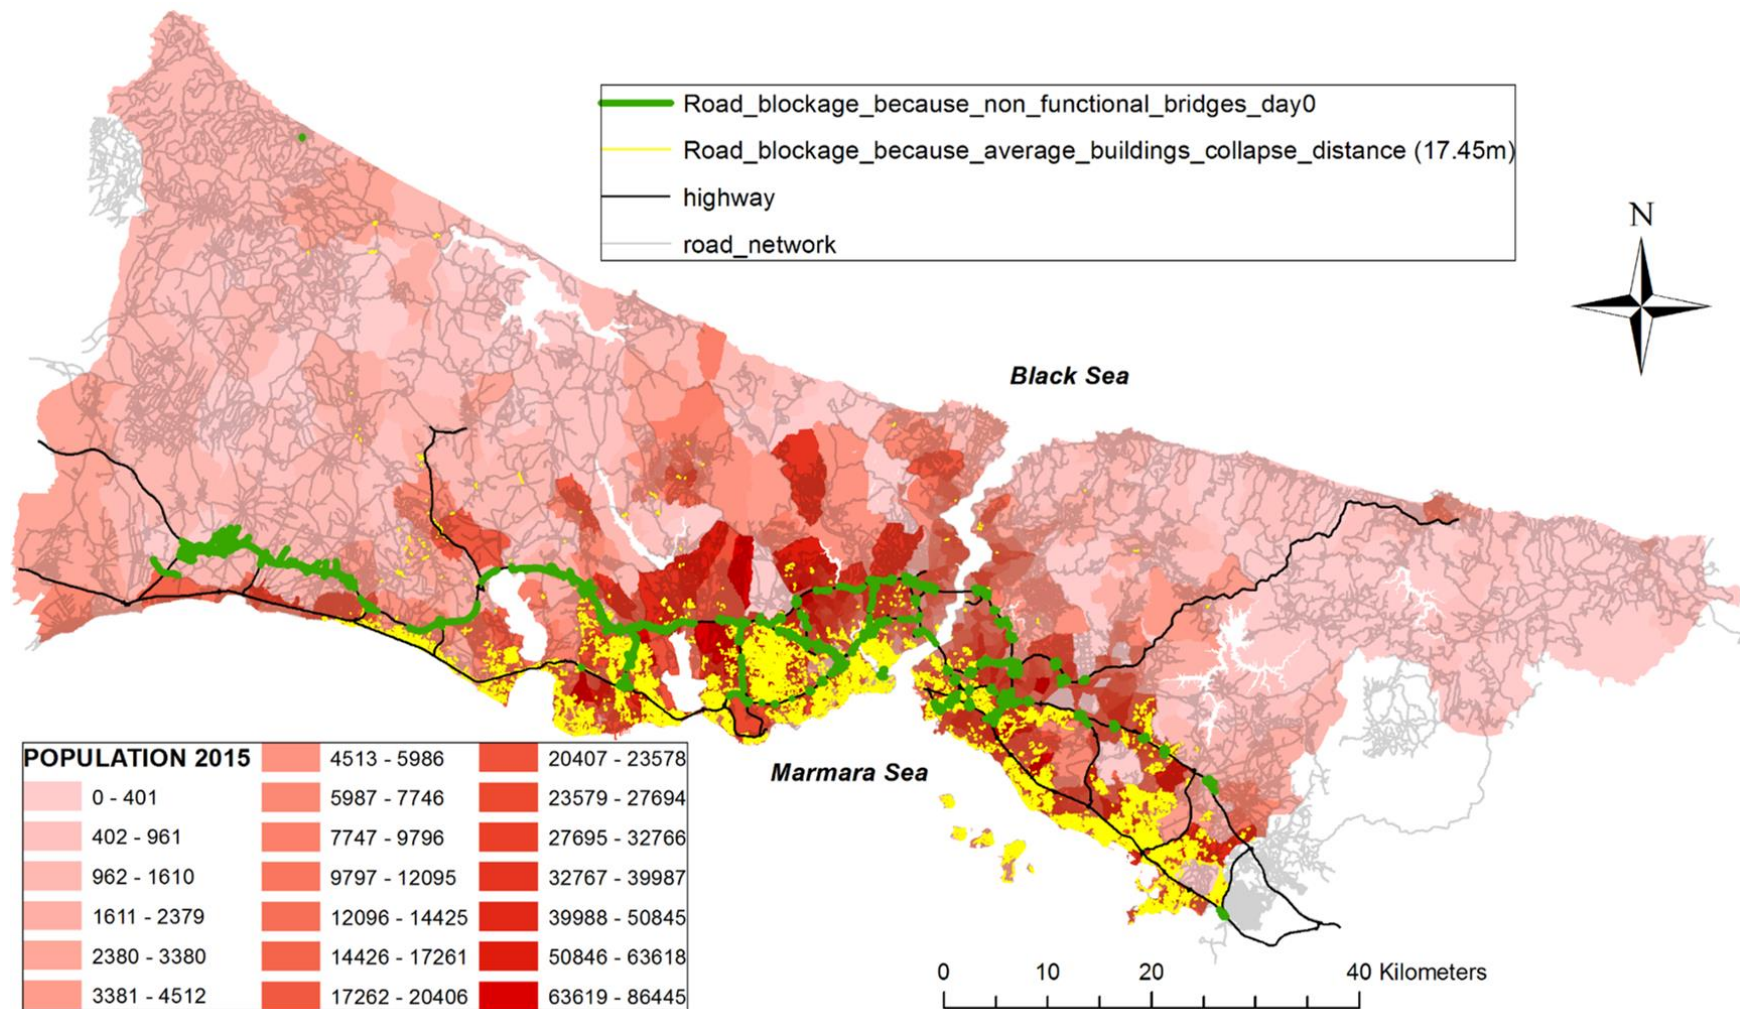
**Figure 9.5 :** Representation of road blockage in Istanbul with population distribution based on sub district.

Figures 9.5 and 9.6 represent population in Istanbul that would be affected by the road blockages based on the sub-district border. As can be seen from the aforementioned figures, mostly populated areas would be affected by road blockage during the response time. Regarding these figures, it is estimated that these road blockages would affect 8,308,190 people around non-functional roads after an earthquake in Istanbul. This situation could cause an increase in the number of deaths or injuries in people because of a lack of access treatment.

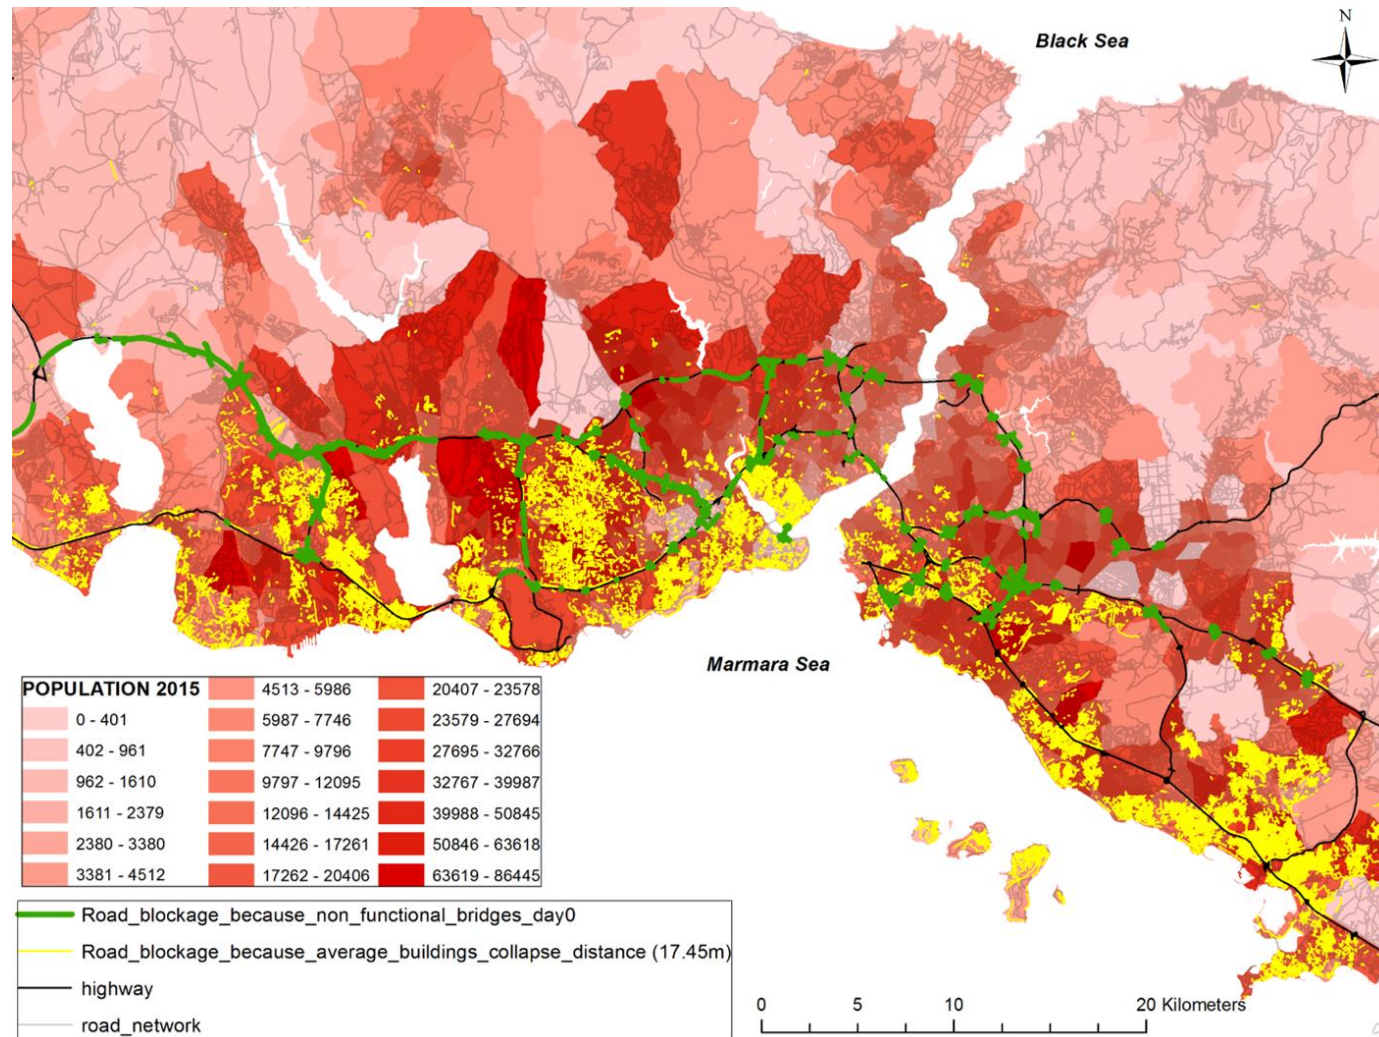
**Figure 9.6 :** Large scale representation of road blockage in Istanbul with population distribution based on sub district.

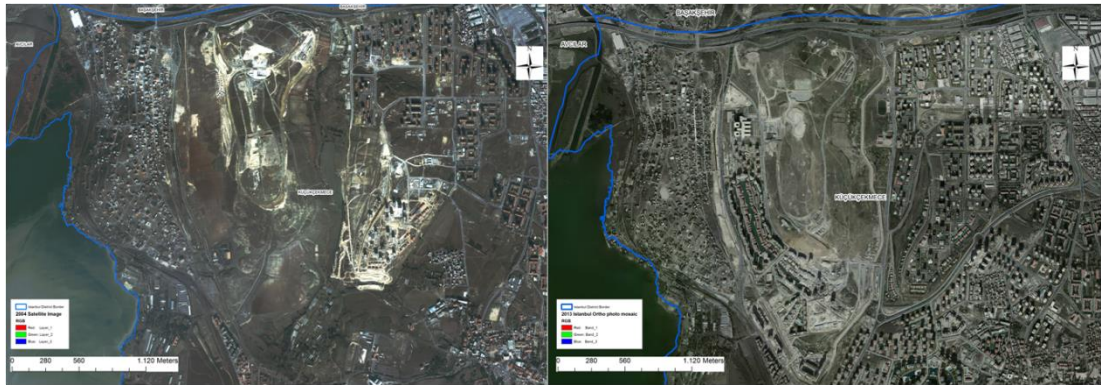
**Figure 10.1 :** Change of buildings at Küçükçekmece district between 2004 and 2013.

It was also important to validate the study with the data where the age information of the buildings was known. The Küçükçekmece district of Istanbul was an important sample to identify the ages of buildings where both empty lands, collapsed buildings and urban transformation projects existed (Figure 10.1).

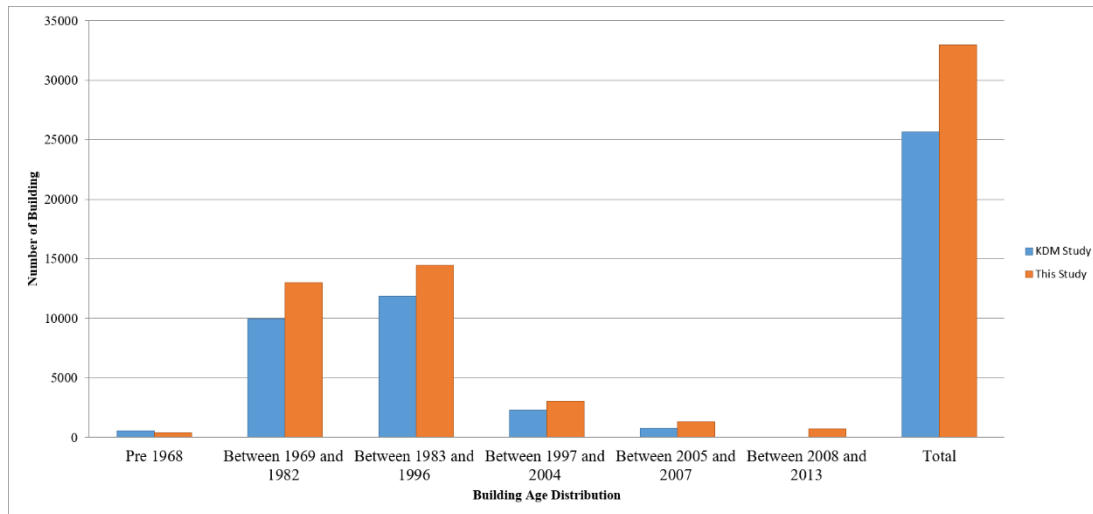
**Figure 10.2 :** Building age comparison of KDMP and this study in Küçükçekmece district.

It can be seen from Figure 10.2 that the rate of increase and the difference in the number of buildings were directly proportional in both studies.

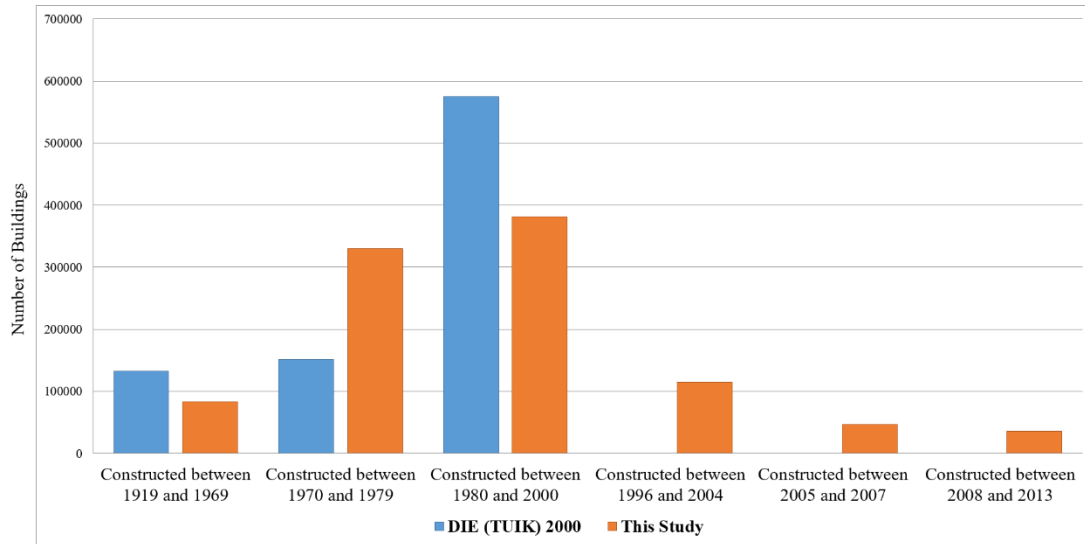
**Figure 10.3 :** Building age comparison of TUIK 2000 and this study.

DIE 1984 counted the building stock in Istanbul in 1984 as 505,224, while this study digitized 432,150 buildings on the 1982 aerial image. TUIK 2000 study declared that the number of buildings in Istanbul in 2000 was 869,444, this study determined that the number of buildings in Istanbul in 1996 was 794,324 and in 2004 was 908,805. When the yearly increase ratio was considered, the estimated buildings count in 2000 from this study's values was estimated to be 851,564.

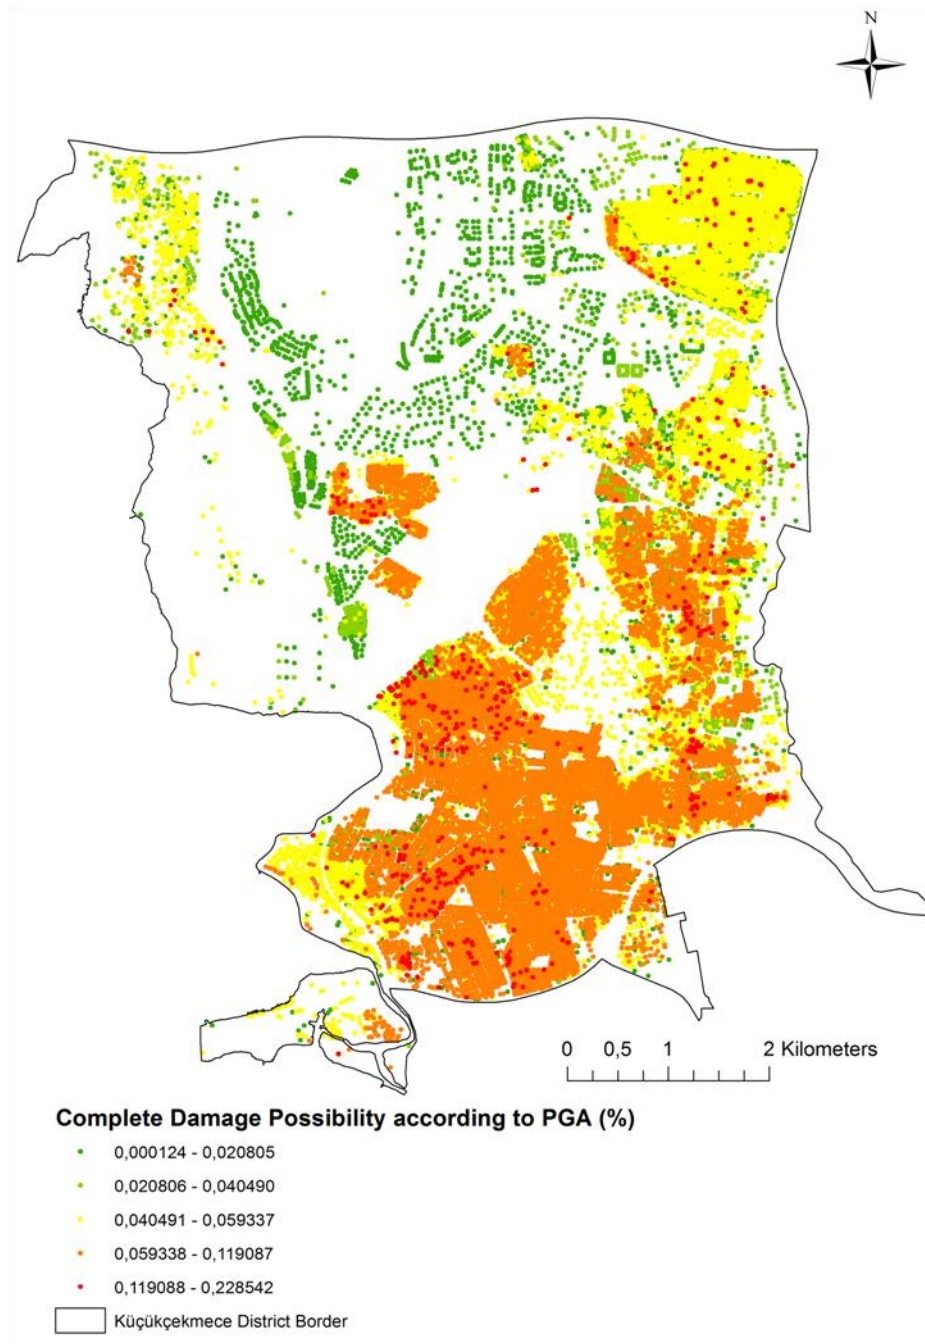
**Figure A.1 :** Complete damage possibility distribution of Küçükçekmece district according to PGA.

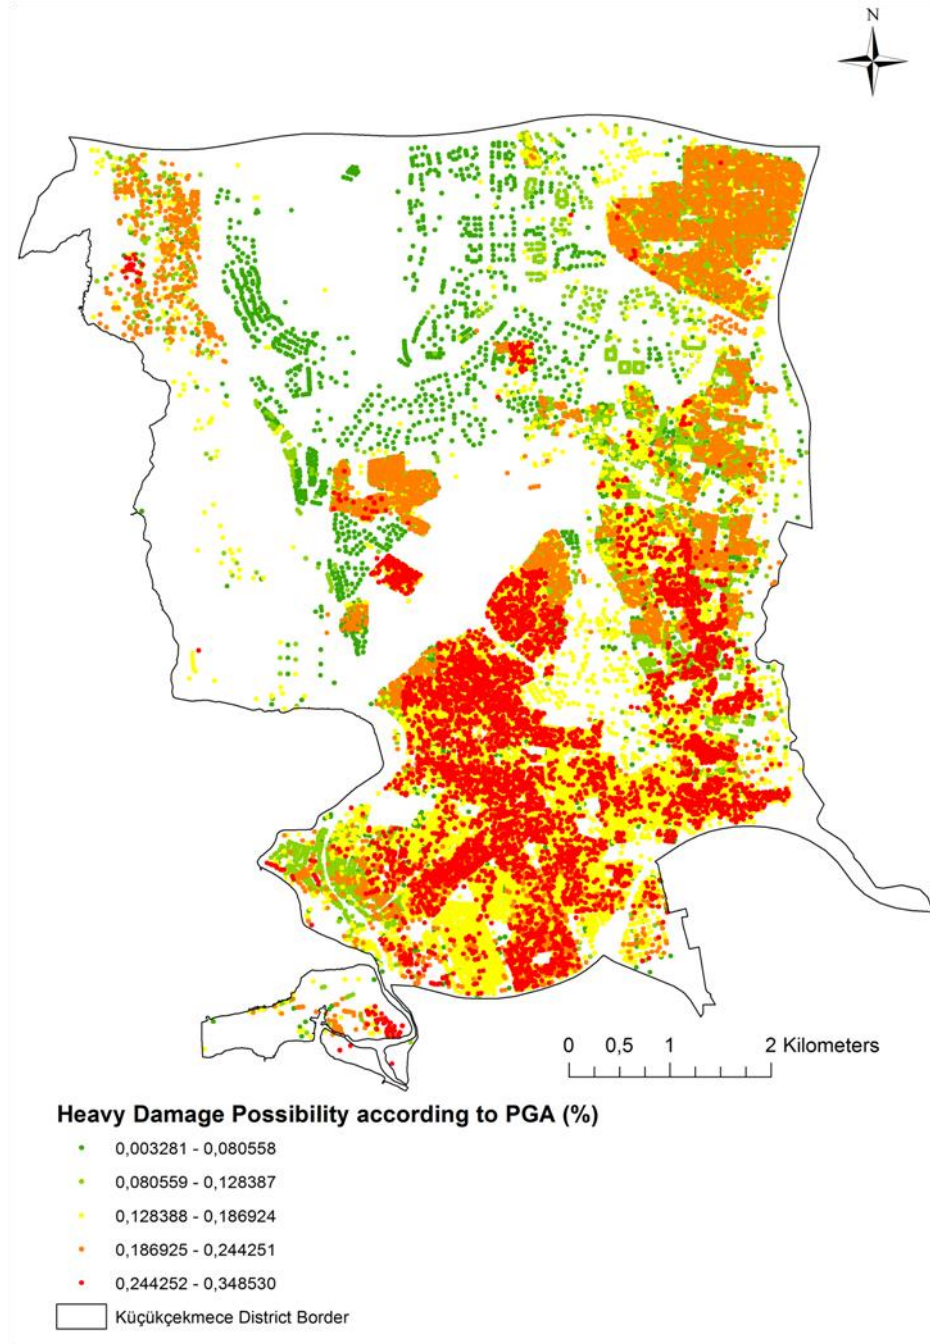
**Figure A.2 :** Heavy damage possibility distribution of Küçükçekmece district according to PGA.
