**EFFECTS OF BUILDING COLLAPSE DIRECTION  
AND BRIDGE FUNCTIONALITY ON ROAD  
NETWORKS FOLLOWING AN EARTHQUAKE**

**Ph.D. THESIS**

**Betül ERGÜN KONUKCU**

**Geomatics Engineering Department**

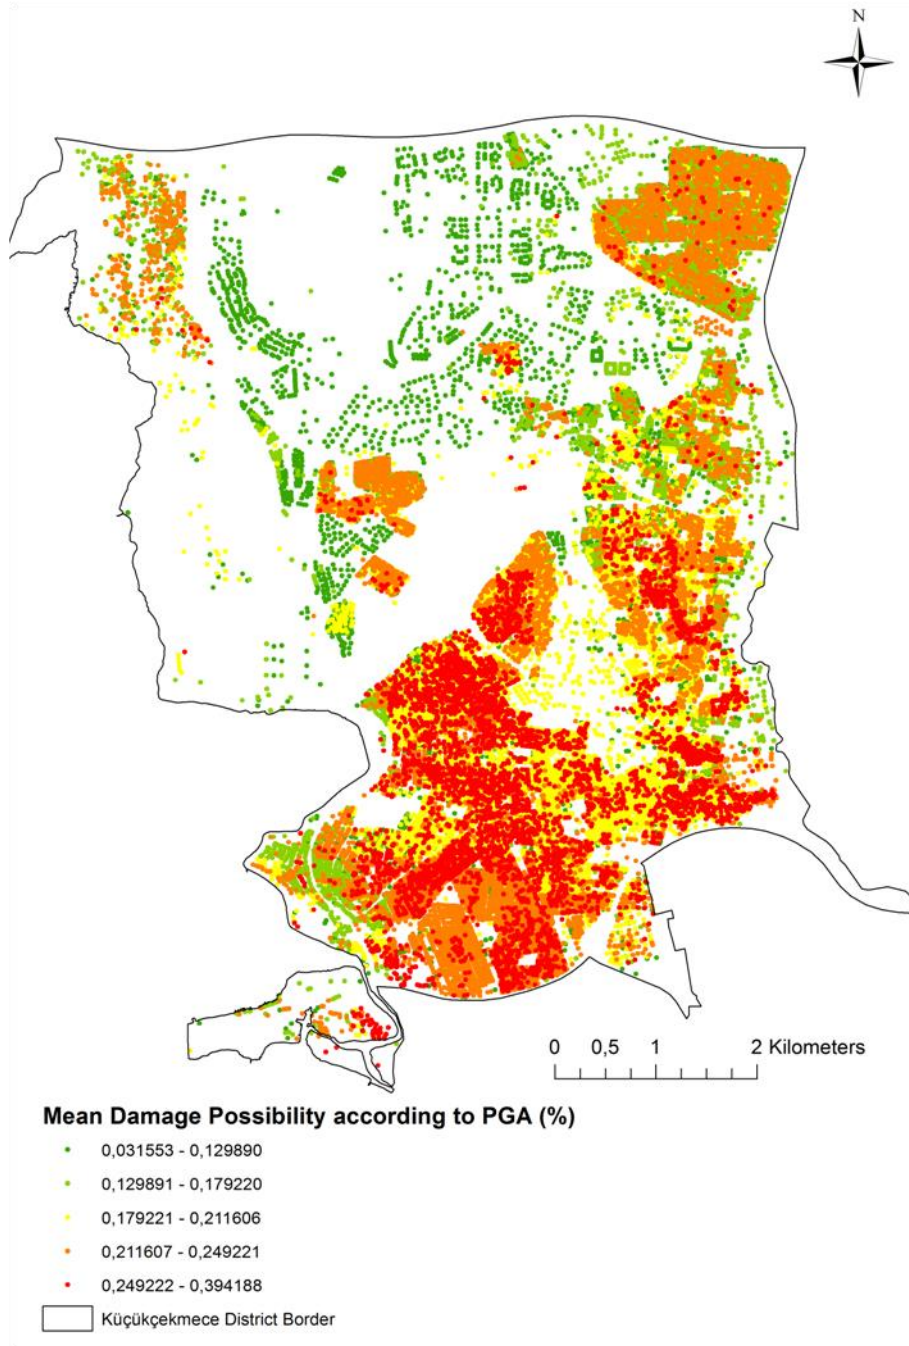
**Figure A. 3 :** Mean damage possibility distribution of Küçükçekmece district according to PGA.

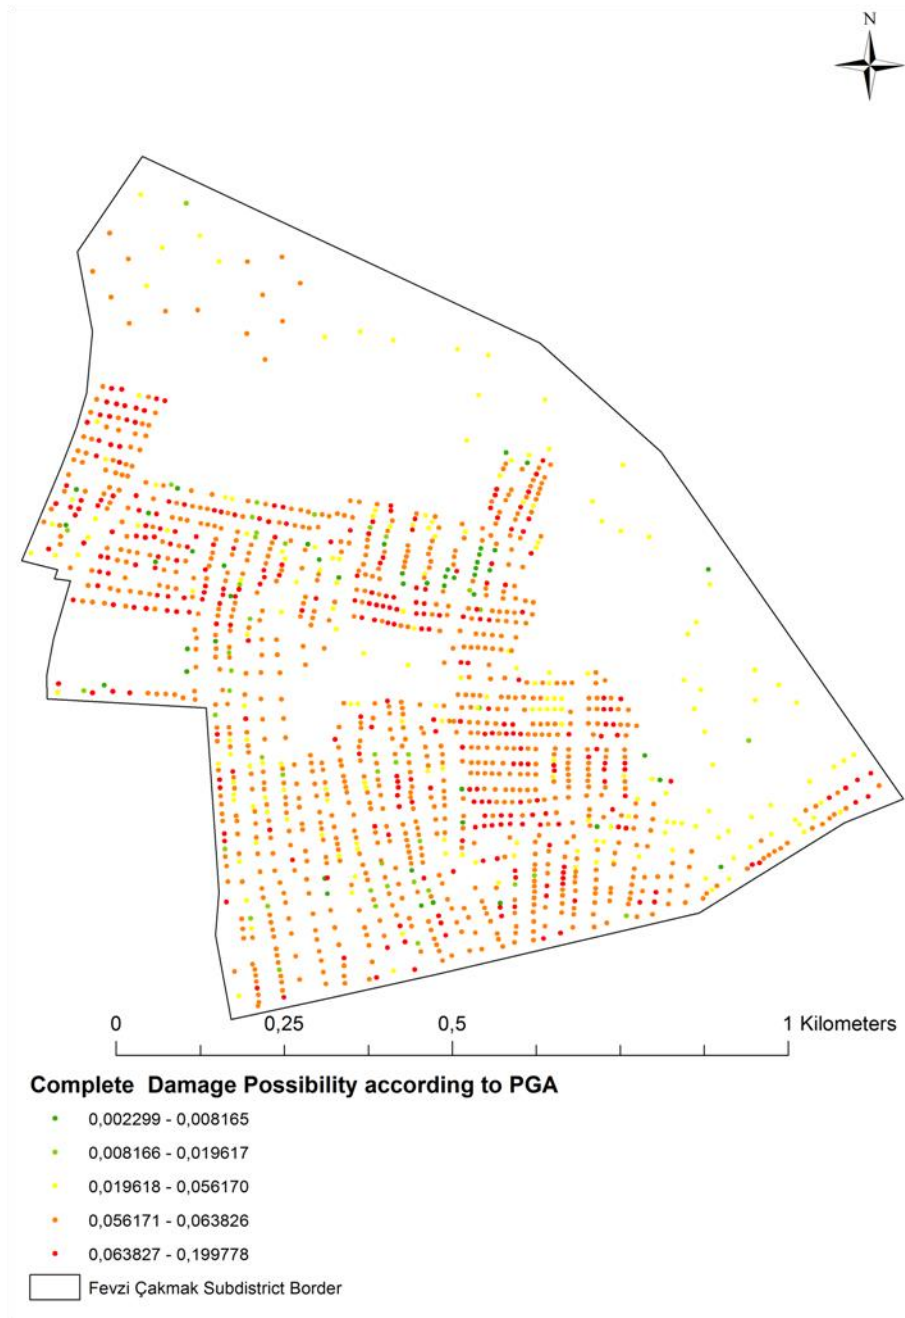
**Figure A.4 :** Complete damage possibility distribution of Fevzi Çakmak sub district according to PGA.

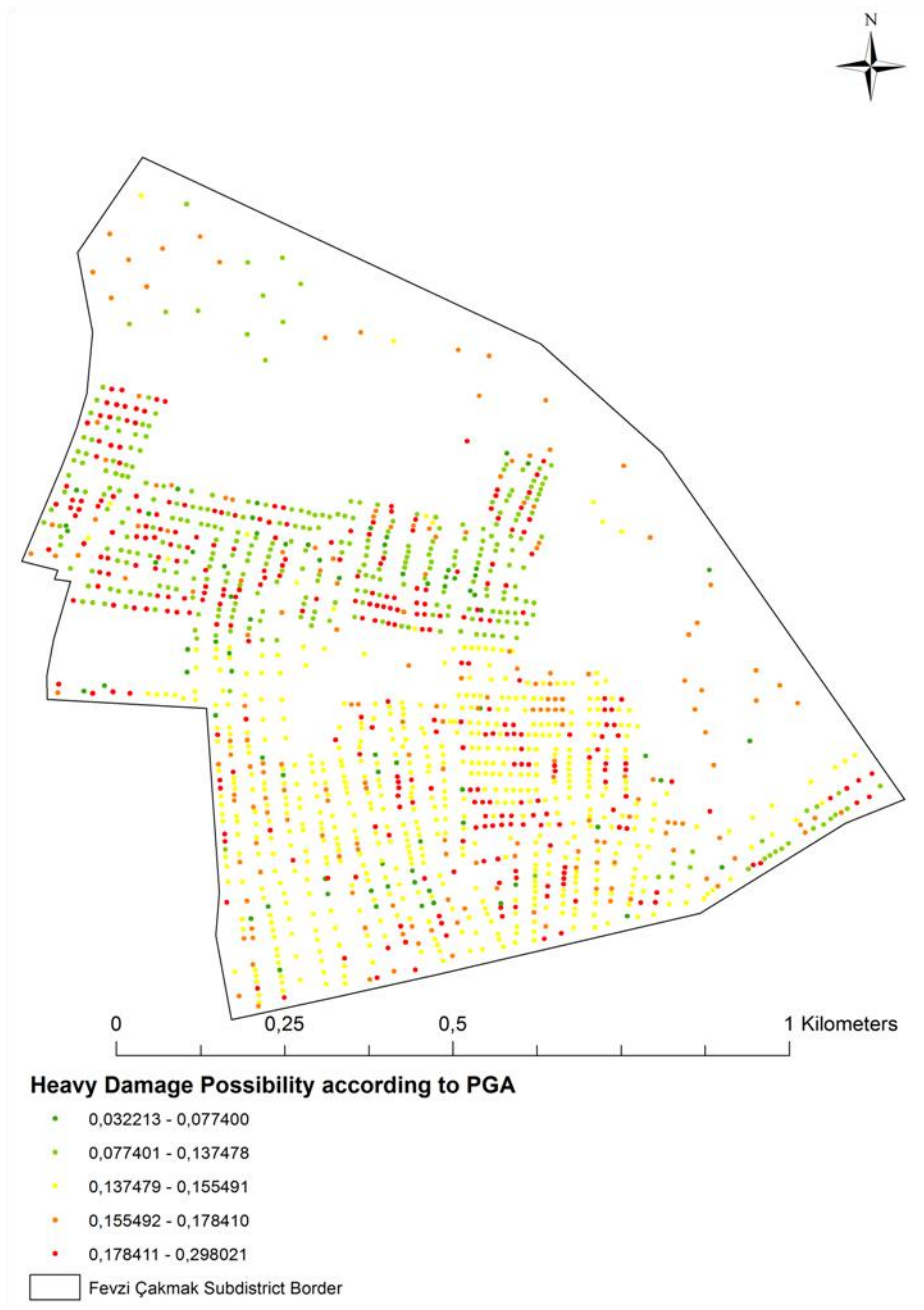
**Figure A. 5 :** Heavy damage possibility distribution of Fevzi Çakmak sub district according to PGA.

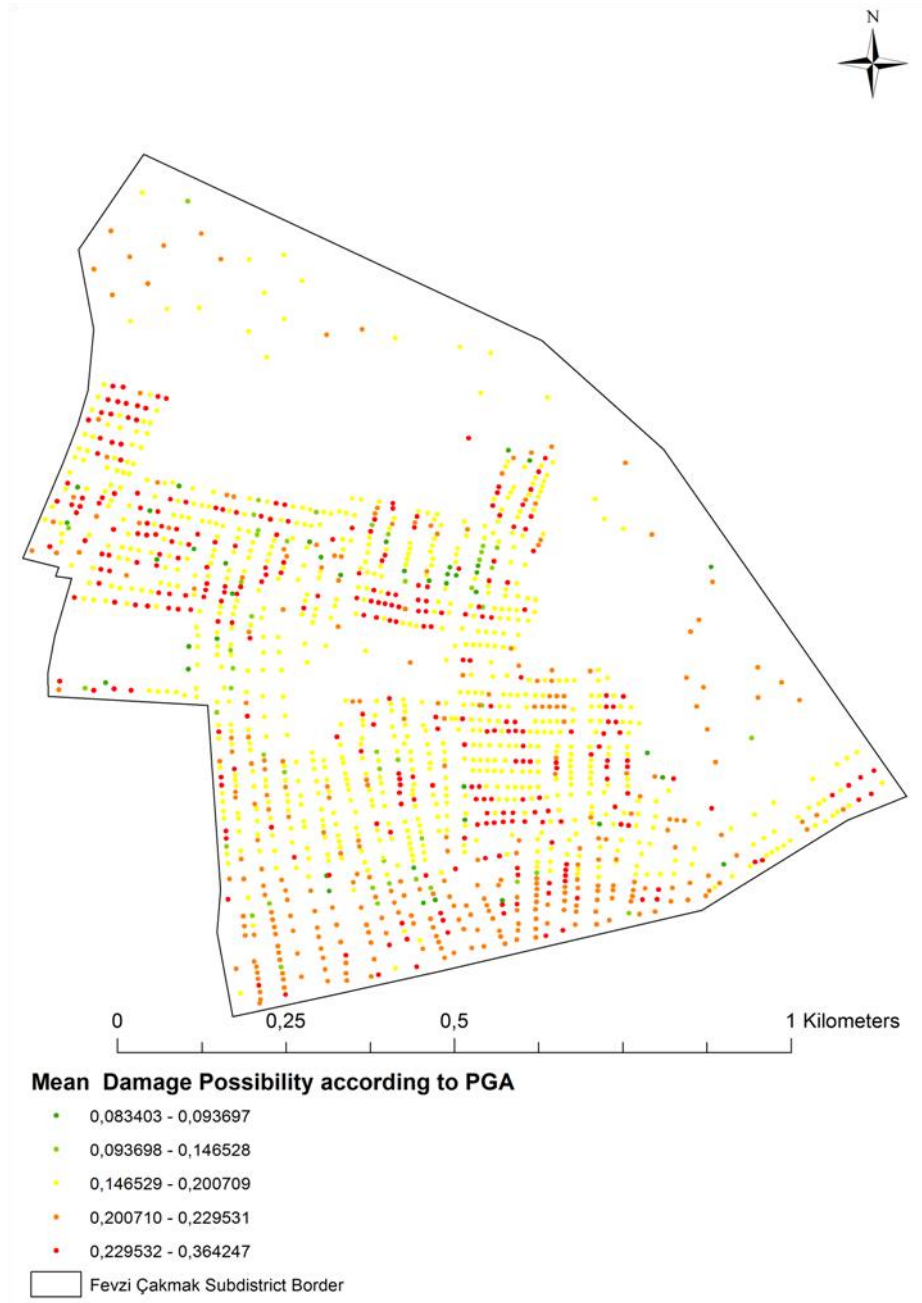
**Figure A. 6 :** Mean damage possibility distribution of Fevzi Çakmak sub district according to PGA.

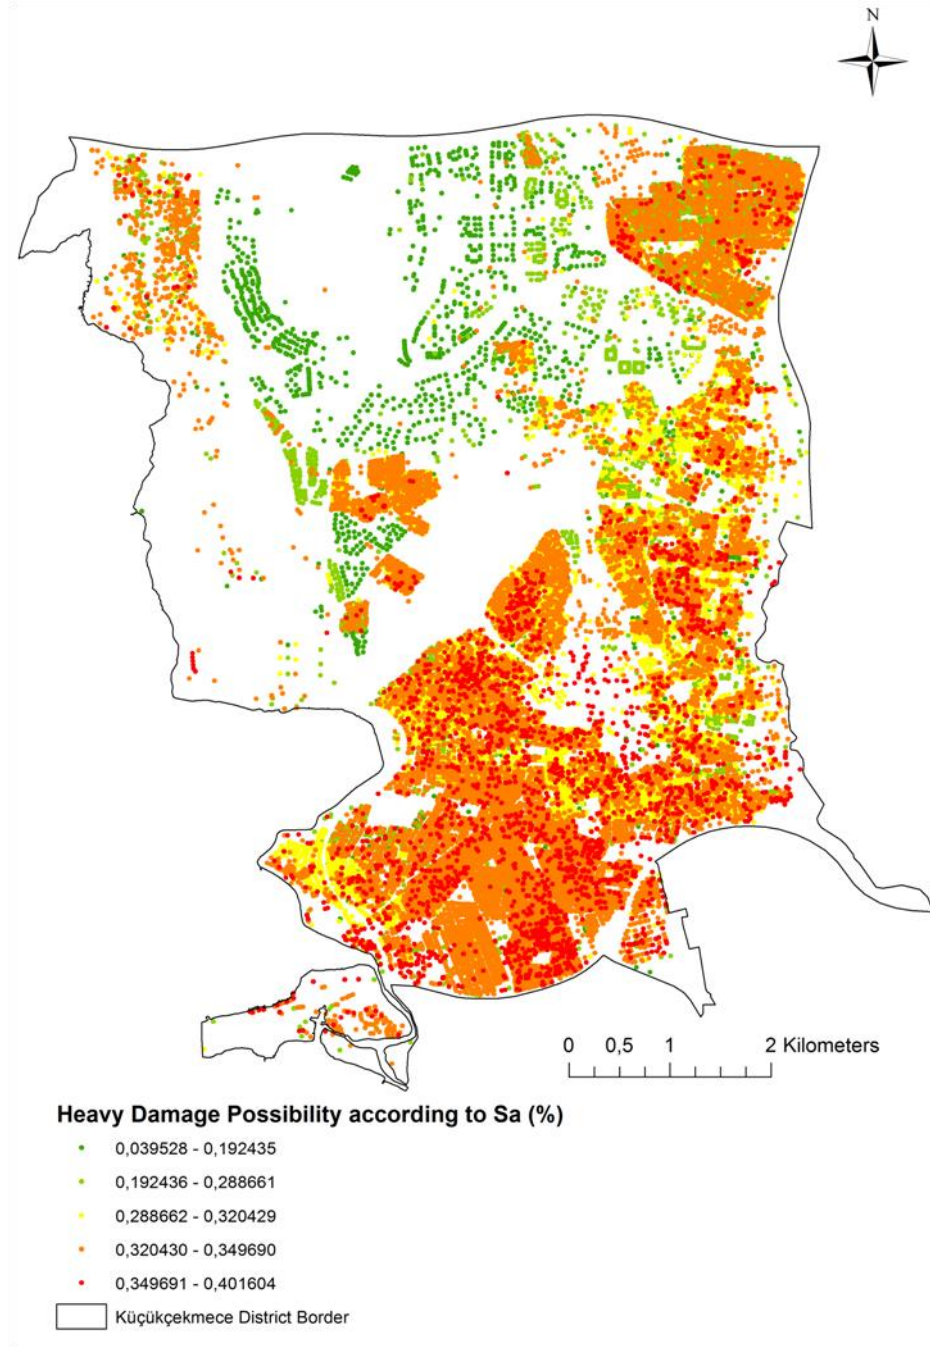
**Figure A. 8 :** Heavy damage possibility distribution of Küçükçekmece district according to Sa.

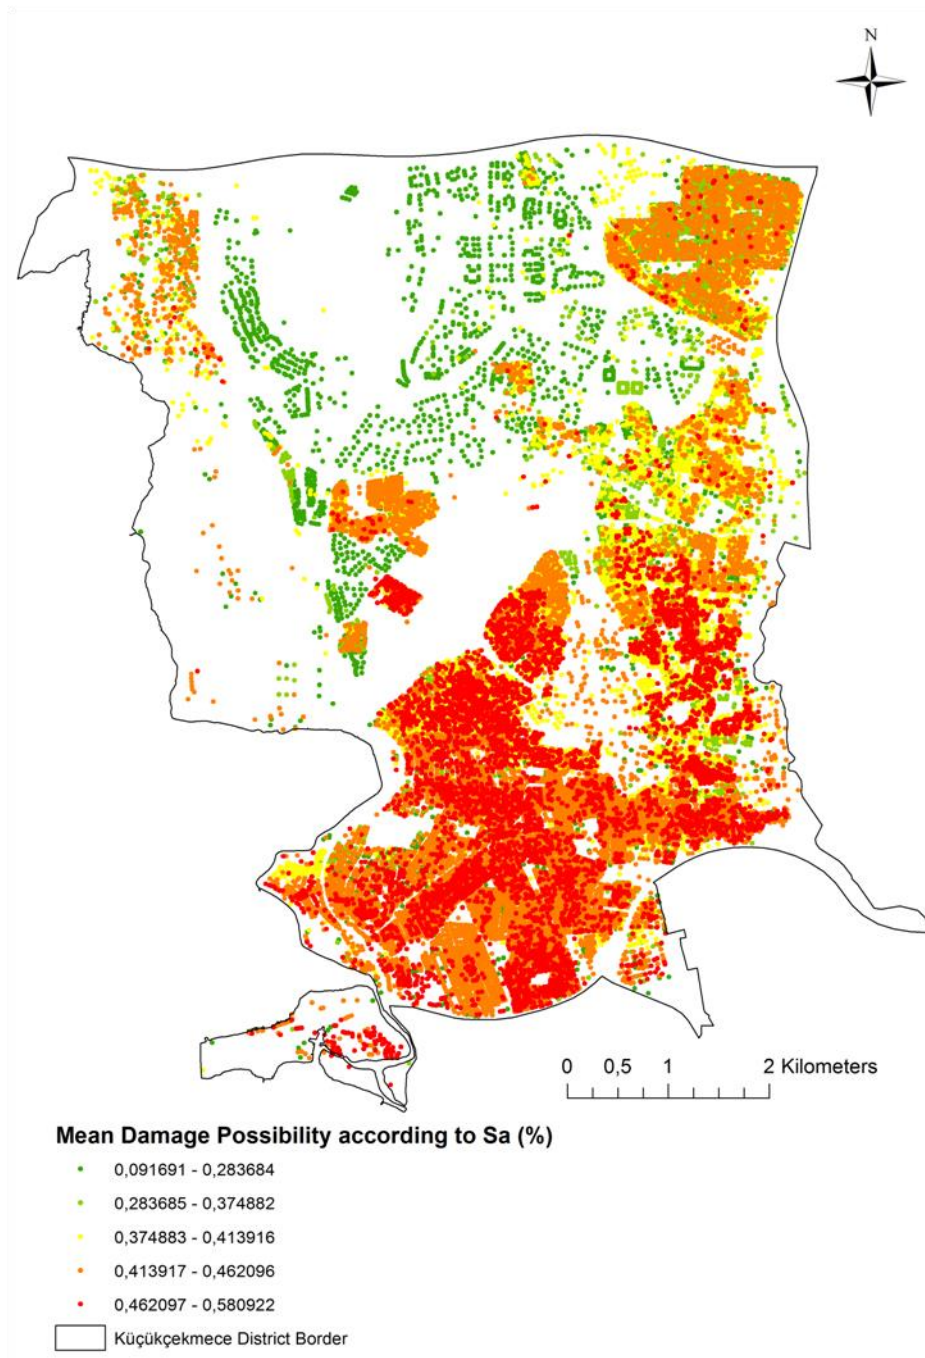
**Figure A.9 :** Mean damage possibility distribution of Küçükçekmece district according to Sa.

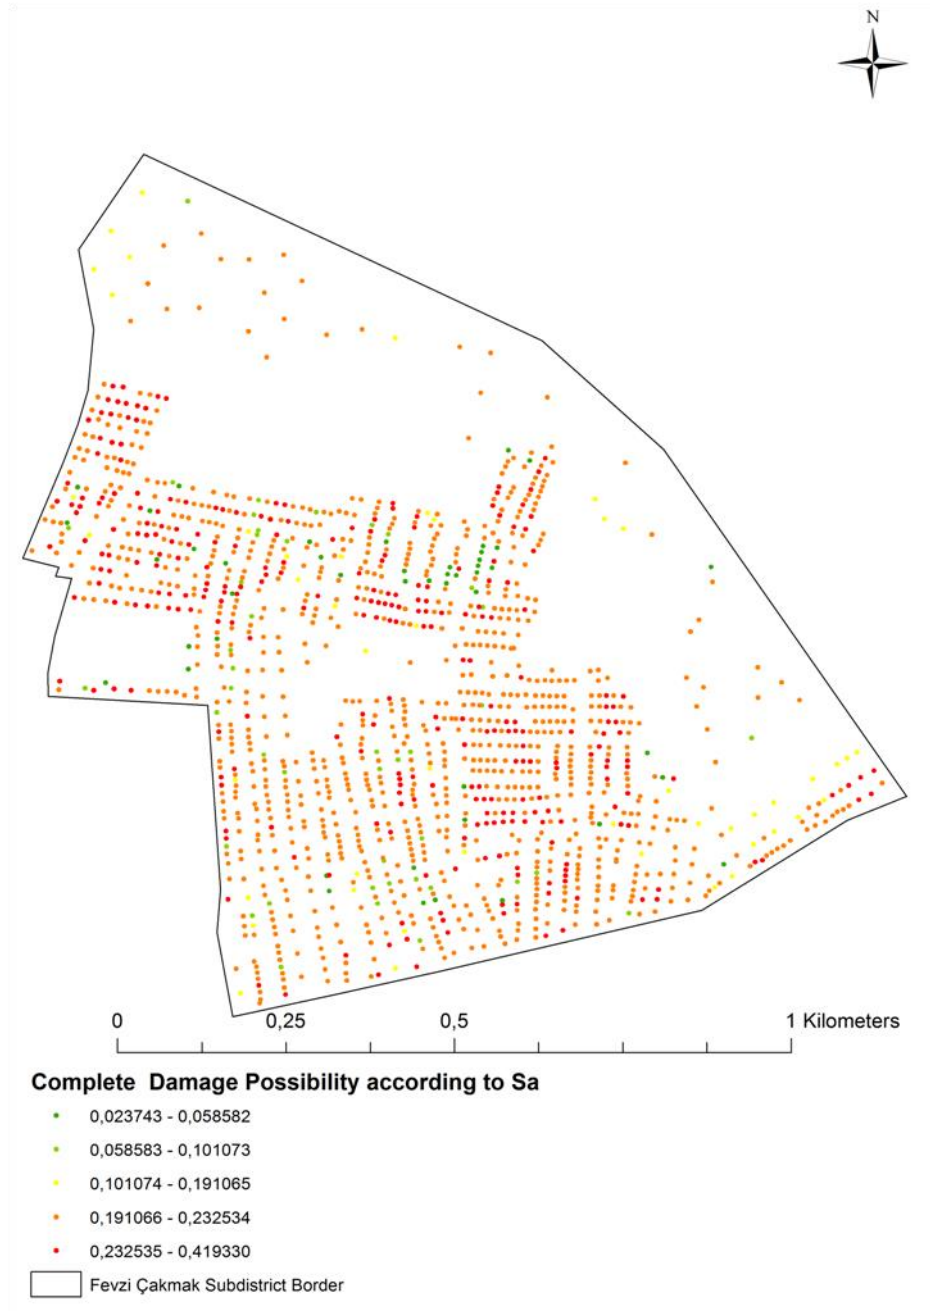
**Figure A.10 :** Complete damage possibility distribution of Fevzi Çakmak sub district according to Sa.

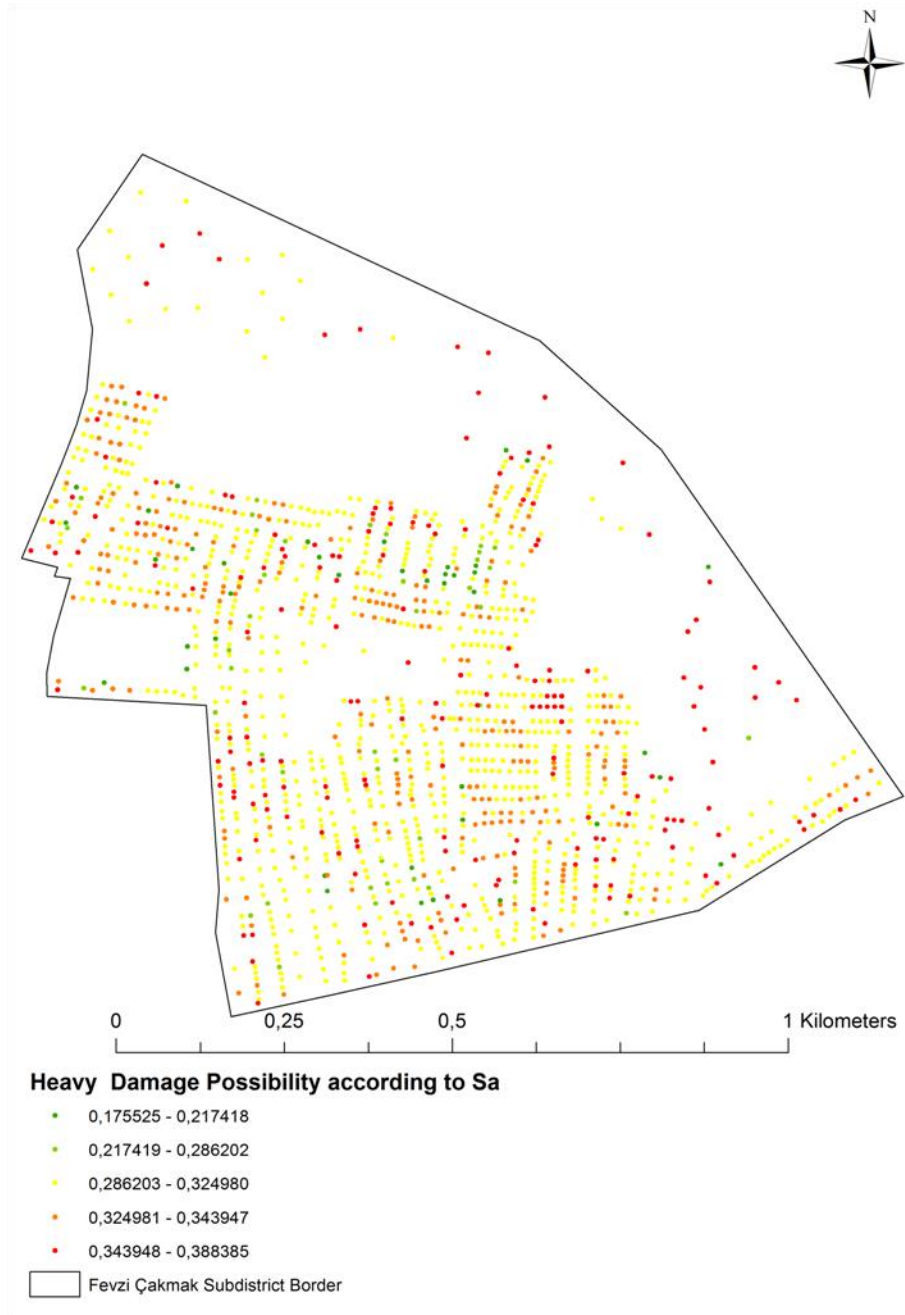
**Figure A. 11 :** Heavy damage possibility distribution of Fevzi Çakmak sub district according to Sa.

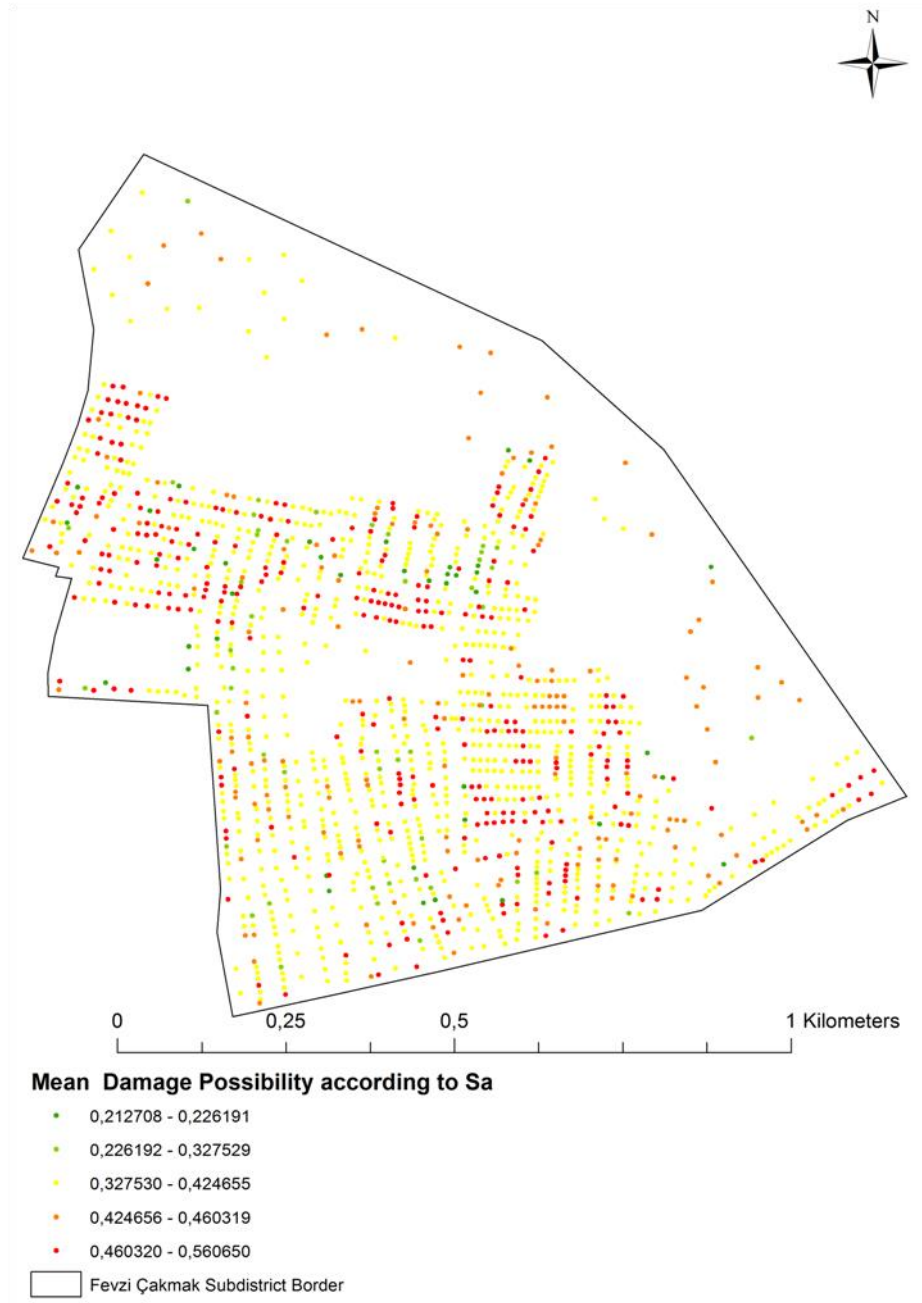
**Figure A.12 :** Complete damage possibility distribution of Fevzi Çakmak sub district according to Sa.
