BİR TAM CEPHE TÜNEL AÇMA MAKİNASININ KAZI PERFORMANSINA
JEOTEKNİK ÖZELLİKLERİN ETKİSİ

EFFECT OF GEOTECHNICAL PROPERTIES ON THE CUTTING PERFORMANCE OF
A FULL-FACE TUNNEL BORING MACHINE

M.Sc. THESIS

Collector tunnels designed to renew Istanbul's inadequate sewerage network and to clean the very polluted Golden Horn (Haliç) are currently under construction by STFA Construction Co. along The Golden Horn and European side of The Bosphorus. (see Figure 3.1.1.) .[1]

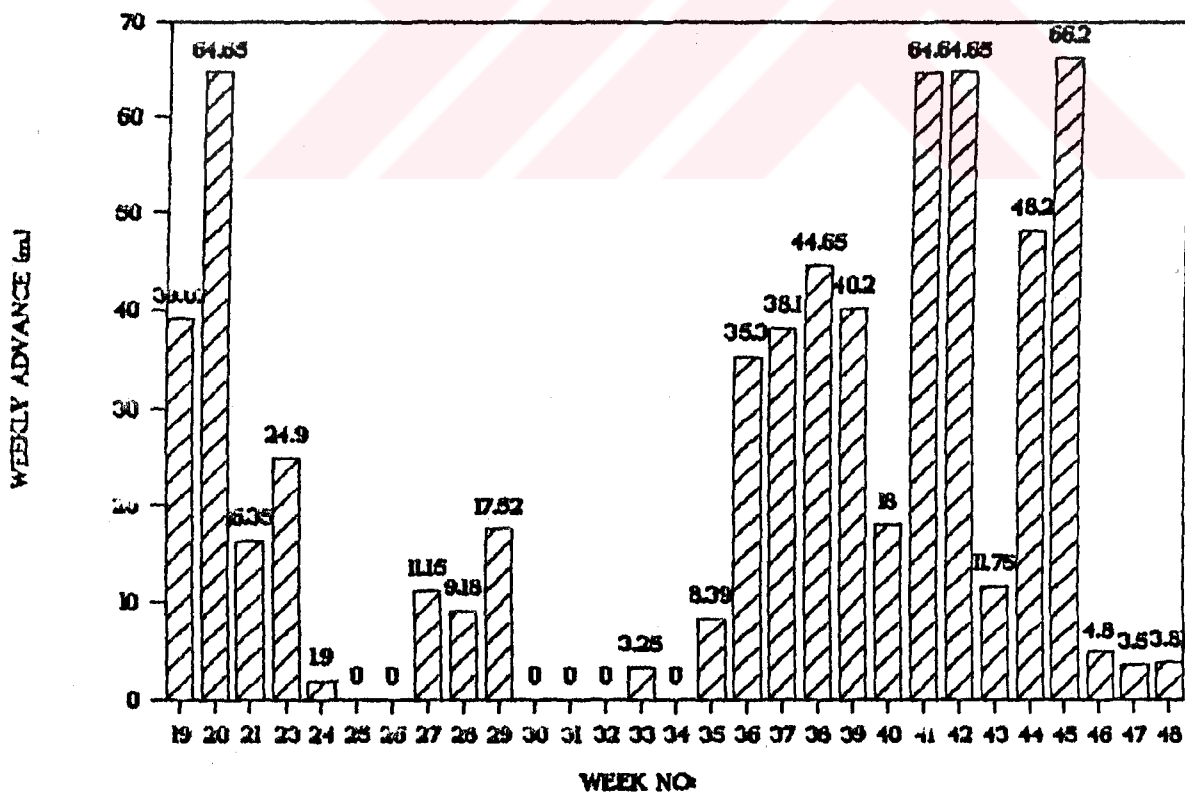
Figure 6.4.3 Weekly Advane In Trakya Formation

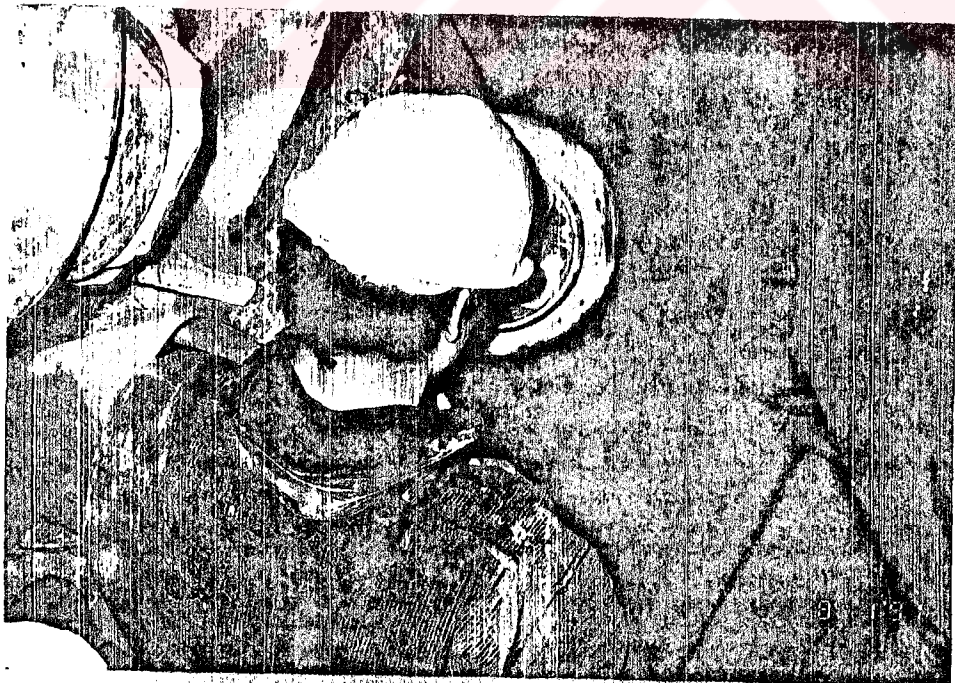
Figure 6.5.2.4 Unscrewing Of The Disc Assembly

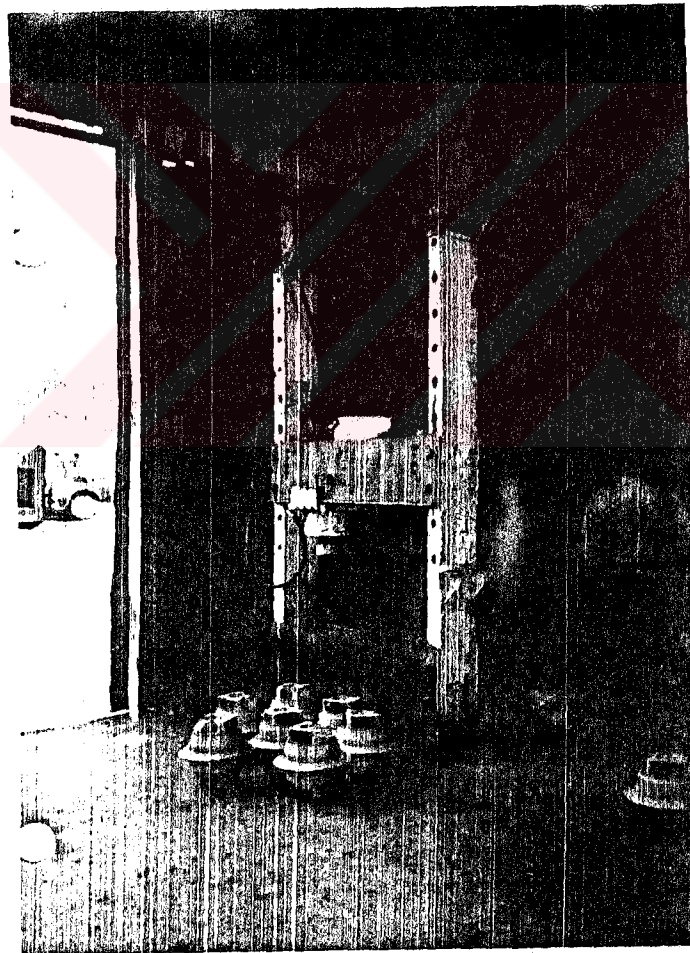
Figure 6.5.2.5 The Rig Being Used For Taking Out Worn Cutter Ring From The Assembly

The changing rig used for worn cutters is seen in figure 6.5.2.5 . For this , disc assembly is put on the rig by a little crane (figure 6.5.2.6) then, as seen in figure 6.5.2.7 load is applied on the assembly to take out worn cutter ring. Job is repeated for each assembly

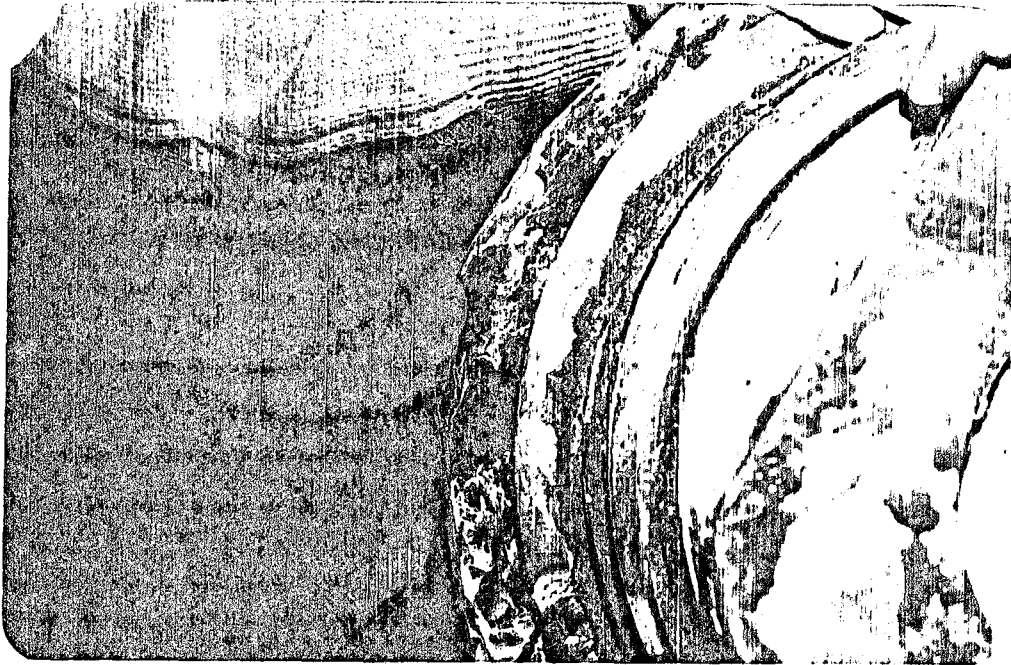
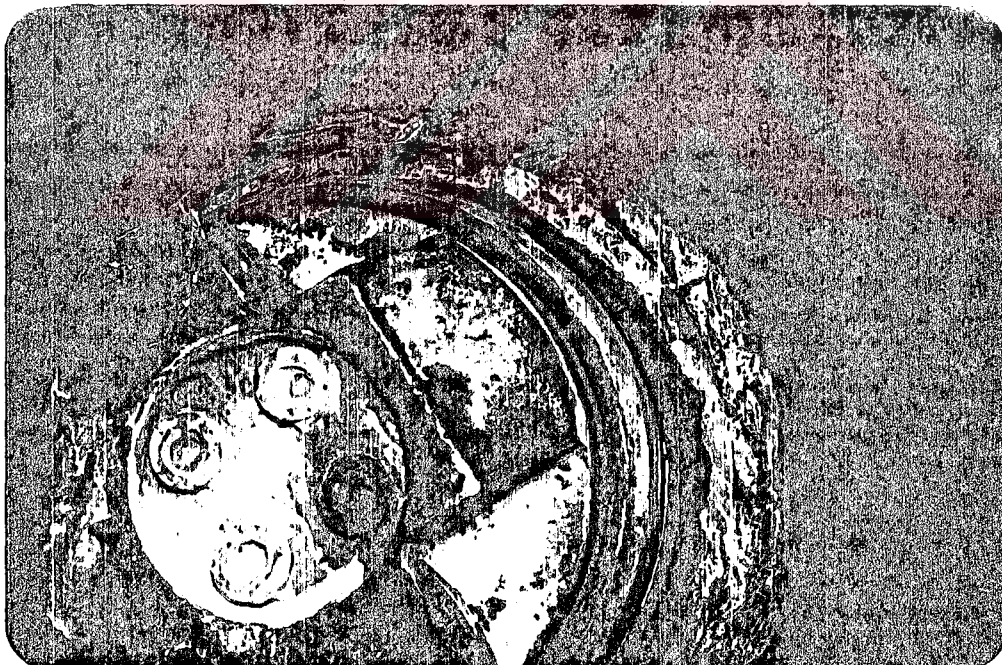
Figure 6.5.2.19 Wearing And Breaking Of Disc Cutters Due To Bearing Failure

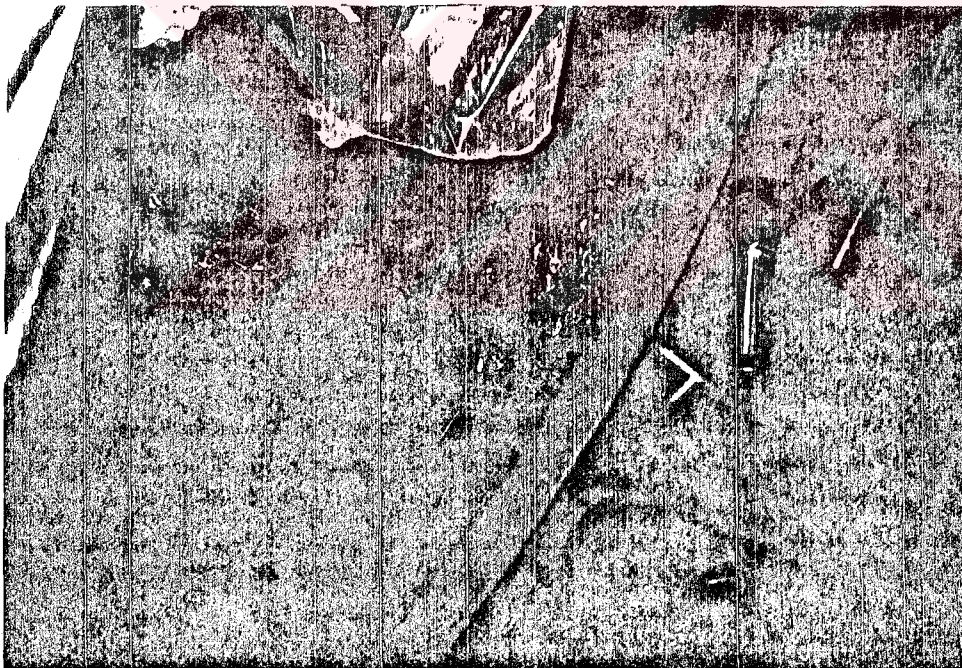
Figure 6.5.3.1 Deformation Of Steel Arches By Gripper Pads

Overbreaks and collapses occurred at different chainages and supporting of this, passing through them caused the excavation performance of the machine to decrease very much. Besides, pressing on the steel arch+shotcrete by the gripper pads caused another big problem, when clay band exist.

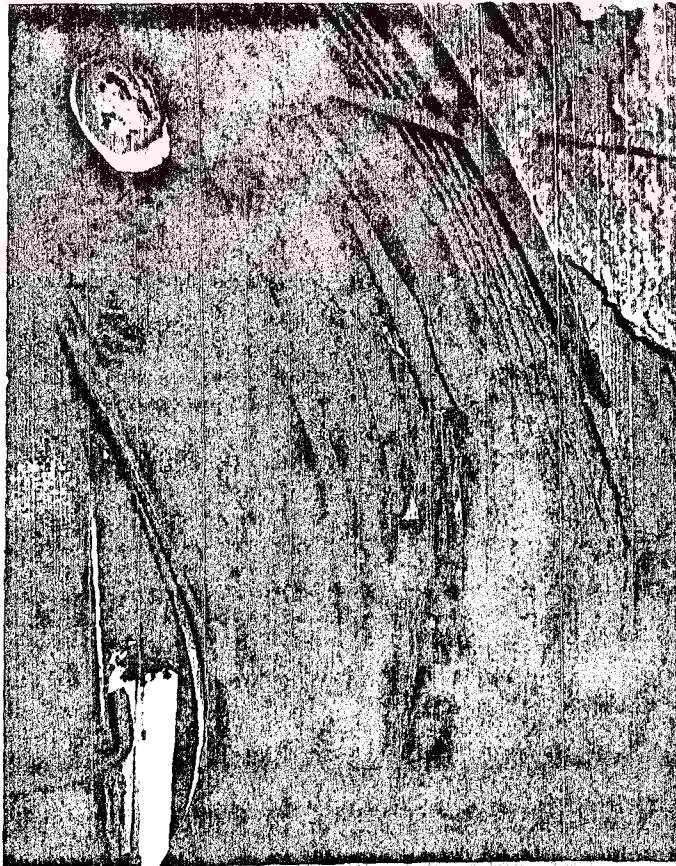
Figure 6.5.3.3 Wooden Blocks Placed Between Grippers And Support System

support system (figure 6.5.3.3). Another problem caused by the pads was the overbreak on the sidewalls (figure 6.5.3.4), shotcreting was generally made in such places for stabilization.

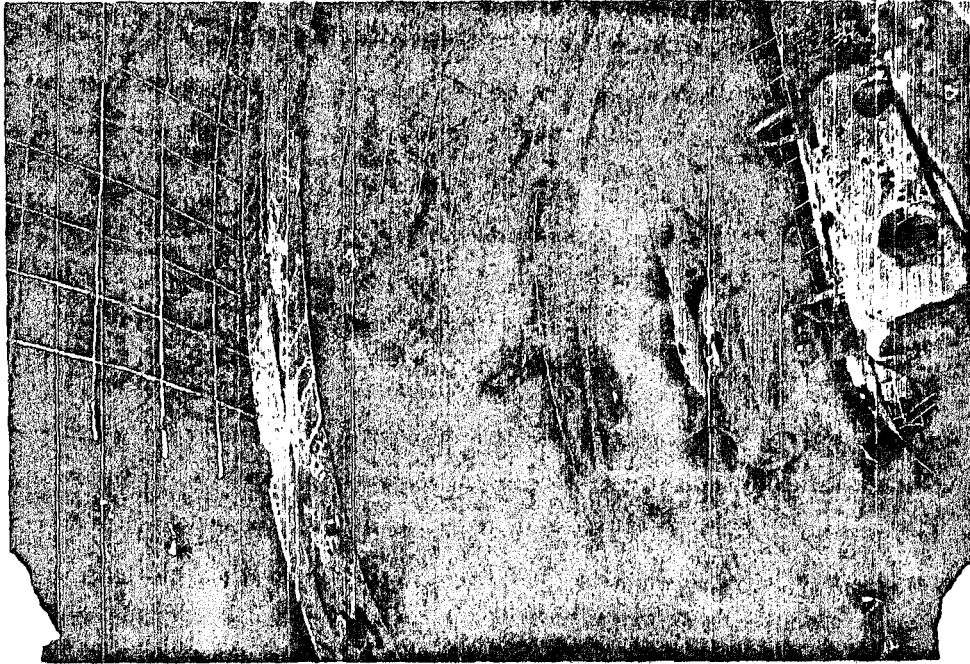
Figure 6.5.3.4 Overbreaks Caused By The Gripper Pads

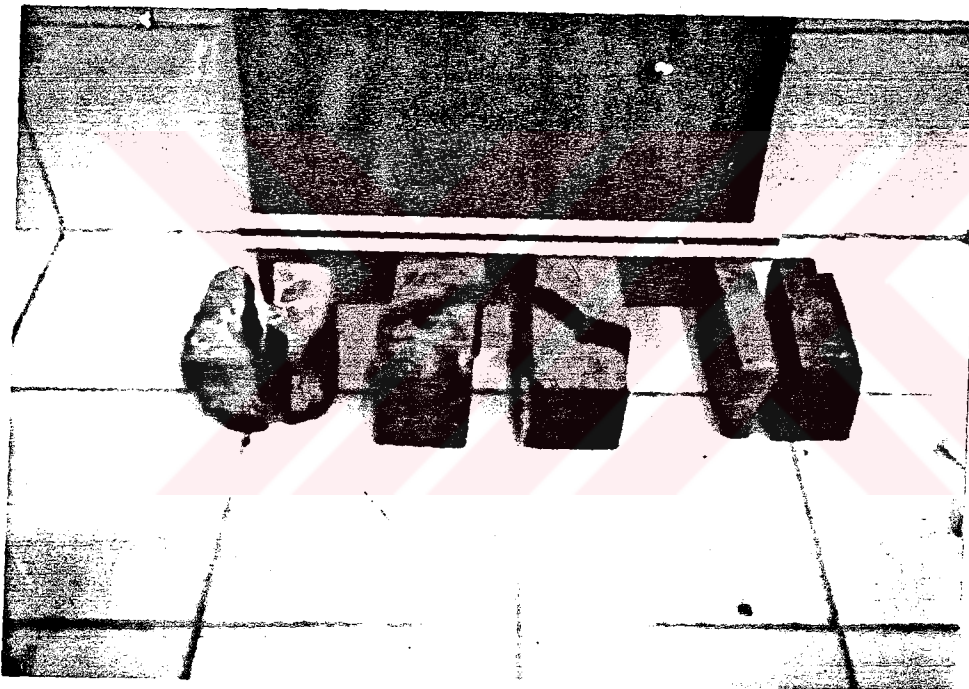
Figure 7.2.4 Some Tested Samples In The Point Load Experiment
