**SEISMIC BEHAVIOUR OF HISTORICAL STONE MASONRY  
MULTI-LEAF WALLS**

**Ph.D. THESIS**

**Cem DEMİR**

**Department of Civil Engineering**  
**Structural Engineering Programme**

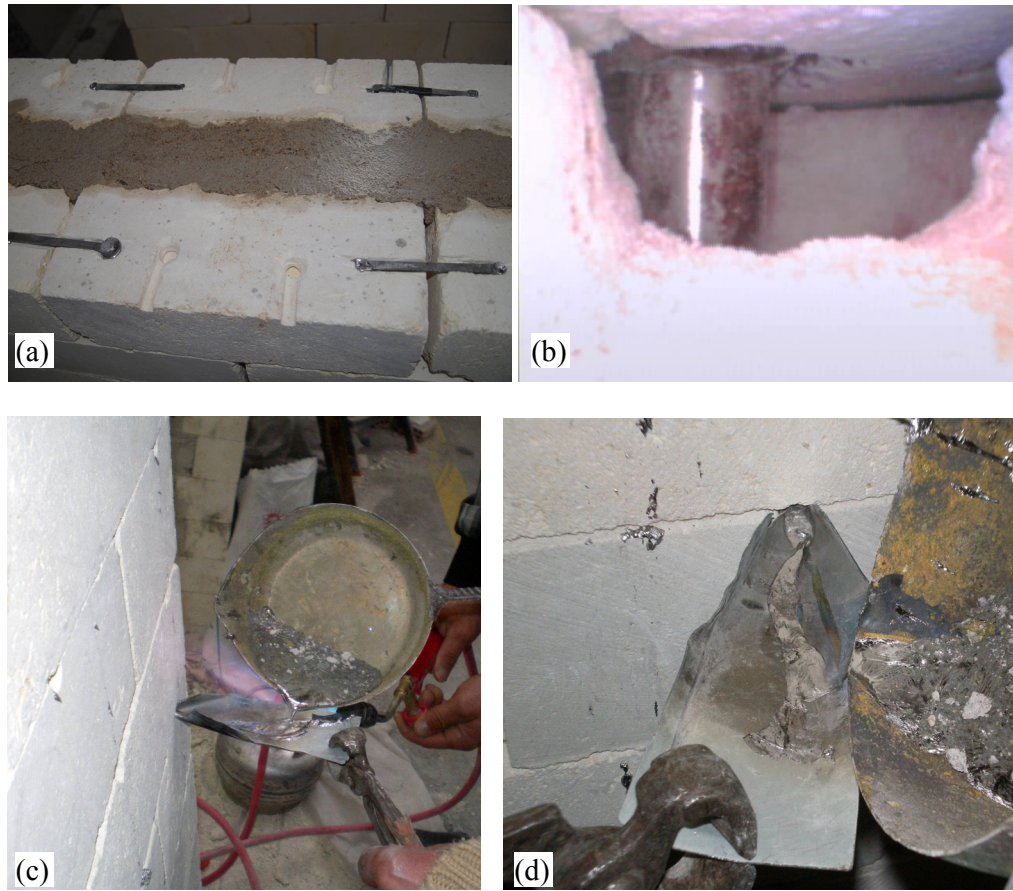
**Figure 3.11 : Installation of the pins.**

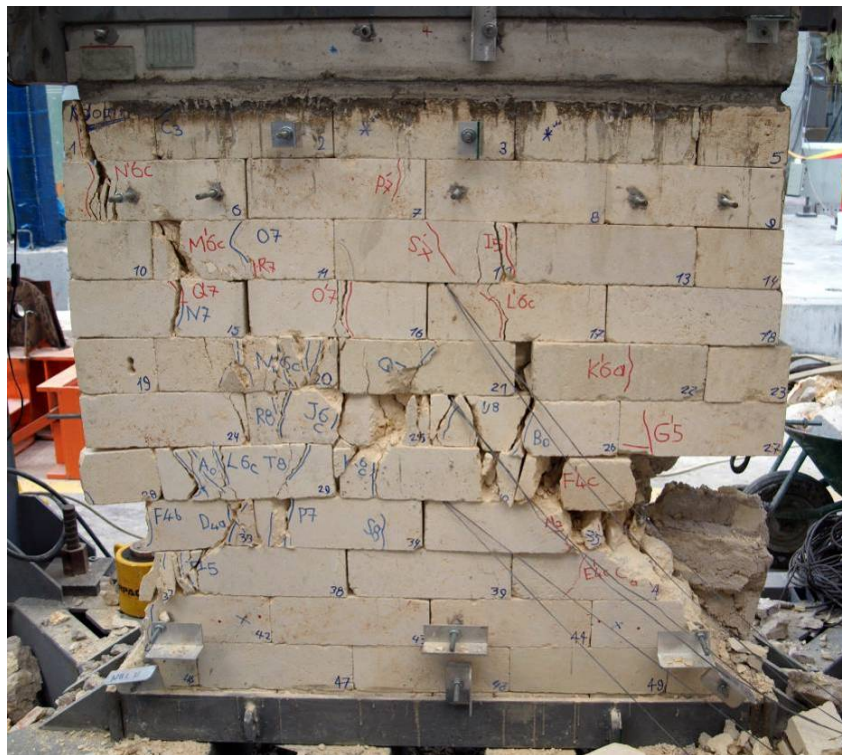
**Figure C.15 :** Cycle 9, North face of M-25-C after 2.0% drift ratio.

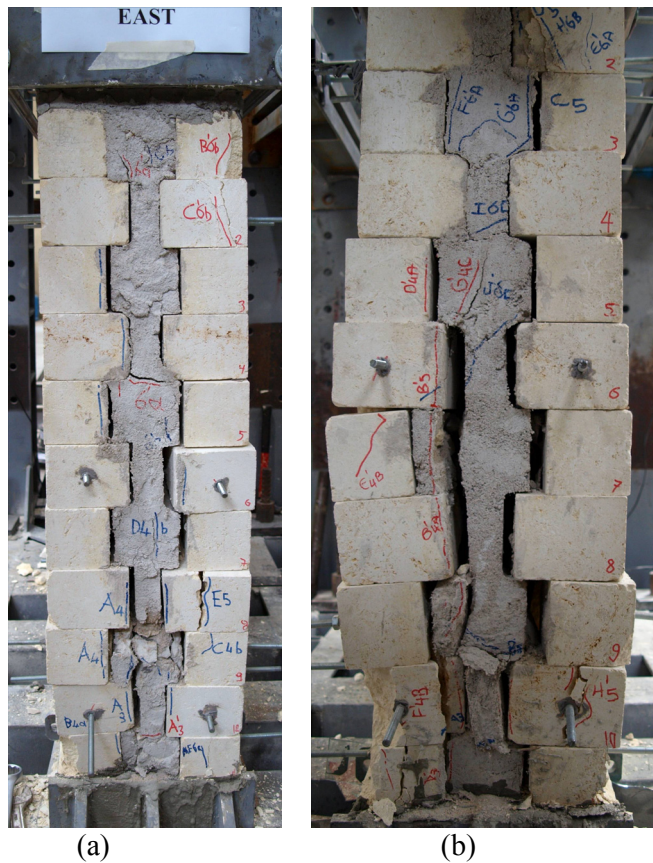
**Figure C.44 :** Cycle 8, (a) East and (b) West faces of M-50-C after 16.50 mm displacement (1.50% drift ratio).

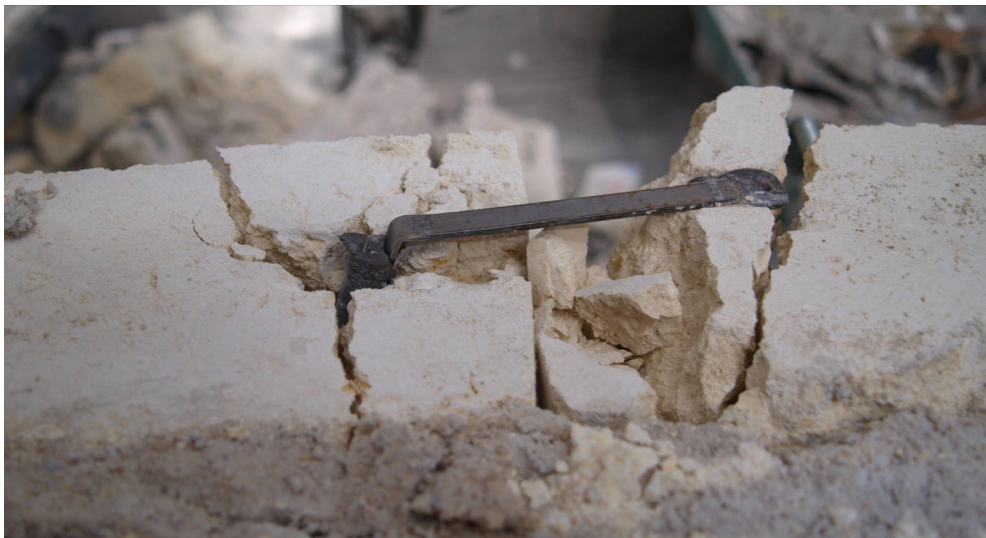
**Figure C.45 :** Damage in the vicinity of cramp anchors, M-50-C.

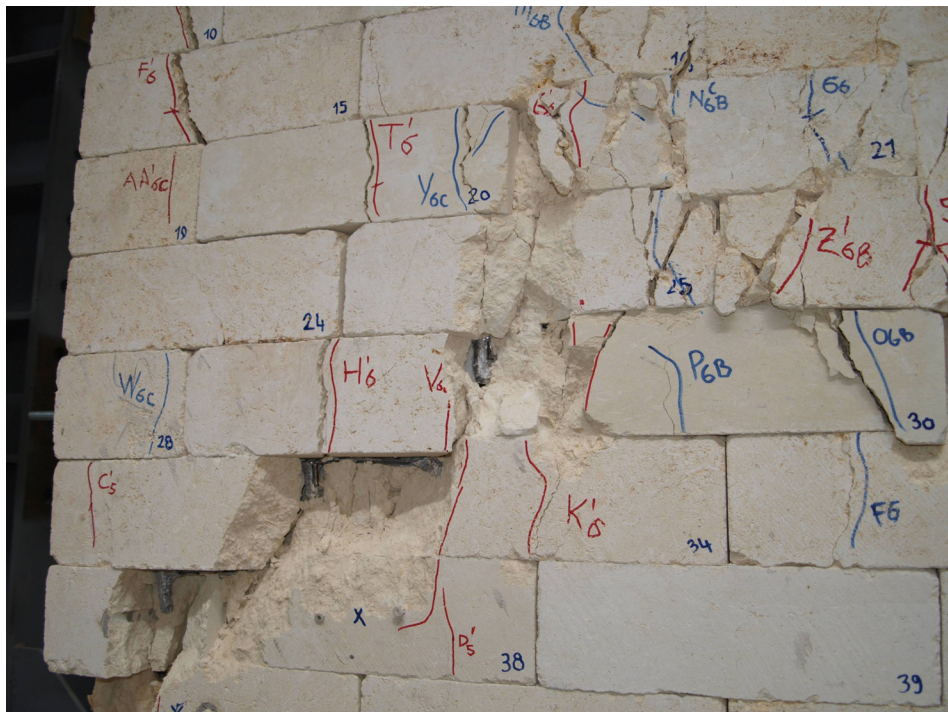
**Figure C.74 :** Damage in the vicinity of cramp anchors, M-75-C.

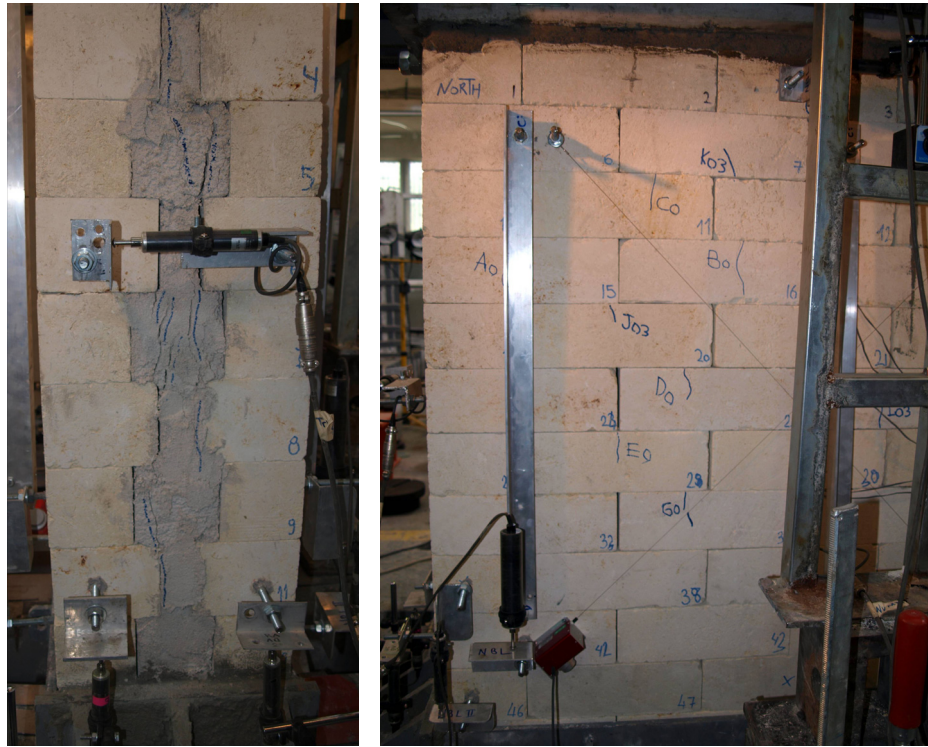
**Figure C.84 :** Observed damage during the axial loading of M-100-C specimen.

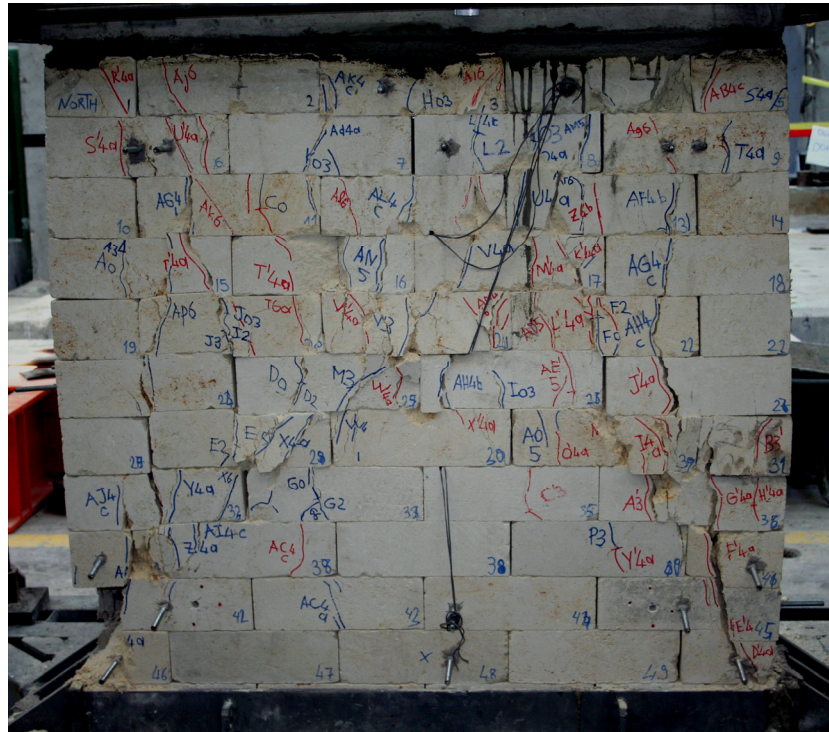
Figure C.100 : Northern face of M-100-C specimen after the test.

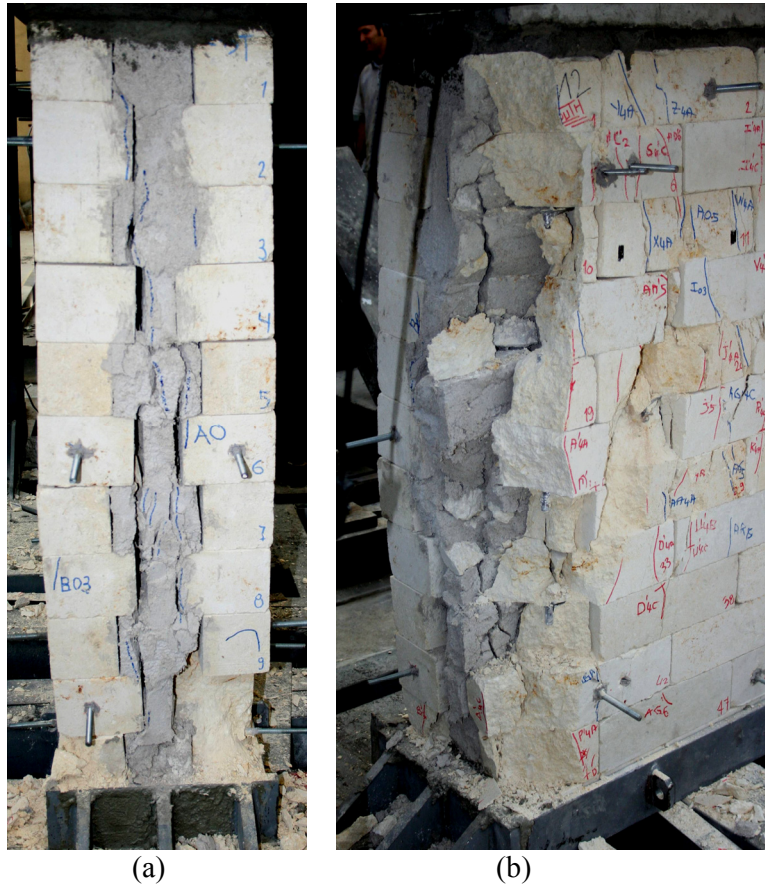
**Figure C.102 :** (a) East and (b) West faces of M-100-C after the test.

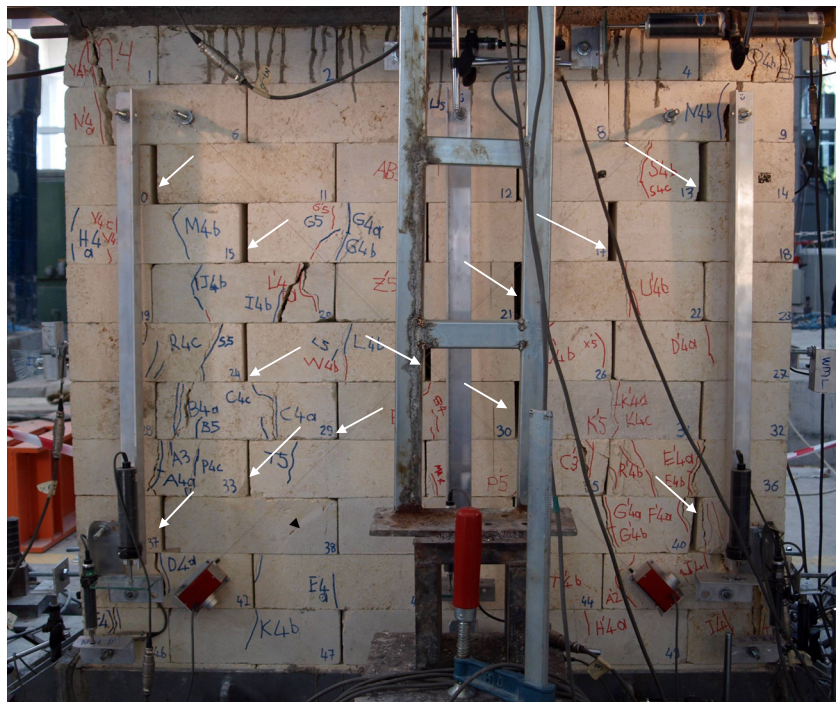
**Figure C.124 :** Cycle 5, Northern face of M-50 after 0.75% drift ratio.

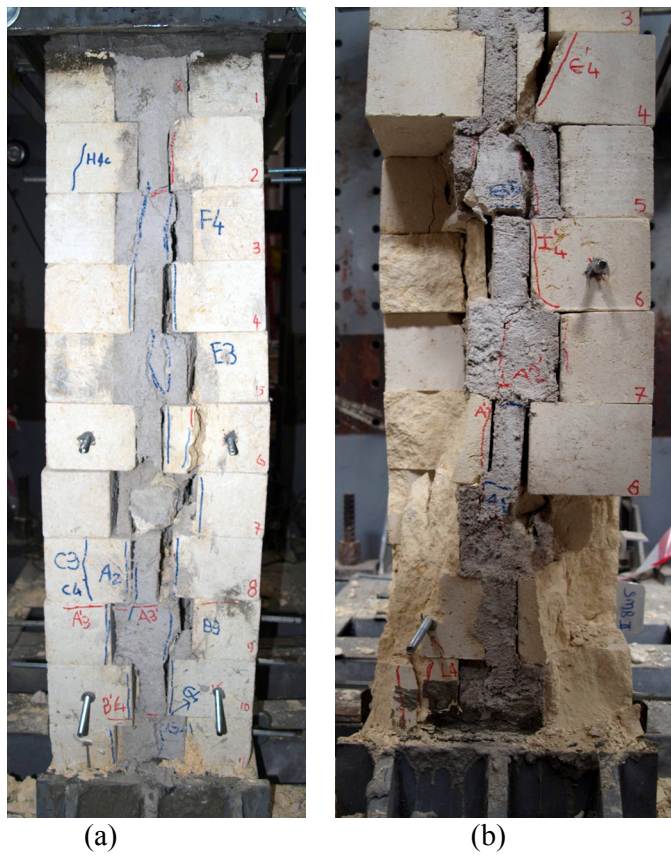
**Figure C.133 :** (a) Eastern and (b) Western faces of M-50 after the test.
