# Slope stability analysis applied to the 5th section of the Northern Marmara Motorway, İzmit, Türkiye

## Abstract

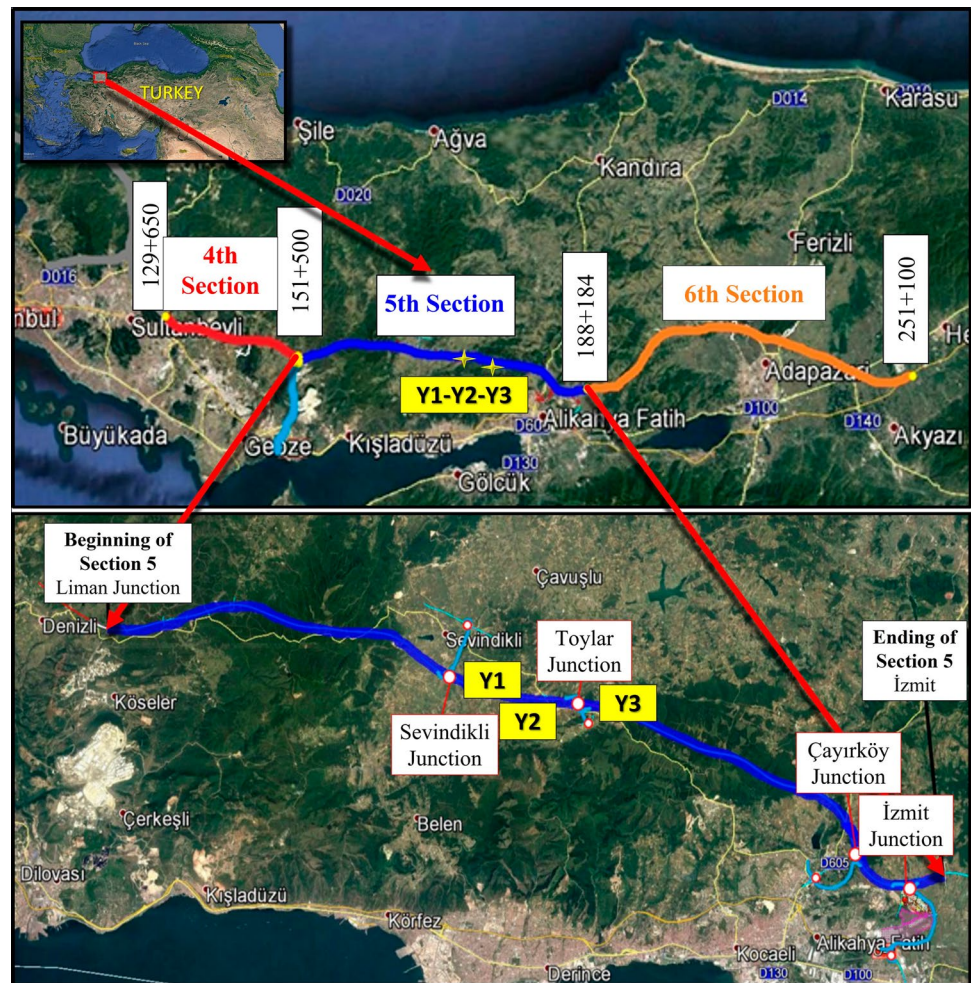
**Fig. 1** Satellite image showing the 5th Section of the Northern Marmara Motorway (Google Earth 2020)

The mass movements that occurred throughout the study area were designated Y1, Y2, and Y3 (Fig. 1). The mass movement that occurred between km: 170 + 300–170 + 400 was designated Y1, the one that occurred between km: 170 + 640 was designated Y2 and finally the mass movement that occurred between km: 175 + 297–175 + 463 was designated Y3. The type of mass movement Y1 was defined as rotational landslide, the type of mass movement Y2 was defined as translational landslide, and the type of mass movement Y3 was defined as flow. Stability assessments were carried out for each mass movement as part of the study. Table 1 shows summarized information on the kilometers, cut heights, and inclinations of the slopes along the 5th section.

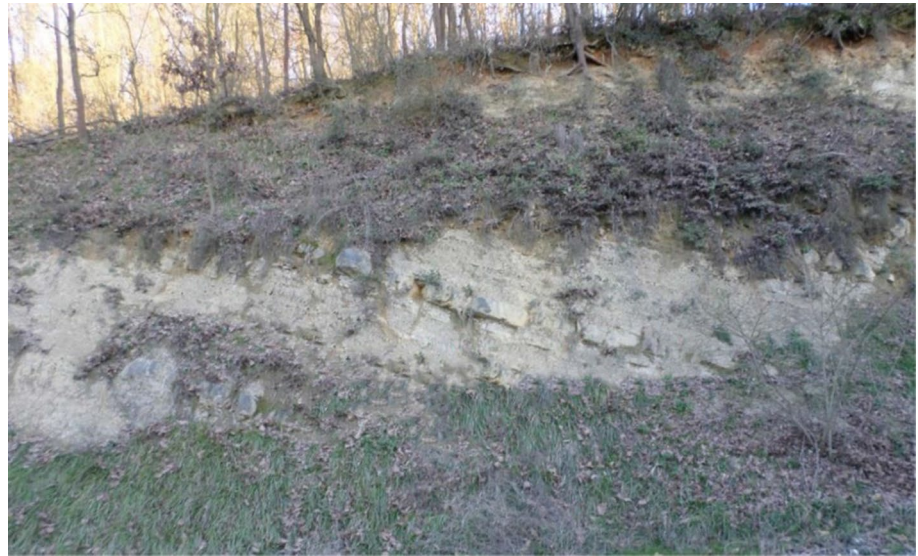
**Fig. 3** A view from the outcrop of the Korucu Formation (Tek) consisting of thin–medium thick-bedded sandstone, and thin-bedded shale alternation

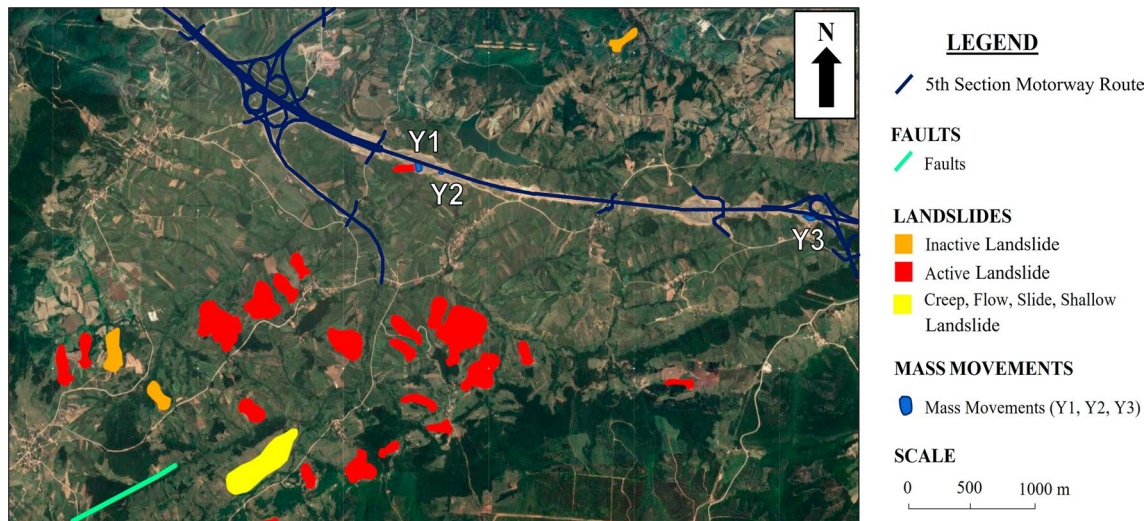
**Fig. 4** Active faults and landslides of the region according to General Directorate of Mineral Research and Exploration (MTA) GeoScience MapViewer (Department of Scientific Documentation and Publicity,

2016) and Y1, Y2, and Y3 mass movements along the 5th Section Motorway Route

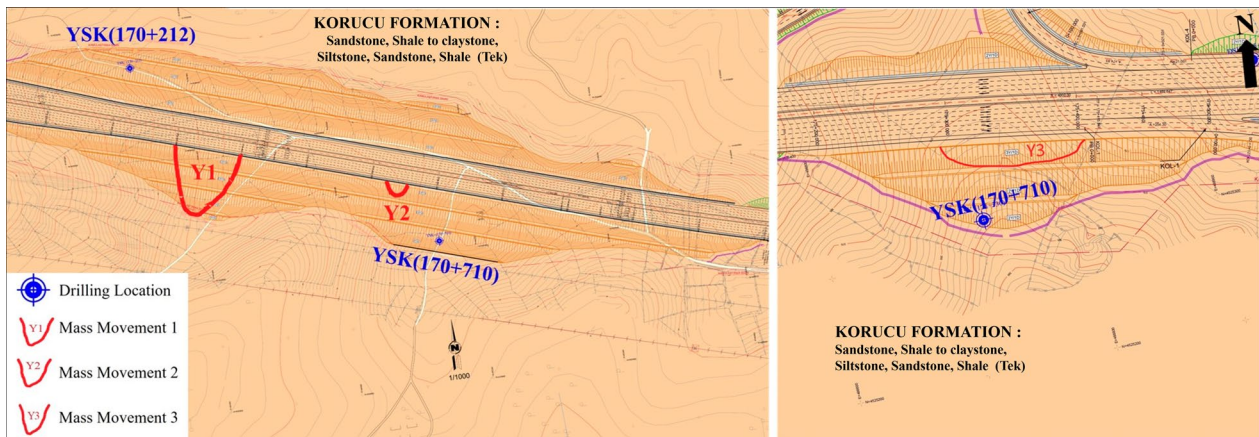
**Fig. 5** Location of boring logs and Y1–Y2–Y3 mass movements

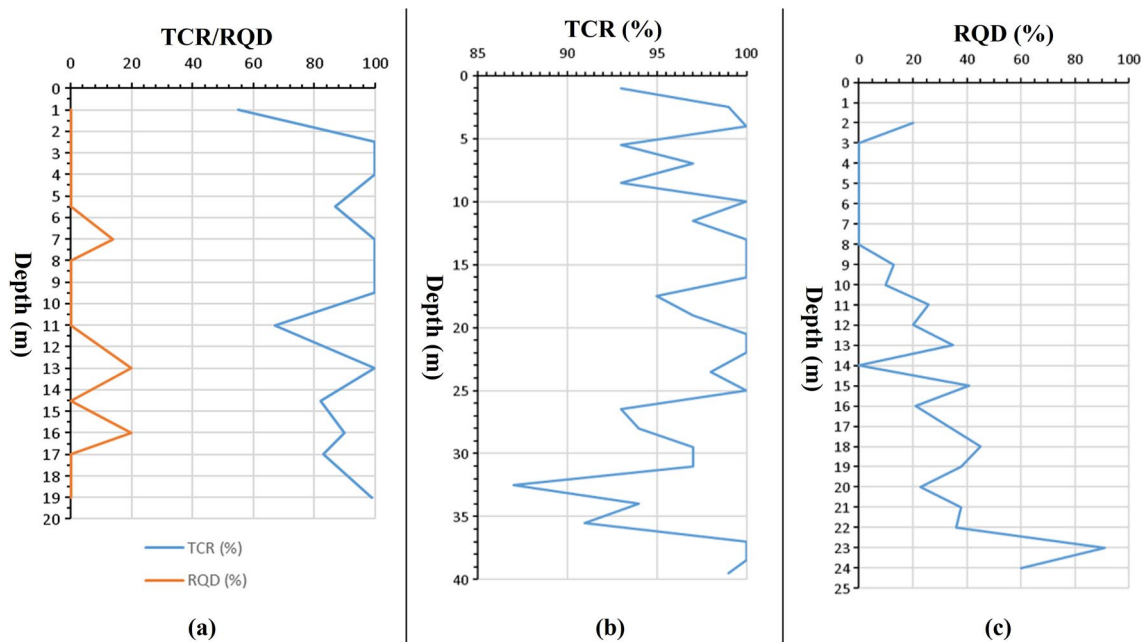
TCR (total core recovery)—RQD (rock quality designation) test result graphics of rock cores made by TTS Engineering (2018) in the study area are given in detail in Fig. 6. For YSK 170+212 borehole, the average TCR value in the claystone–siltstone unit was calculated as 90% and the average RQD value was calculated as 18%. According to the average RQD value, the rock class is very poor. The average TCR value in rock cores for the YSK 170+710 was calculated as 97%. Since there was no sample longer than 10 cm, the RQD value could not be obtained. In the TCR–RQD evaluation of the rock cores for the YSK 175+330 borehole the TCR was 100% and the average RQD value was 34% throughout the drilling. According to the average RQD value the rock class was determined as poor.

**Fig. 6** **a** TCR and RQD values for YSK 170+212 boring log, **b** TCR values for YSK 170+710 boring log, **c** RQD values for YSK 175+330 boring log

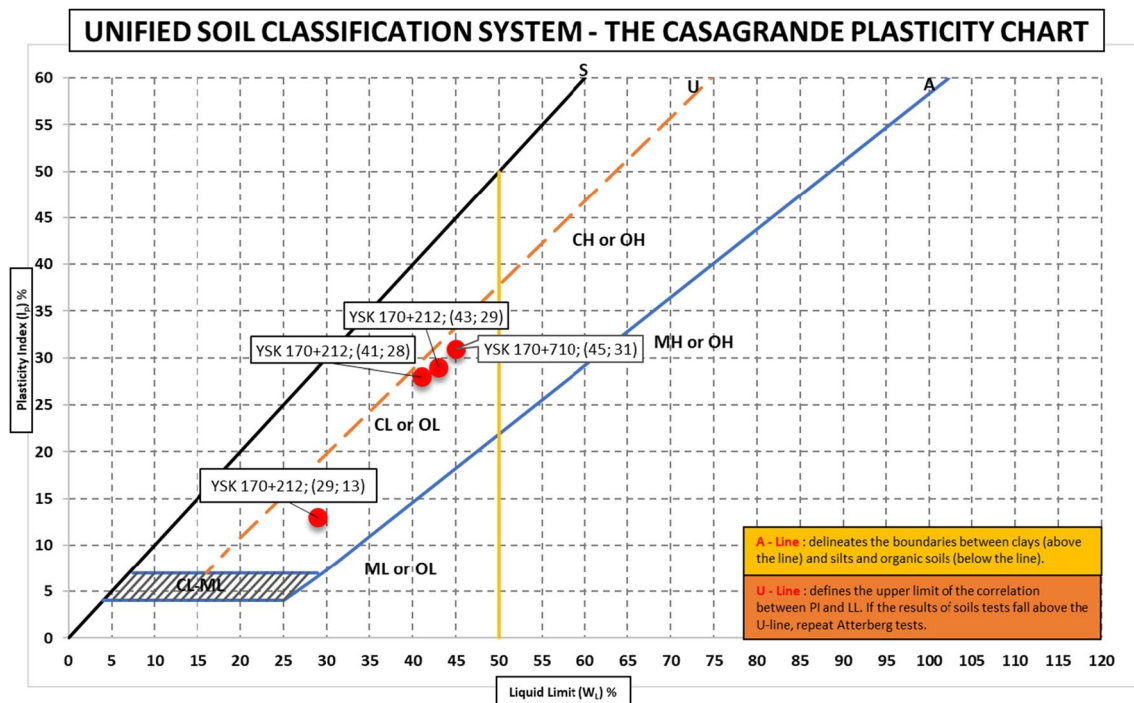
plasticity clay) according to the Casagrande (1932) Plasticity Chart (Table 2). This soil class can be defined as low plasticity sandy/sandy silty clay. As a result of the sieve analysis and Atterberg limit values performed on the SPT-1 sample taken from the YSK 170 + 710 borehole, it was observed that the soil was CL (low plasticity clay) (Table 2, Fig. 7).

**Fig. 7** Evaluation of YSK 170 + 212 and YSK 170 + 710 boreholes according to the unified soil classification plasticity chart

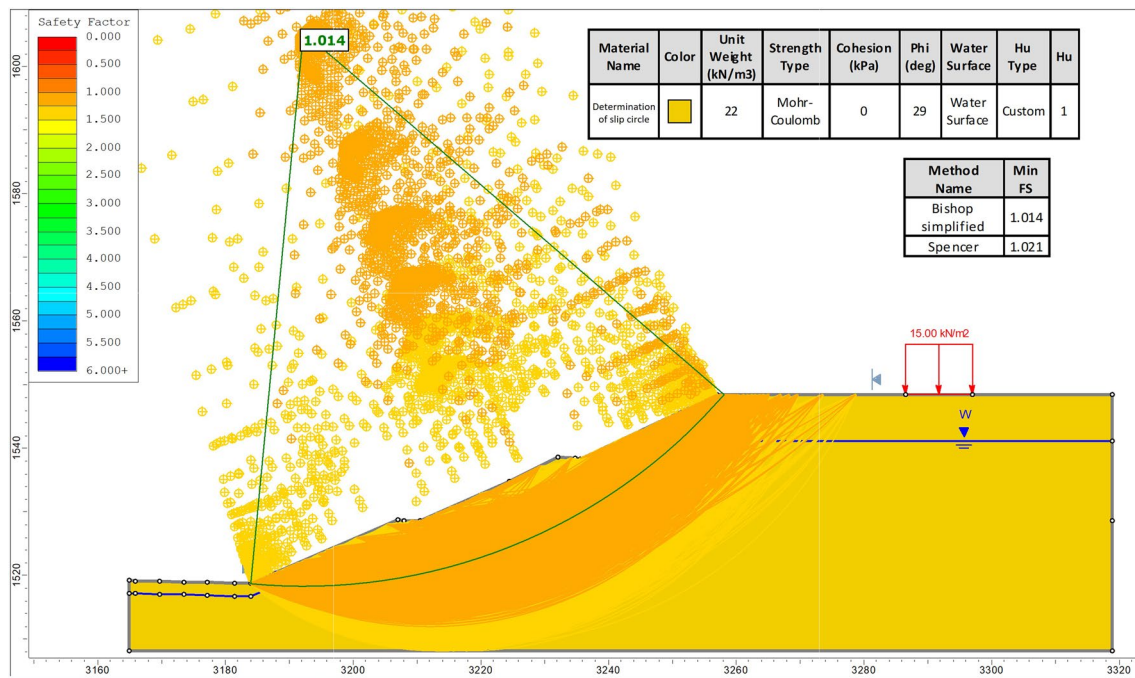
Due to the mass movement in the sections determined to be safe in the previous calculations made in the study area, in situ strength parameters were also calculated by the back-analysis method. For this purpose, the slope geometry before the sliding motion has been created with the Rocscience Slide2 (2004) software as a first step. The groundwater level in slope geometry was assigned as 7.2 m based on YSK 170 + 212 drilling. For the pylon at the top of the slope, a 15 kN/m<sup>2</sup> surcharge load has been added to the top of the slope in the software. In the analysis, slip parameter values were sought for FS = 1 in the critical slip circle and the value of  $c$  was found to be 0 kPa, the value of  $\phi$  was found to be 29° (Fig. 14).

**Fig. 14** Image of the process of determining the slip plane parameters

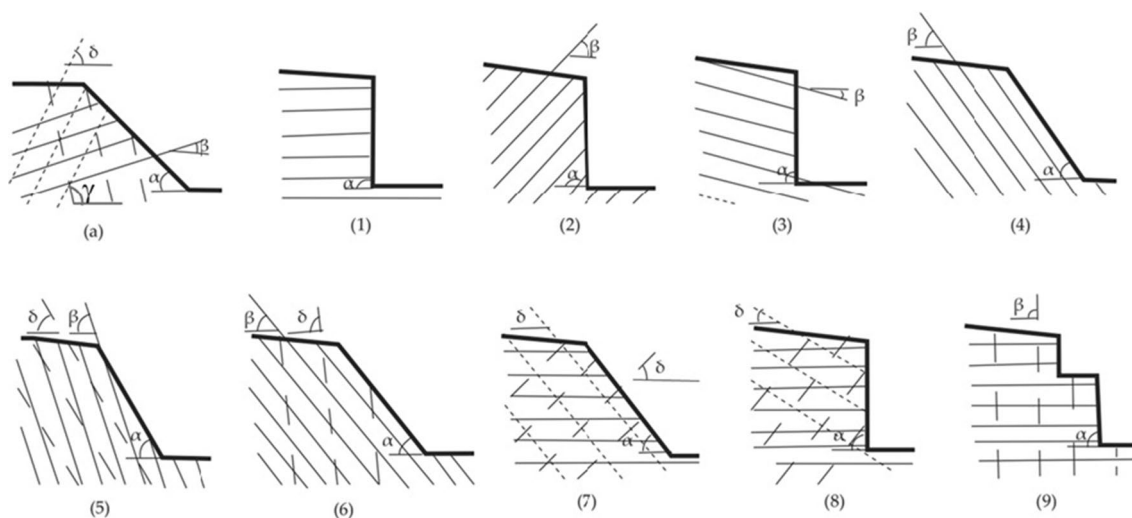
**Fig. 19** Recommended appropriate slope angles to be arranged in the rocks according to the bed and fracture conditions (Erguvanli 2016, modified from Terzaghi 1962)

conjunction with RMR and RocData software). Terzaghi (1962) suggested that the convenient slope angles should be given according to the fracture and layer conditions of the rocks empirically (Fig. 19). According to Fig. 19, the slope of Y2 (Fig. 9c) is an intense fractured rock mass as shown in case 4 in Fig. 19 ( $\phi < \beta \rightarrow \alpha_c = \beta$ ). In this case, although the initial slope angle ( $\alpha = 27^\circ$ ) provides case number 4 shown in Fig. 19, it would be incorrect for the highly weathered fragmented fractured rock environment.
