**EVALUATION OF REPAIR MATERIALS FOR HIGH  
PERFORMANCE CONCRETE**

**M.Sc. Thesis by  
Tahsin Alper YIKICI, B.Sc.**

**Department : Civil Engineering**

**Programme: Structural Engineering**

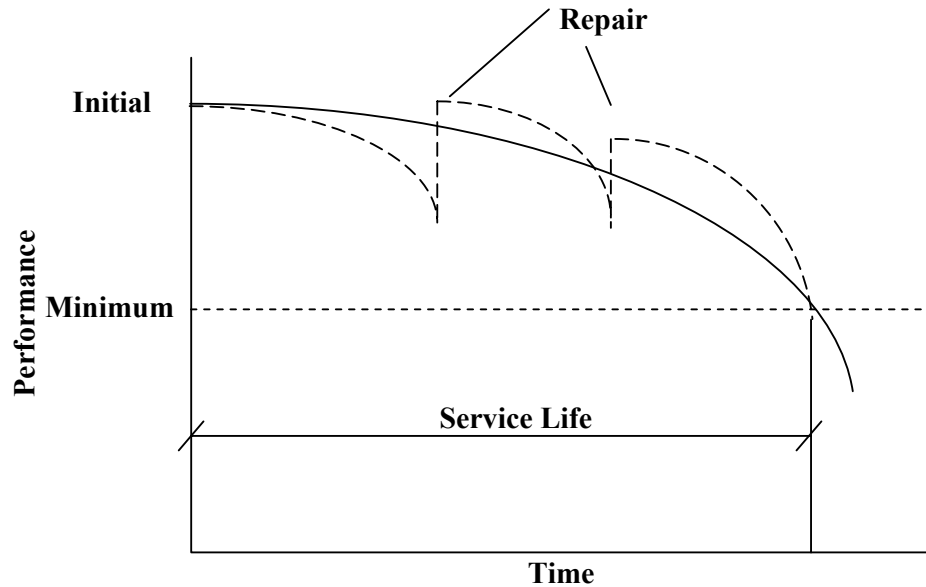
**Figure 1.1:** Performance and Service Life

There are many competent repair materials available at the market and many unconfirmed claims for suitability and success. Even the highest-quality materials may fail if the application is incorrect. Poor repair works fail early or deteriorates the sound concrete material in a quite short period of time. As shown in the Figure 1.1 a good repair improves the function and performance of the concrete structure, whether the structure is a pavement, or a bridge, or a building [12].

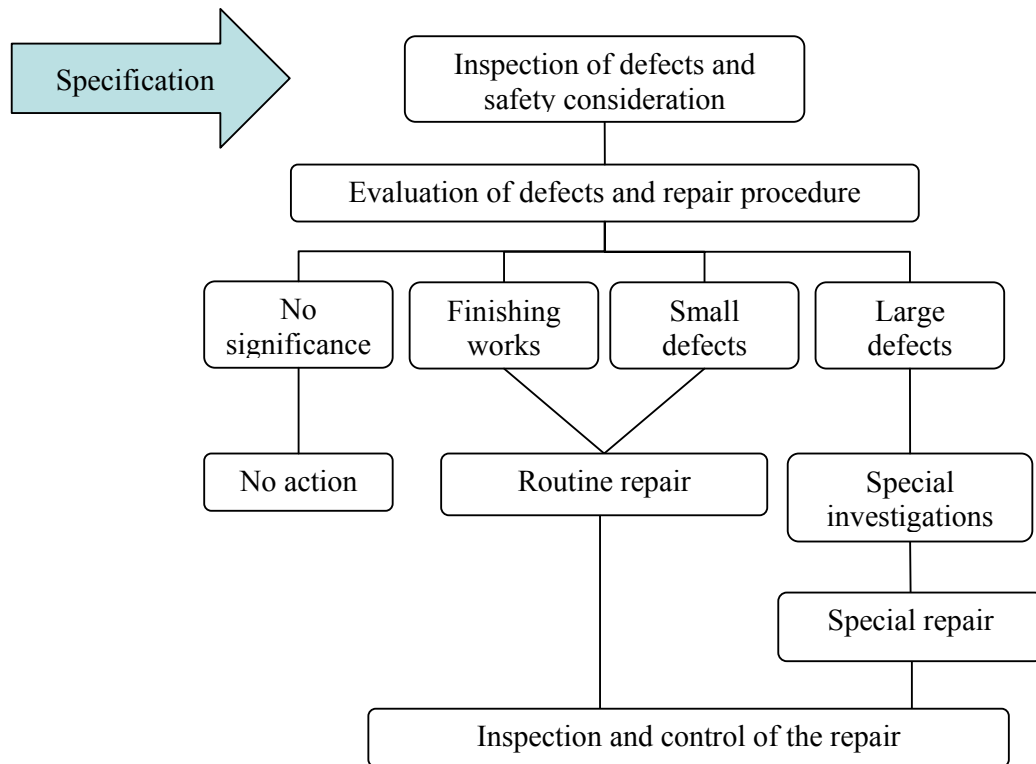
**Figure 1.2:** Procedure for Repair Management [43, 44]

There are different stages to recognize before starting a repair job. Preparation of detailed drawings, guidelines and specifications are required first. Specific requirements in terms of material specifications should be included. The specification should be clear and comprehensible. Since the full extent of concrete damage may not be completely known until concrete removal begins, plans and specifications for repair projects should be prepared with as much flexibility with regard to material quantities as possible [3]. The procedure for the repair management is shown in the Figure 1.2.

The first stage of a repair is the evaluation of the current condition of the structure after demoulding and the documentation of damage such as it is type and extent and

plans of the structure. Conditions where the structure is located may be important for the execution of the work on site. It shall be decided if a visit to the structure is necessary before doing the planning. Information from the examination of the structure such as loads, environmental exposure and possible repair work shall be evaluated. The evaluation may also include a visual examination, non-destructive testing (NDT), crack size measurement, cover control and laboratory analysis of concrete core samples [3, 43, 44].

The second stage involves the evaluation of defects on basis of bearing capacity, aesthetic demands, durability and environmental impacts and economical consequences. On basis of these considerations, it is evaluated whether the defects are of little or great significance or of no importance at all. Normally, defects of no importance are left unrepaired. Large non-conformities require thorough investigations and evaluation of possible remedial actions [43, 44].

The third stage is the execution of repairs. This is a specialized job and those who have the essential expertise and equipment should be engaged. Because the success of a repair job will depend on the degree to which the work is executed in conformance with plans and specifications. The engineer should have a good knowledge of the procedures and give a considerate organization. In some cases it is required to monitor the efficiency of repairs by some tests before and after the repairs have been performed. Today, the work performed on repair projects requires much more attention to practice than for a new construction. The repair process consists of preparations such as removal of damaged concrete, cleaning and preparation of the surface before application. The second part of the execution is the application and finishing including curing [3, 43, 44].

The last stage of the repair management is the inspection during repairs and after completion. It is necessary to carry out inspections during the execution of work to adjust the demands to the executions of repairs, including preparations. At the end of the work, the repairs are inspected to ensure that they are of the required quality. The final inspection includes testing of adhesion, visual inspections of the surface and of samples and cores [43, 44].

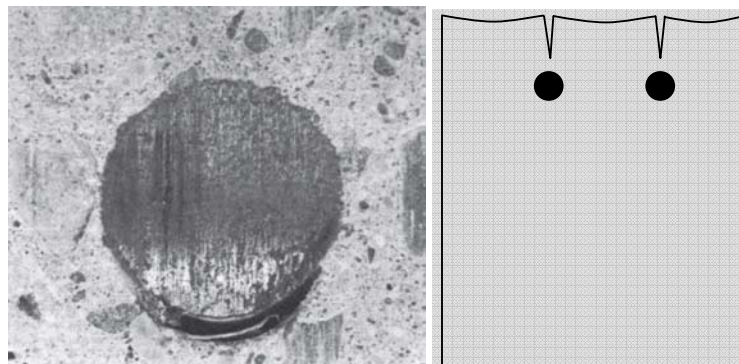
**Figure 2.2:** Void Under Rebar, Plastic Settlement Over Rebars [1]

In green concrete, the paste has a lower density than the particle density of aggregates so that gravity will tend to pull the heavier particles downwards and the water is displaced upward. This mechanism may cause voids under rebars or large aggregates, plastic settlement cracks, which may create routes for harmful compounds affecting the corrosion process (Figure 2.2). Working with low w/c ratio and better workmanship in vibration and finishing will improve plastic failures.

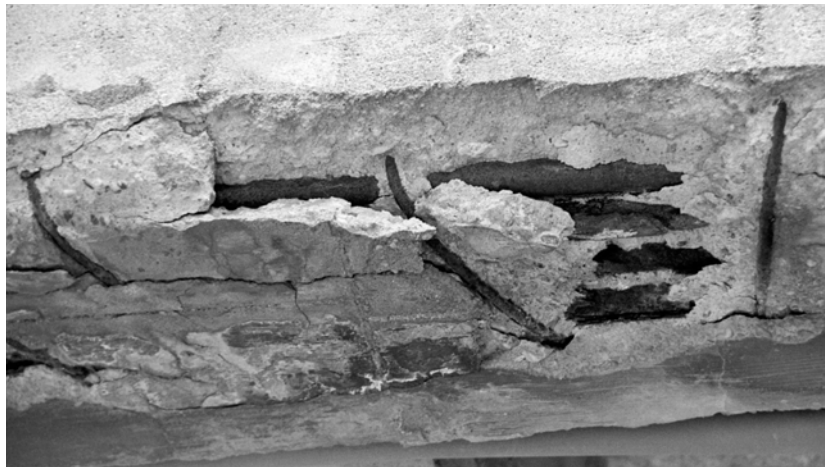
**Figure 2.3 :** Spalling of Concrete due Carbonation and Chloride [42]

Penetration of chemical solutions in to the concrete contributes to the corrosion of the embedded steel, resulting damage of concrete (Figure 2.3). The high alkalinity of the concrete, usually pH above 12, leads to an oxide coating passive layer forming on the rebars that reduces the possible rusting. The passivation zone can be destroyed by

The other one is the carbonation of concrete, which leads to early cracking and spalling with comparatively little reduction of rebars. When the depth of carbonation has reached reinforcement, the paste in contact with the metal loses its alkalinity and the passivation zone will be destroyed by oxygen. Because it begins from the outer surface of the concrete, rebars near to the surface are in danger of carbonation and are not protected against corrosion. Barrier protection systems are commonly used to minimize the effects of corrosion [42].

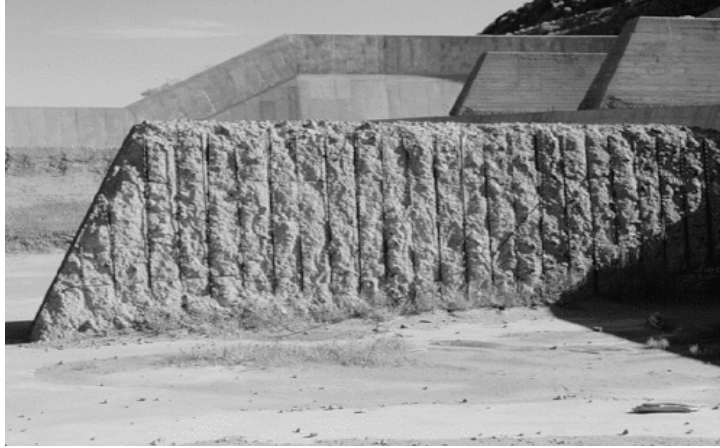
**Figure 2.4 : Freeze and Thaw at a Wall [2]**

As water turns to ice, there is an increase in volume of about 9%. When porous concrete is saturated with water this expansion on freezing may lead to damage (Figure 2.4). Use of de-icing salts containing chlorides increases the chance of frost damage. To prevent hardened concrete from frost damage, air is entrained into the fresh concrete using an admixture which creates about 1 mm small and evenly dispersed air bubbles. The water can expand freely without disrupting the concrete into the voids. However, concrete, with a 5% air entrainment may become a strength reduction of about 15% [2].

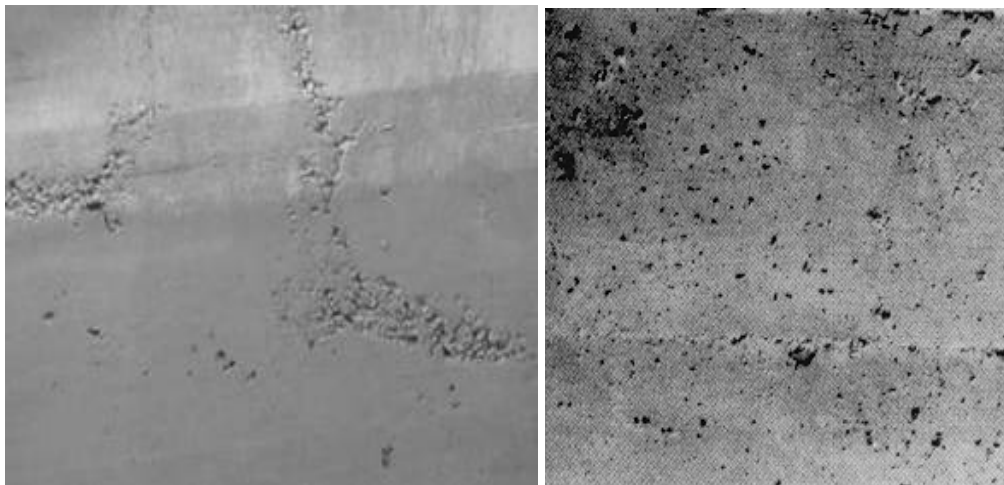
**Figure 2.5 :** Honeycombing and Bug Holes on the Surface [2]

Usually, most of the construction errors do not lead directly to deterioration. Errors made during construction such as adding improper amounts of water to the concrete mix, inadequate consolidation, inadequate formwork, improper location of rebars and improper curing may cause distress and deterioration which results cracking of the concrete. Cold joints, exposed reinforcing steel, irregular surface, honeycombing and bug holes can be observed at any concrete structure (Figure 2.5).

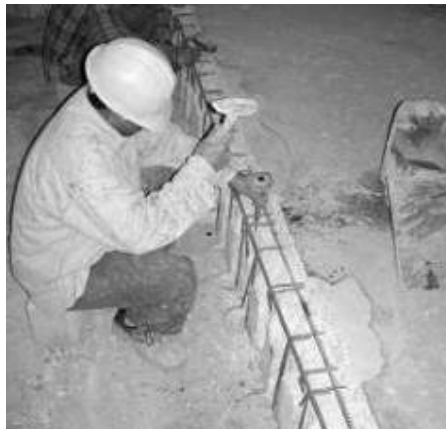
**Figure 3.1 : Impact Removal Technique**

It is essential that all of the deteriorated concrete be removed before repair materials are applied to provide sound concrete for the repair material to bond to. It is always false economy to attempt to save time or money by shortchanging the removal of deteriorated concrete. Whenever possible, the first choice of concrete removal technique should be high pressure hydro blasting or hydro demolition. These techniques have the advantage of removing the unsound concrete while leaving high quality concrete in place and they do not leave micro cracked surfaces on the old concrete. Impact removal techniques, such as bush hammering, scrubbling, or jack hammering, can leave surfaces containing a large amount of micro cracks which seriously reduce the bond of the repair material to the existing substrate (Figure 3.1).

Impact concrete removal techniques, such as jack hammering for large jobs and chipping for smaller areas; have been used for many years. These removal procedures are quick and economical, but it should be kept in mind that the costs of subsequent removal of the micro cracked surfaces resulting from these techniques must be included when comparing the costs of these techniques to the costs of high pressure water blasting. The larger jackhammers remove concrete at a high rate but are more likely to damage surrounding sound concrete. The larger hammers can impact and loosen the bond of concrete to reinforcing steel for quite some distance away from the point of impact. Pointed hammer bits, which are more likely to break the concrete cleanly rather than to pulverize it, should be used to reduce the occurrence of surface micro cracking [6].

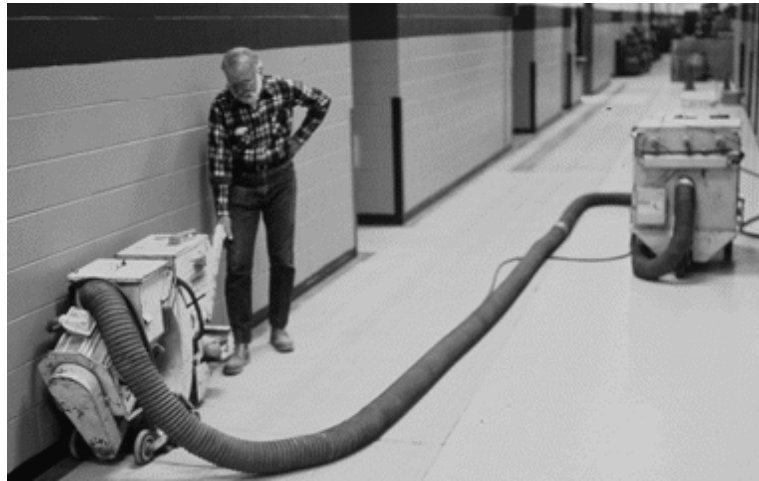
**Figure 3.2 :** Shot blasting Equipment to Remove Shallow Concrete Deterioration [4]

Shallow surface deterioration, usually less than 1.5 cm deep, is best removed with shot blasting or dry or wet sand-blasting. Shot blasting equipment is highly efficient and usually includes some type of vacuum pickup of the resulting dust and debris (Figure 3.2.). The use of such equipment is much more environmentally acceptable than dry sand blasting. Shallow deterioration to concrete surfaces can also be removed with tools known as scrabblers. These tools usually have multiple bits which hammer and pulverize the concrete surfaces in the removal process. Their use multiplies the micro fractures in the remaining concrete surfaces. Extensive high pressure water, sand, or shot blasting efforts are then needed to remove the resulting damaged surfaces. Such efforts are seldom attained under field conditions [4].

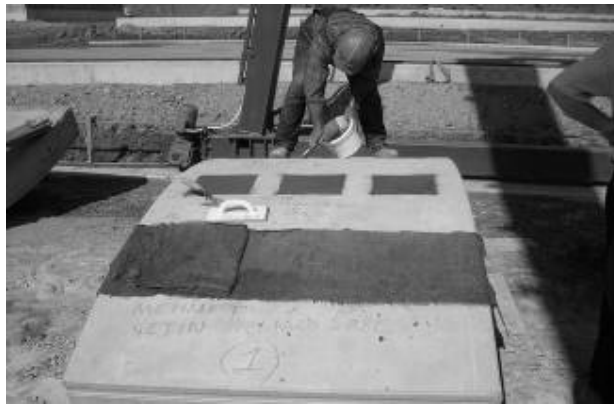
**Figure 3.3 : Curing of the Repair**

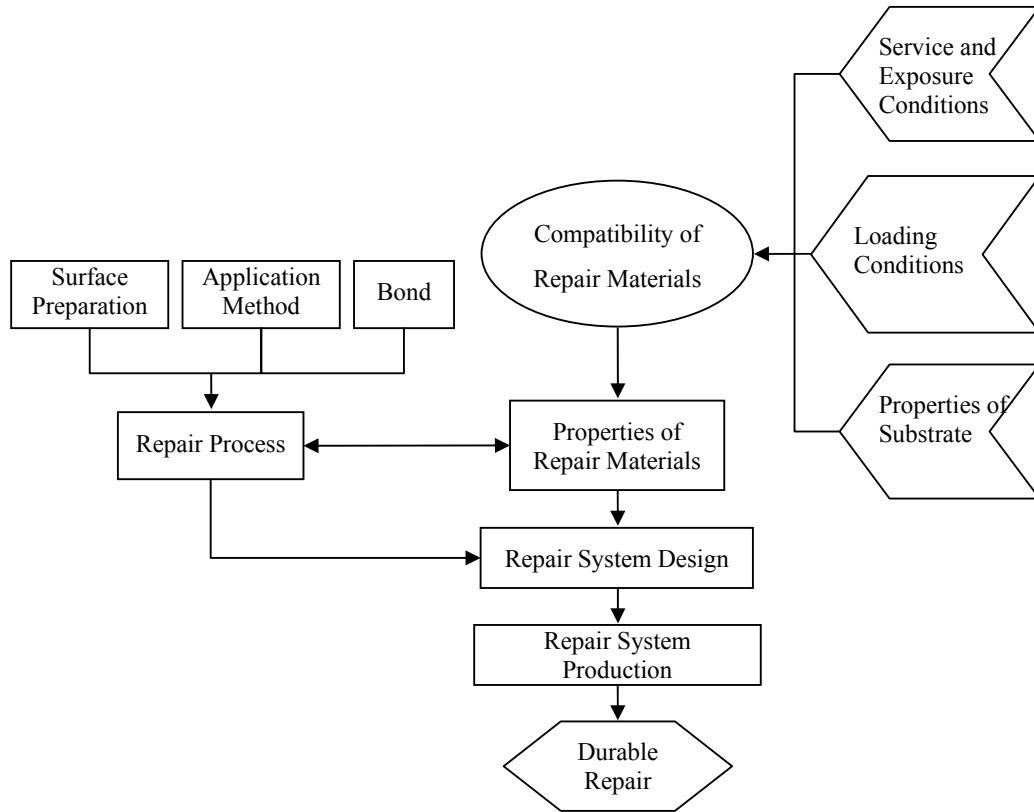
**Figure 4.1 :** Factors Affecting the Durability of Concrete Repair Systems [16]

Concrete structures damaged by various mechanisms need to be repaired in order to maintain safety, appearance and durability to extend their service life. The main objective of any repair should be to maintain a durable repair. As shown in the Figure 4.1 factors affecting the design and selection of repair systems are considered

as components of one composite system. The proper repair depends on the evaluation of the causes of deterioration. Selection of a repair material is one of the many major steps for making durable and reliable repair; equally important properties are availability of materials, equipment, skilled labor, surface preparation, the method of application, construction practices, and inspection [16].

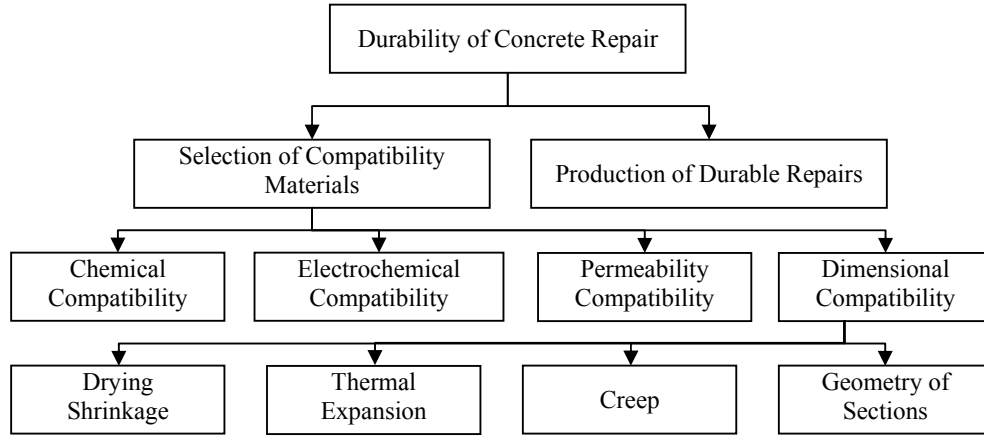
**Figure 4.2 : Durability of Concrete Repairs due to Compatibility [15]**

Factors affecting durability of repair system are shown in Figure 4.2. These factors must be considered in the design process to make the compatible repair material selection. Compatibility is defined as the balance of physical, chemical, and electrochemical properties and dimensions between the repair material and the old concrete without distress and deterioration over a designed service life. However dimensional compatibility, which is the phenomenon of volume changes, is one of the major problems affects the durability and strength of repairs. Restrained volume changes of the repair, the restraint being provided through bond, causes cracking and debonding of the repair work [15].

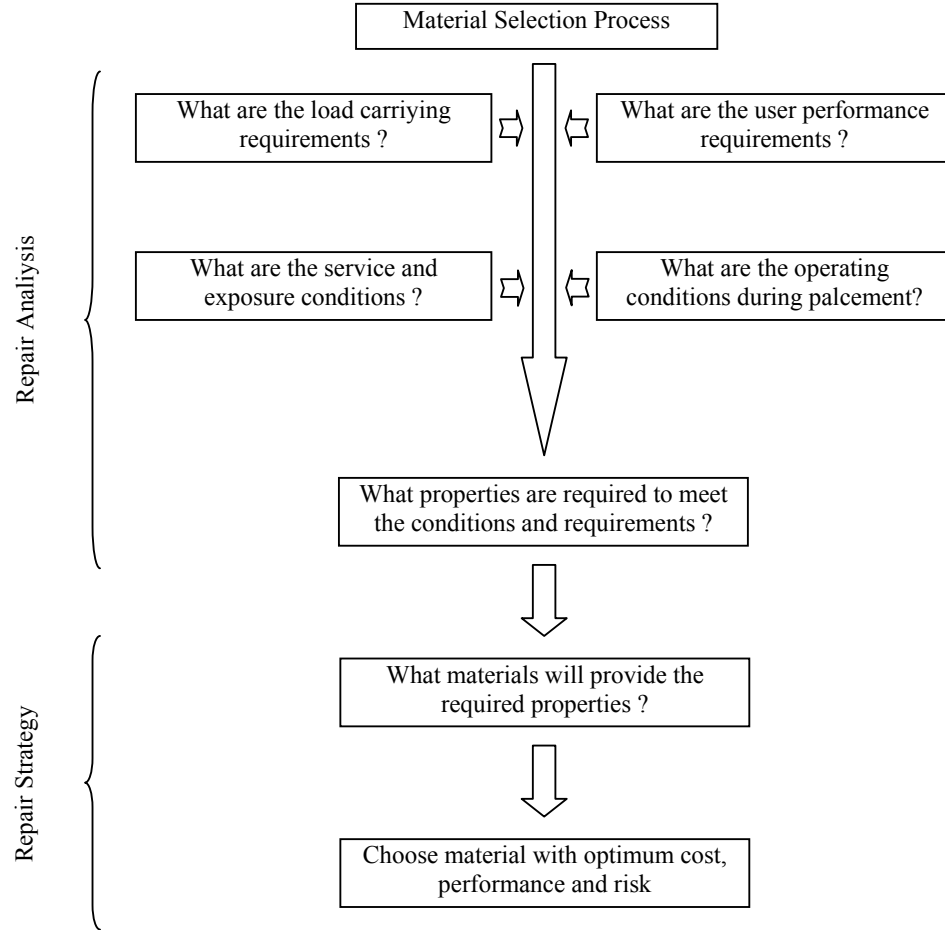
**Figure 4.3 :** The Selection Process for a Repair Material [1]

Figure 4.3 shows an organized approach that is required in the selection of a repair material, which accounts for all applicable parameters and their impacts on the choice between alternatives [1].

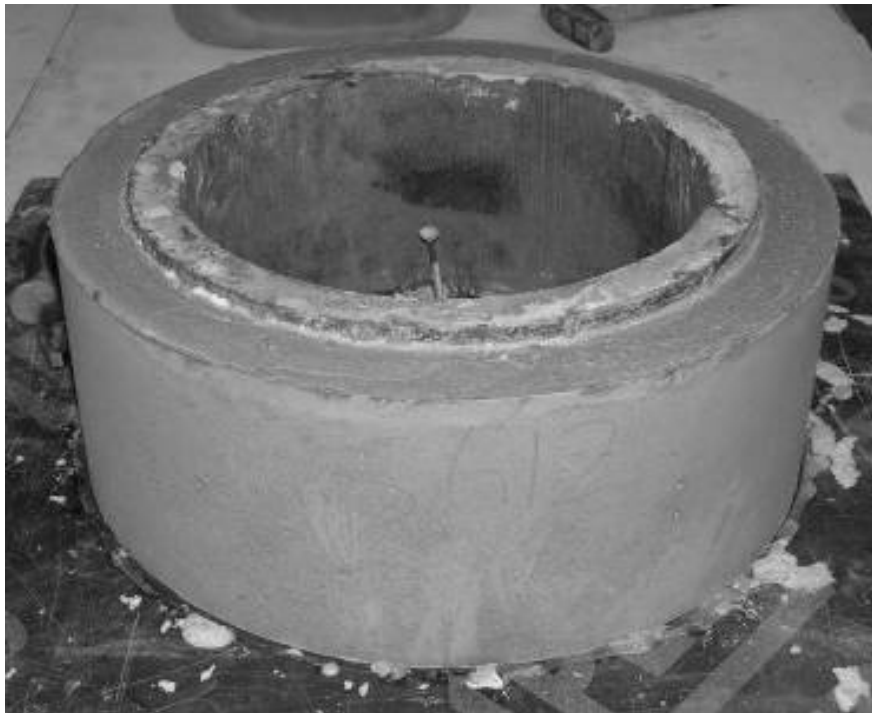
**Figure 4.4 : Ring Restraint**

Ring test (Figure 4.4) allows the determination of materials sensitivity to cracking caused by restrained volume changes. The ring is monitored daily for evidence of cracking and the day that cracking is observed is recorded and the initial crack width is measured.

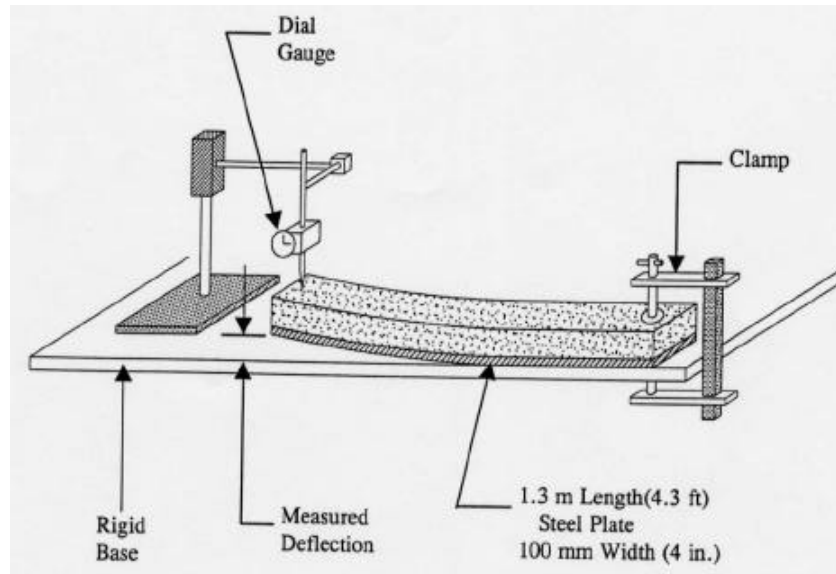
**Figure 4.5 : SPS Plate Test [9]**

The Structural Preservation System (SPS) plate test specimen was a nominal 51- by 102- by 1.321-mm beam (Figure 4.5). As the material expanded or contracted in response to moisture and temperature changes, deflection of the unrestrained end of the specimen is measured [9].

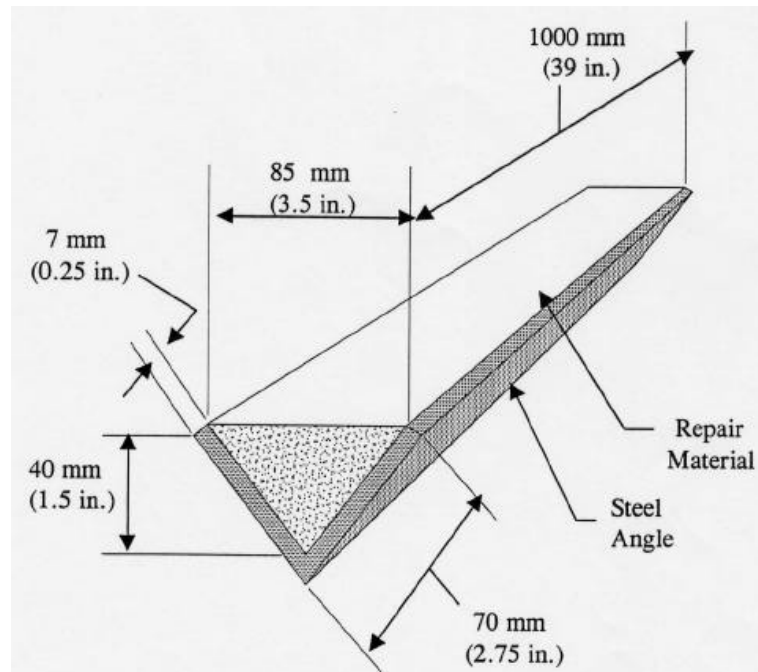
**Figure 4.6 : German Angle Test [9]**

The German angle test consists of 70- by 70-mm steel angles that are 1.0 m long (Figure 4.6) with a repair material. After casting, the test specimens are monitored for cracking under field-exposure conditions. Both, the SPS Plate and German Angle Tests can be used for a general assessment of a material's dimensional compatibility, or resistance to cracking [8].

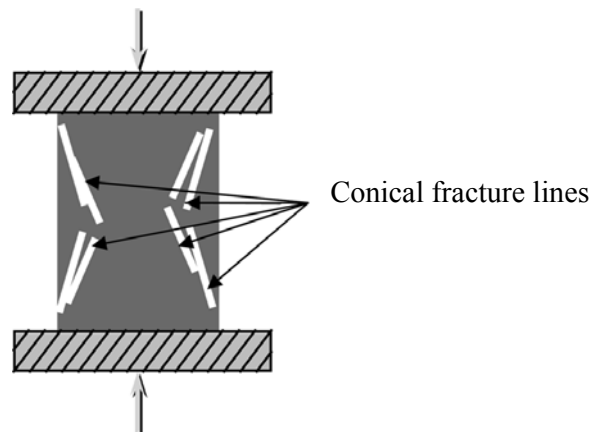
**Figure 4.7 :** Compression Test Setup [13]

Compressive strength is the ultimate failure stress determined on 28 days under 20°C moisture cured specimens. Generally, it is not an important property in many repair applications. It is expected that the repair material have strength similar to or greater than the concrete substrate. ASTM C 39 and ASTM C109 are the test methods available for compressive testing (Figure 4.7) [13].

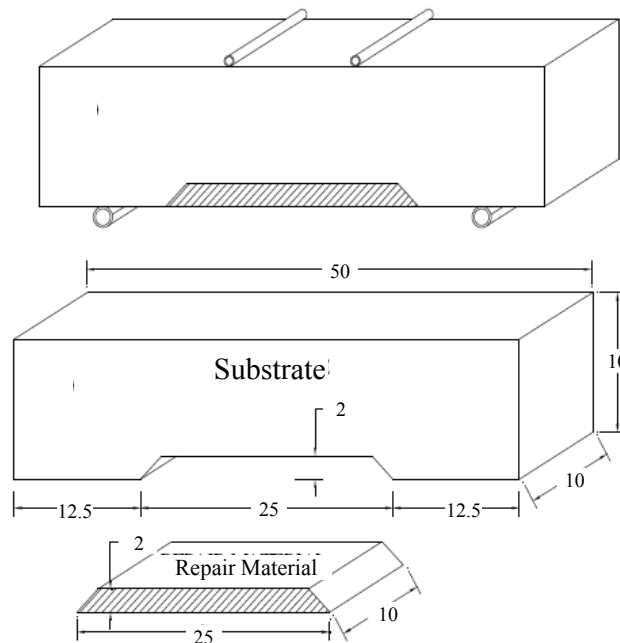
**Figure 4.8 :** Composite Beam Test Specimen (dimensions in cm) [7]

It is generally observed that a repair section is mostly performed at the joints or in the tension area. Tension is created in the concrete by bending of the structure due to loading . Therefore, flexure test method would be an appropriate method to study the compatibility between repair and substrate material. Flexural strength is defined as the ultimate bending capacity of concrete. It is determined with three point bending test either with one or two loading points. ASTM C 78 - Standard test method for flexural strength of concrete is modified by Czarneck et al. 1999 to investigate the composite beam behavior with repair materials. The repair applied on the bottom of the concrete prism is evaluated compatible or incompatible with the substrate by the mode of failures (Figure 4.8) [10, 13].

It is well known that a stiffer material deflects less in the flexure test compared to a weaker material under the same loading. In the composite beam, if the compressive strength of the repair material is greater than the strength of substrate concrete, the stress-strain curve should have greater slope than the slope of the stress-strain curve of substrate concrete beam itself. If not, then the load transfer to repair material is not adequate and the repair material is not compatible with the substrate concrete [10].

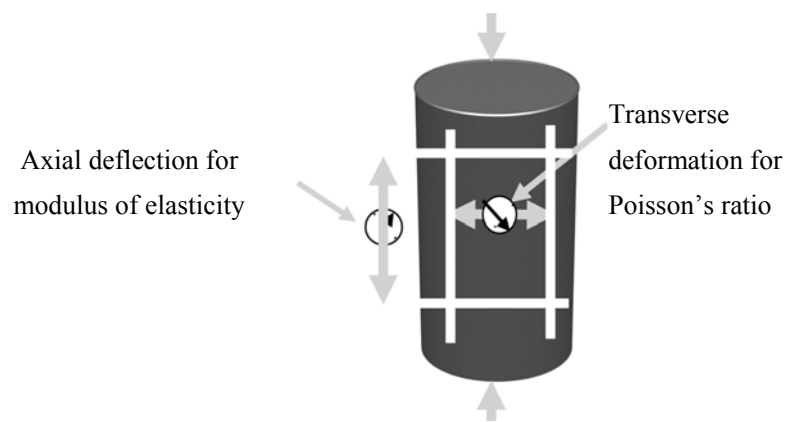
**Figure 4.9 :** Determining Modulus of Elasticity [13]

Modulus of elasticity of the repair material should be similar to the substrate concrete, especially for structural repairs. Variations between repair and the concrete can lead to uneven load distribution. If the repair material has a higher modulus of elasticity, it will attract more of the applied load; if it has a lower modulus of elasticity, deformation occurs and the load is transferred to the concrete. For nonstructural projects expectations changes, with low modulus elasticity repair material volume stability and related compatibility can be achieved easily, the potential for cracking and Delamination is reduced. ASTM C 469 is the standard test method to determine the modulus of elasticity under compression. (Figure 4.9) [13].

| | <u>Page</u> |
|---|---|
| <b>Figure 4.9</b> : Determining Modulus of Elasticity..... | 30 |

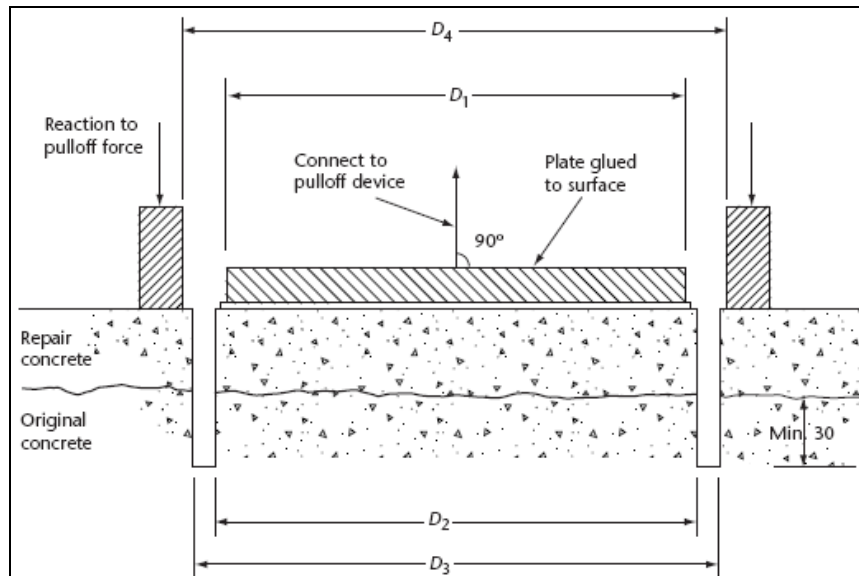
**Figure 4.10 : Pull-Off Test (dimensions in mm) [24]**

Bond strength is the resistance of the repair material to separation from the old concrete. Generally good bond quality of the repaired region is the primary requirement for a successful repair. There are many types of pull techniques to determine the adhesion of bonded toppings by tensile load. The pull-off test, CAN A23.2-6B setup shown in the Figure 4.10, is the mostly known test procedure to determine the bond between concrete substrate and repair materials. For this test a cylindrical semi-core sample is prepared and a tension force is applied to produce either a bond or nonbond failure. If the specimen fails away from the bonded area, bond strength is greater than the failure load in the test. If it fails at the bond area, the measured load is the bond strength. But this technique is sensitive to material mismatch, eccentricity of coring and coring depth into the substrate. Because of the improper preparation the pull-off load will reduce [19].

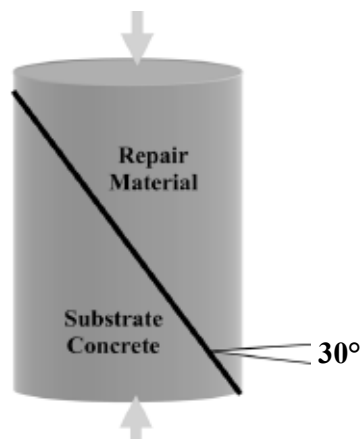
**Figure 4.11 : Slant Shear Test Setup [13]**

The second category measures the bond strength under a state of stress that combines shear and compression. The slant shear test ASTM C 882 to determine the bond strength by measuring the resistance to sliding between repair and the concrete along an inclined interface of the composite cylinder under compression, falls under this category. A square prism or a cylindrical sample made of two equal halves bonded at 30 degrees and tested under axial compression (Figure 4.11) [19].

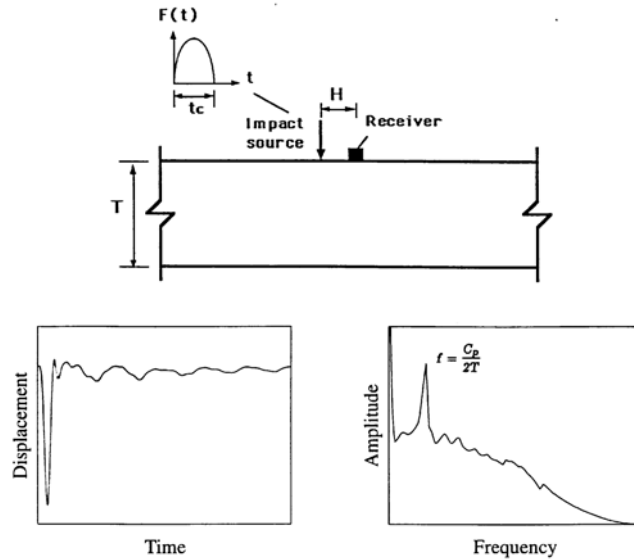
**Figure 4.12 :** Impact-echo Test, Displacement Waveform, Amplitude Spectrum [20]

sphere on concrete must be greater in magnitude than the tensile strength of the bond at an interface, if the waves are going to be used. The P-waves generated by an elastic impact are compression waves. They change phase and become tensile only when they are reflected from the free boundaries of the structure or from internal cracks or voids. Thus, the initial P-wave is a compression wave, but the P-wave reflected from the opposite boundary of the structure, such as the bottom of a plate, is a tension wave. It is this tension wave that has the potential to break the bond at an interface as it propagates through the structure. That is, it has the potential to produce stresses that are larger than the tensile bond strength at the interfaces that exist within the concrete structure (Figure 4.12) [20, 21].

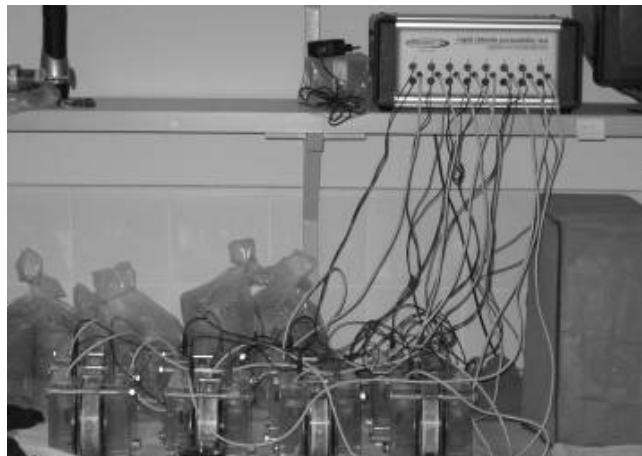
**Figure 5.1 : ASTM C1202 Test Setup**

The chloride permeability of concrete was determined in accordance with ASTM C1202 using a 50 mm thick, 100 mm mortar disc cut from the 100 mm x 200 mm cylinder prepared in the laboratory. The disc specimens were fixed between two cells containing ionic solutions (Figure 5.1). One of the cells was filled with 0.3 M NaOH solution and the other with 3.0% NaCl solution whilst a 60V DC was applied between the two cells. The resistance of concrete to chloride ion penetration is represented by the total charge passed in coulombs during a test period of 6 h. The chloride ion permeability test was carried out on the core specimens after 28 days.

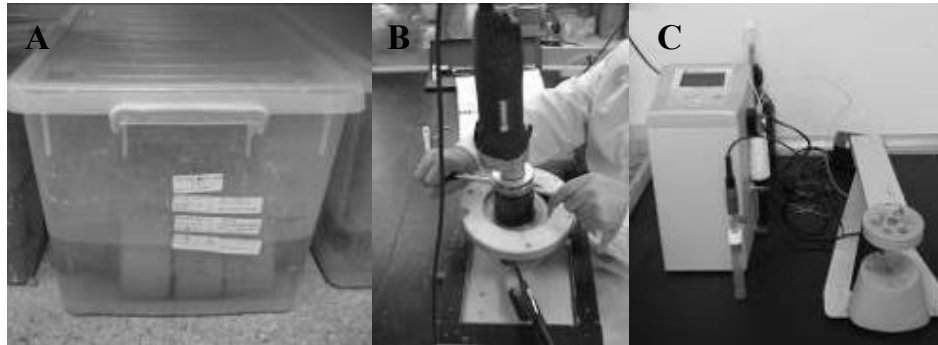
**Figure 5.2 :** Chloride Diffusion Test Procedure. A- NaCl Exposure, B- Powder Grinding, C- Potentiometric Titration

A water-saturated, 60 mm thick, 100 mm mortar disc cut from the 100 mm x 200 mm cylinder casted in the laboratory was, on one plane surface, exposed to water containing sodium chloride. After 35 days of exposure time, thin layers are ground off parallel to the exposed face of the specimen and the chloride content of the layers,  $C_x$ , is measured by potentiometric titration (Figure 5.2). The original (initial) chloride content of the mortar,  $C_i$ , is measured at a suitable depth below the exposed surface. The effective chloride transport coefficient,  $D_e$ , and the boundary condition of the chloride profile at the exposed surface,  $C_s$ , are calculated by non-linear regression. The penetration parameter,  $K_{Cr}$ , is calculated for a selected chloride concentration,  $C_r$  [30].

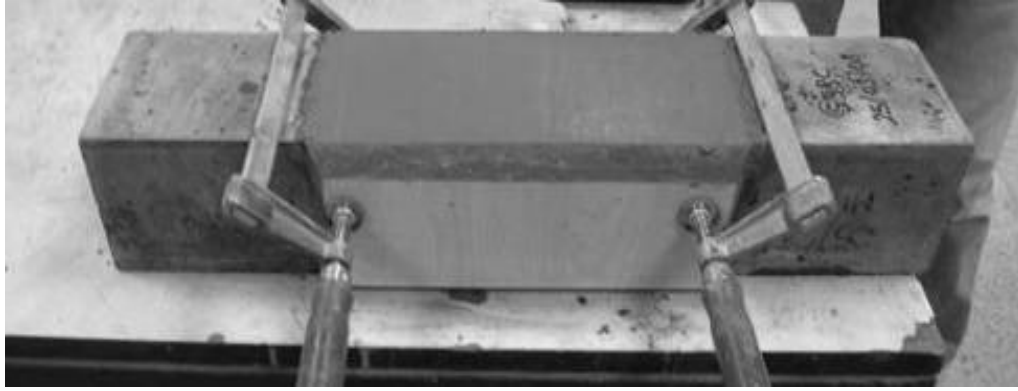
**Figure 5.3 :** Composite Beam Test Specimen

This test was conducted for compatibility between repair and substrate concrete. The prism for evaluating the compatibility of repair material with substrate concrete was fabricated to the dimensions of 10x10x50 cm with a wide-mouthed notch 20x10x2 cm. After demoulding, the prisms were moist cured for minimum 28 days, and the notch areas were textured using a handheld breaker and primer was applied on the roughened surface. Two types of primers were used for each repair material, to investigate the effects of primer types on the failure characteristics. One of them was cementitious the other one was epoxy based. During the test, the repair material was placed on the bottom (tension side of the specimen) of the specimen as shown in the Figure 5.3.

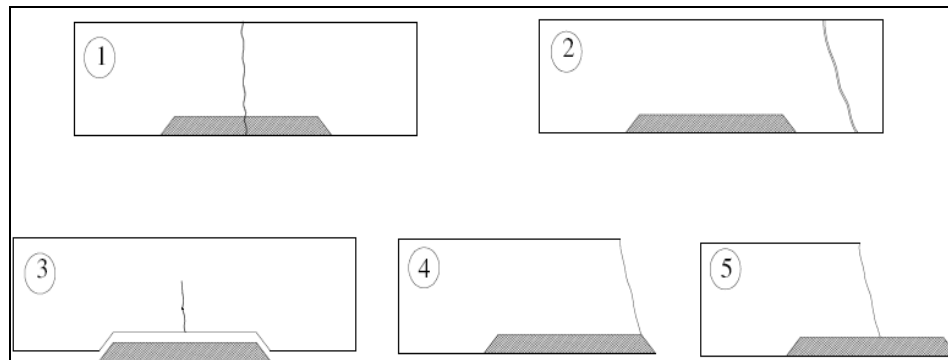
**Figure 5.4 :** Test Evaluation. 1,2-Compatibility; 3,4,5-Incompatibility [10]

The repair materials were assessed compatible or incompatible with the substrate concrete by the mode of failures. In this study weaker repair materials are used to investigate the compatibility between repair materials and substrate. In addition load-deflection behaviors of the composite beams are evaluated. Since the repair materials are weaker in compressive strength and the load transfer at four point bending test is adequate, composite beam is forced to fail in the middle third portion of the beam or in the middle of the beam through the repair material due to maximum stress caused. If the failure mode is on the edge of the notch or if the repair material is popped out, instead of failing in the middle-third of the composite beam, then the repair material is not compatible with the substrate beam as shown in the Figure 5.4. [10].

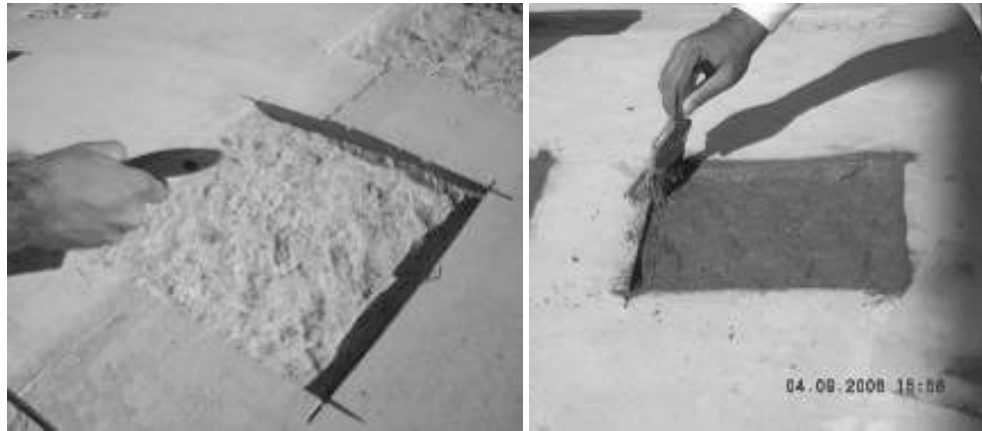
**Figure 5.5 :** Preparation of the Repair Surface and Application of the Primer

Tests were performed on the trial panel structures one of the TBM Tunnel construction in Istanbul. As shown in the Figure 5.5, 30 by 30 cm, nearly 3 cm deep patches were prepared with handheld breakers on the concrete structure. For the application with cementitious binder the existing surface was moistened and the binder was applied with brush. There is no need for moistening when epoxy binder is used. Specific instructions provided by the manufacturer were followed in preparation of a batch. All batches were mixed with a mixer on the field.

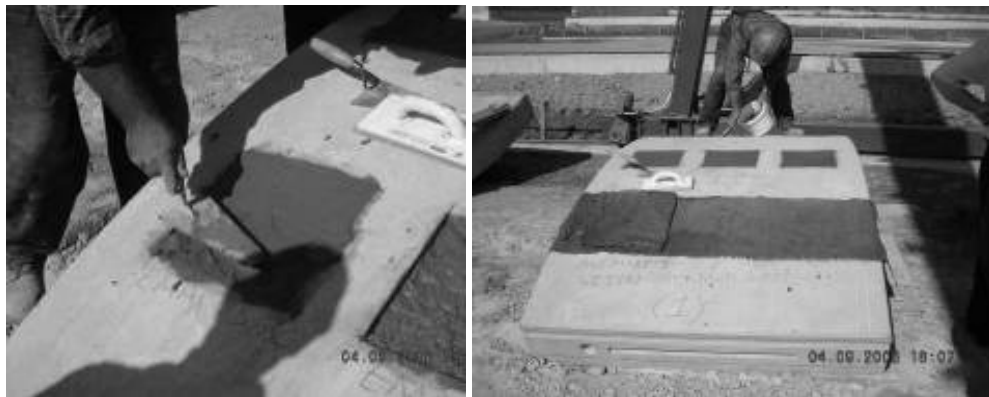
**Figure 5.6 :** Application and Curing of the Repair

Each repair was applied with trowel by hand and immediately covered for curing as shown in the Figure 5.6. The cover was watered periodically for about one week.

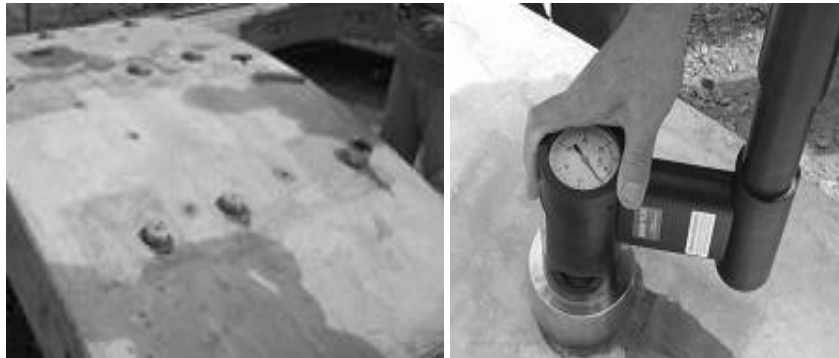
**Figure 5.7 : Pull-off Preparation**

The in-situ pull-off testing was performed according to NT BUILD 365. A cylindrical Ø75 mm semi core sample is prepared on the repaired structure and a roundel was glued on centrically above the repaired area. When the glue has hardened the roundel was pulled by the equipment centered above as shown in the Figure 5.7 and the bond strength was calculated.

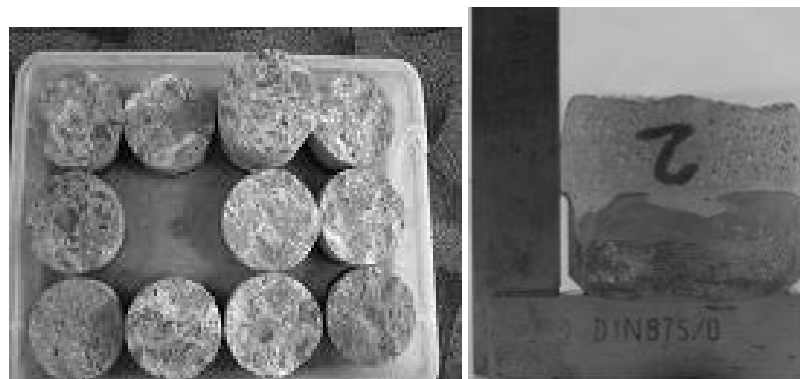
**Figure 5.8 : Specimen Control after Rupture**

The location of rupture for each specimen was observed and the eccentricity was controlled by taking pictures (Figure 5.8).

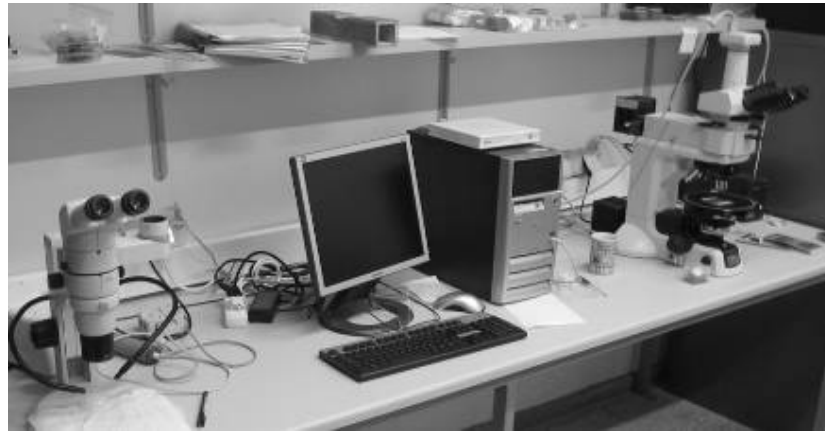
**Figure 5.9 :** Optical Microscope on the Left, Polarizing Microscope on the Right

For microstructural analysis, specimens were prepared from the 100 mm x 200 mm cylinders casted in the laboratory and Ø100 mm cores from repaired structures according to the Danish standards, DS 423.39 and DS 423.40 2002. As shown in the Figure 5.9 an optical stereomicroscope and a polarizing stereomicroscope were used to perform the analysis.

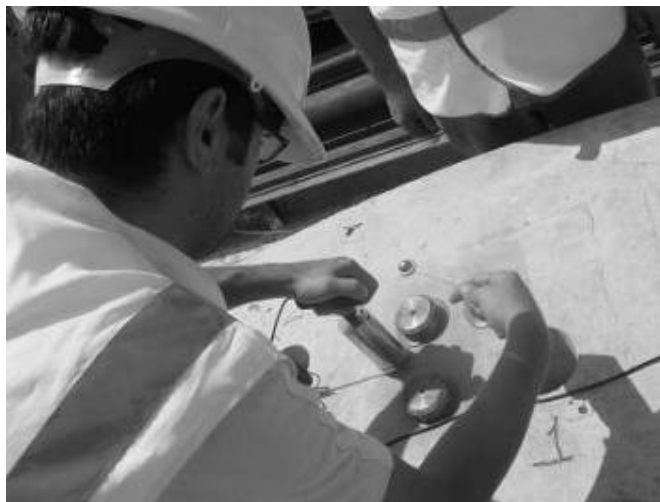
**Figure 5.10 : Impact-Echo Testing on the Construction Site**

The impact-echo method was used to determine interfacial bond quality, specifically unbonded fraction of area and bond tensile strength, in concrete precast panels (Figure 5.10). Specimens on trial panels on the construction yard were designed to study the effects on the impact-echo response caused by variations in bond strength. Therefore pull-off testing was performed after obtaining the impact-echo response from the portion of the repaired structure. The objectives were to determine how bond strength affects the impact-echo response and whether the impact-echo-method could be used to quantify the bond strength [20-21].

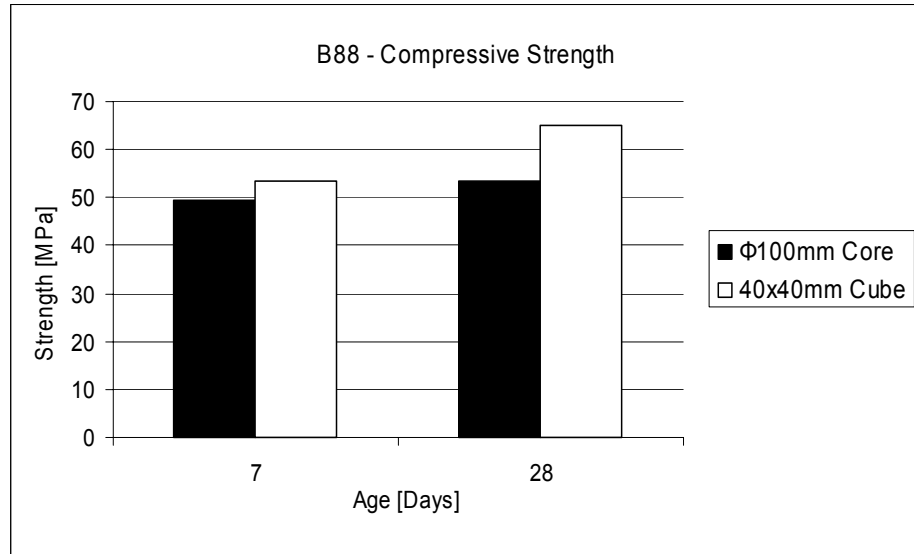
**Figure 6.1 : Size Effect on B88 Repair Mortar**

Further investigations revealed that different size repair mortar specimens show different compressive strength values at same ages. In Figure 6.1 and Figure 6.2 shows the size effect on mortar specimens at 7 and 28 days.

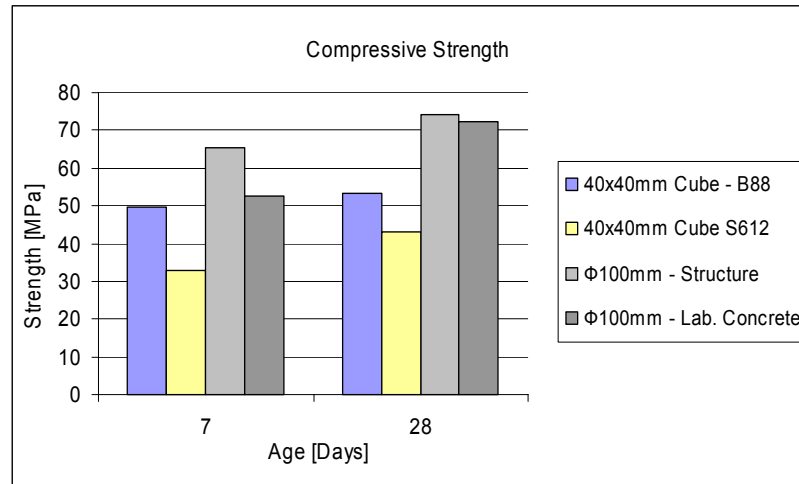
**Figure 6.3 : Difference in Compressive Strength Results**

Figure 6.3 shows the difference in compressive strength between repair mortars and the substrate concrete at 7 and 28 days. It can be observed from the Figure 6.3 that the substrate concrete specimens have more than 35% compressive strength at 28 days.

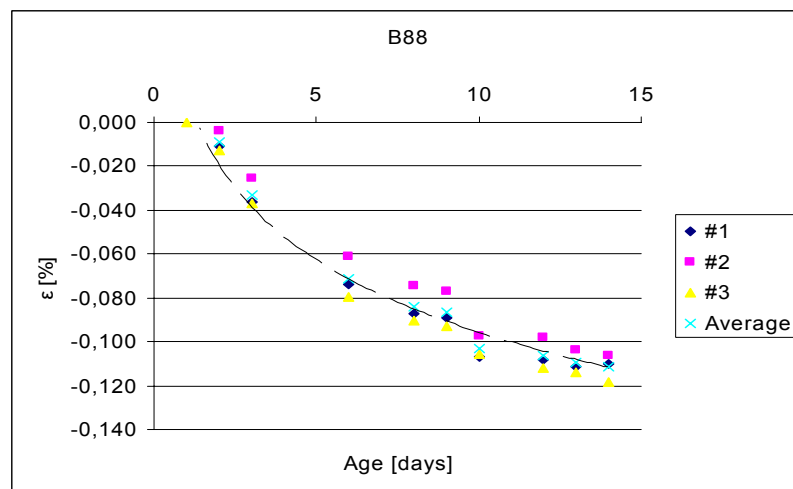
**Figure 6.4 : Autogenous Shrinkage Test Results of B88**

Autogenous shrinkage test results of the repair mortars are shown in Figure 6.4 and Figure 6.4. There are three specimens for each mortar and the values of the each specimen are shown in the appendix Table A6 and Table A7. Measurements were taken daily until 14 days. According to the test results shrinkage values are over 0.05 %, which is corresponding to moderate shrinkage.

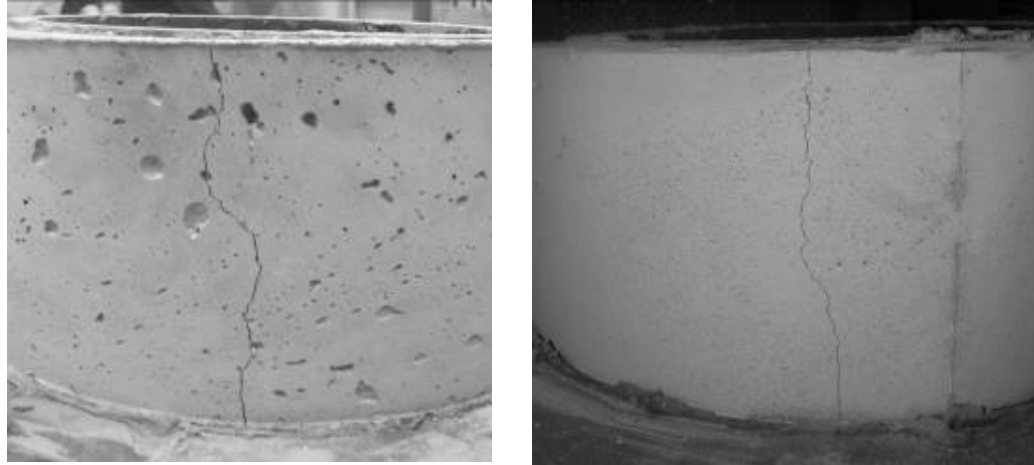
**Figure 6.6 : Ring Test, B88 and S612**

One ring specimen is cast for each repair material and rings are monitored daily for evidence of cracking. The day that cracking is observed is recorded and the initial crack width is measured with a crack comparator. Both specimens were cracked on the tenth day after casting and initial crack width was 0.15 mm. After three weeks there were two more cracks and the width of the initial crack was increased up to 0.50 mm. The type of cracking is shown in the Figure 6.6.

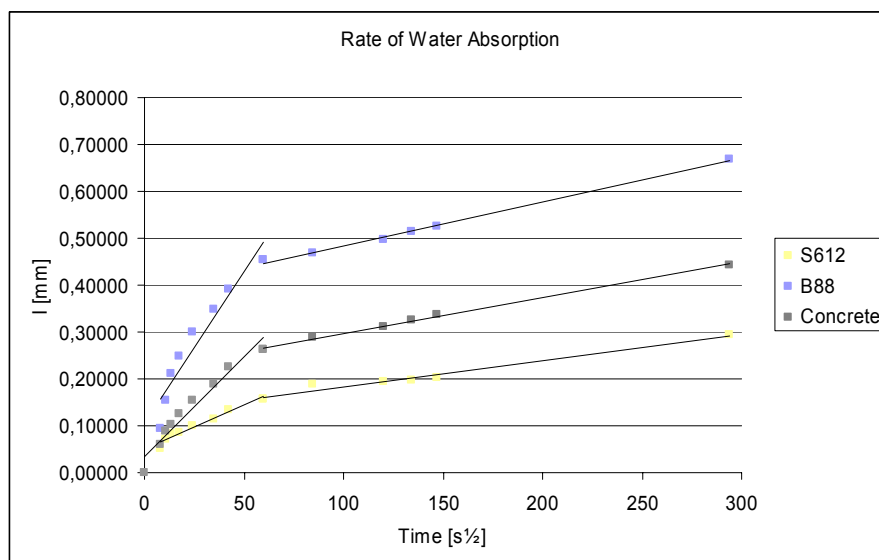
**Figure 6.7 : The Average Capillary Water Absorption**

The capillary water absorption test results for repair materials are shown in the Figure 6.7. The initial rate of absorption and the secondary rate of absorption values are calculated as shown in the Table 6.5.

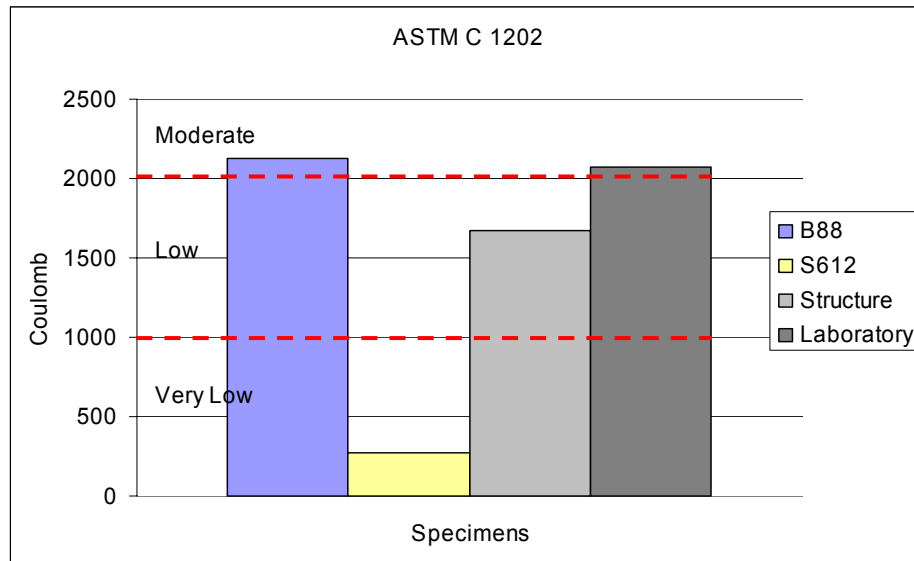
**Figure 6.8 : Rapid Chloride Test Results**

The classification of permeability according to the ASTM C1202 is shown in the Figure 6.8. B88 is moderately permeable with the substrate concrete specimens, they are nearly low permeable. Nonetheless, S612 is low permeable, which means there are less connected capillary voids and cracks, thus its permeability can be neglected.
