**EVALUATION OF REPAIR MATERIALS FOR HIGH  
PERFORMANCE CONCRETE**

**M.Sc. Thesis by  
Tahsin Alper YIKICI, B.Sc.**

**Department : Civil Engineering**

**Programme: Structural Engineering**

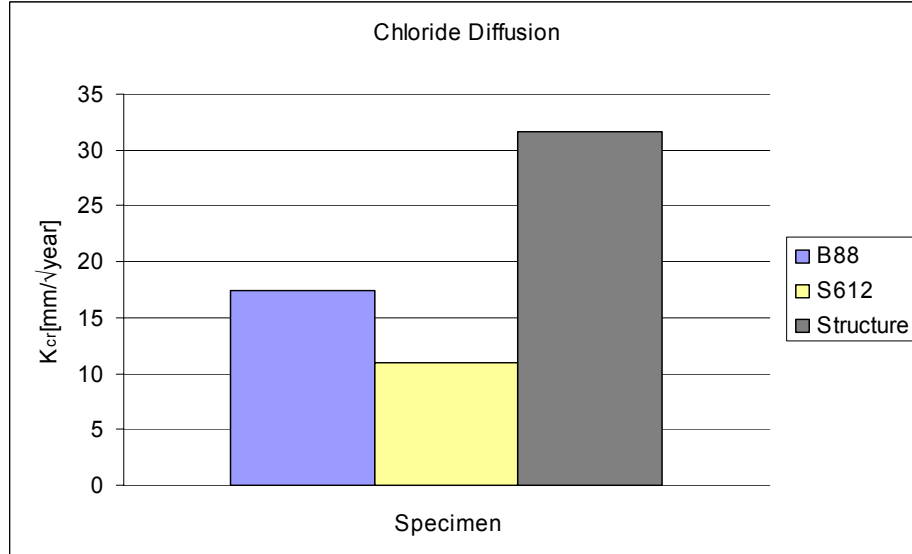
**Figure 6.9 :** Penetration Parameter,  $K_{Cr}$

From the chloride diffusion test results obtained from the non-linear regression analysis on hardened specimens, the effective chloride transport coefficient,  $D_e$ , and

the penetration parameter,  $K_{Cr}$  are proportional as shown in the Figure 6.9 and Figure 6.10. As a result the desired chloride permeability is achieved, thus the results of repair materials are less than the substrate concrete.

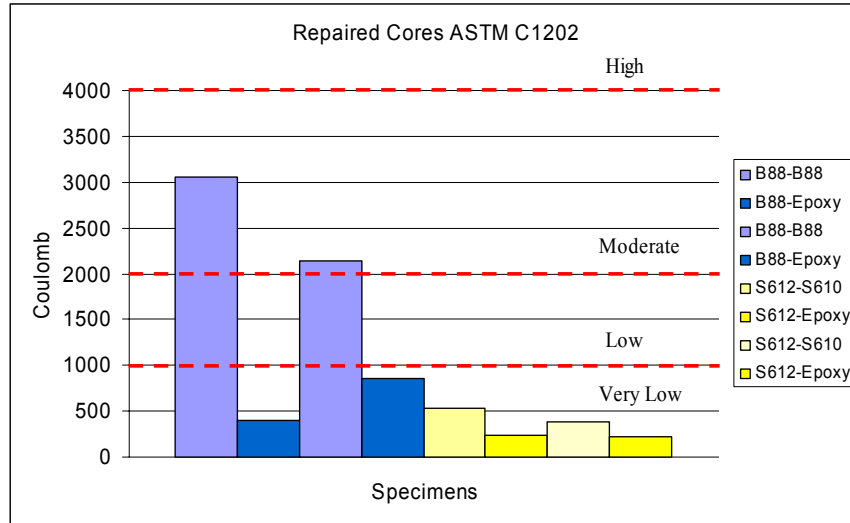
**Figure 6.11 : Composite Cores Test Results**

Obviously, using primer between repair material and substrate affects the results. As shown in the Figure 6.11 there are two trials for both repair material and each trial is performed once with cementitious primer, and once with epoxy primer. It can be observed from the results in Figure 6.11 that in all repair materials using epoxy primer reduces the chloride permeability. Permeability class of the cores repaired with B88 using cementitious primer is, moderate and the cores repaired with S612

using cementitious primer, very low. It can be observed that the chloride diffusion of the repairs B88 is much higher than the repairs S612. Even though the permeability class for all specimens repaired with epoxy primer is very low, it can be observed that results of the specimens with B88 are higher than the specimens with S612. The results for S612 are as low as negligible.

Consequently, rapid chloride permeability of the repairs is affected by repair material quality and mostly by primer type.

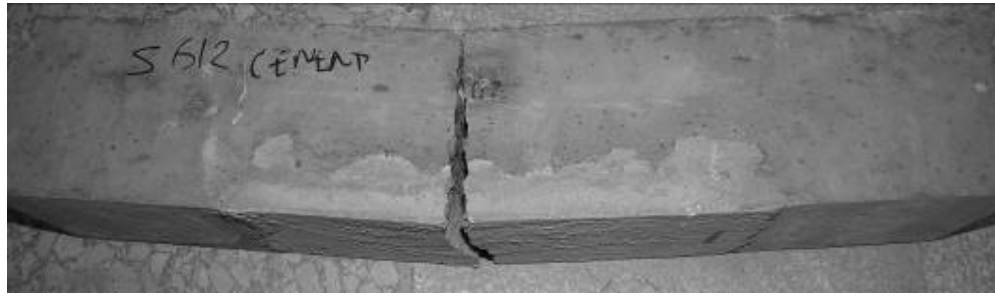
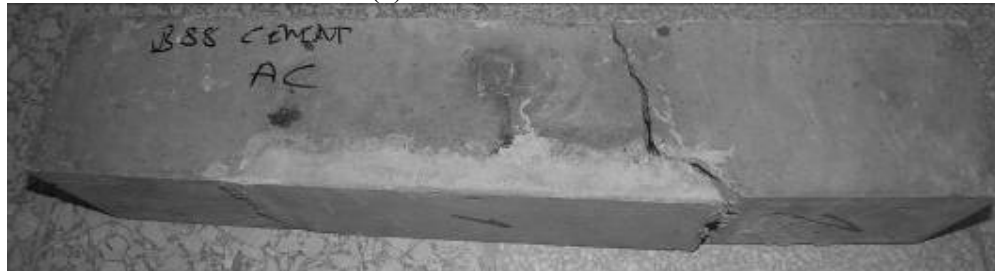
**Figure 6.12 : Failure Patterns**

Figure 6.12 shows the failure patterns for the composite beam specimens subjected to flexural loading and Table 6.11 shows the results of the failure types observed in the composite sections prepared with cement based primer and epoxy based primer, for moist cured and air cured specimens.

(a) Failure at the center

(b) Failure at the edge

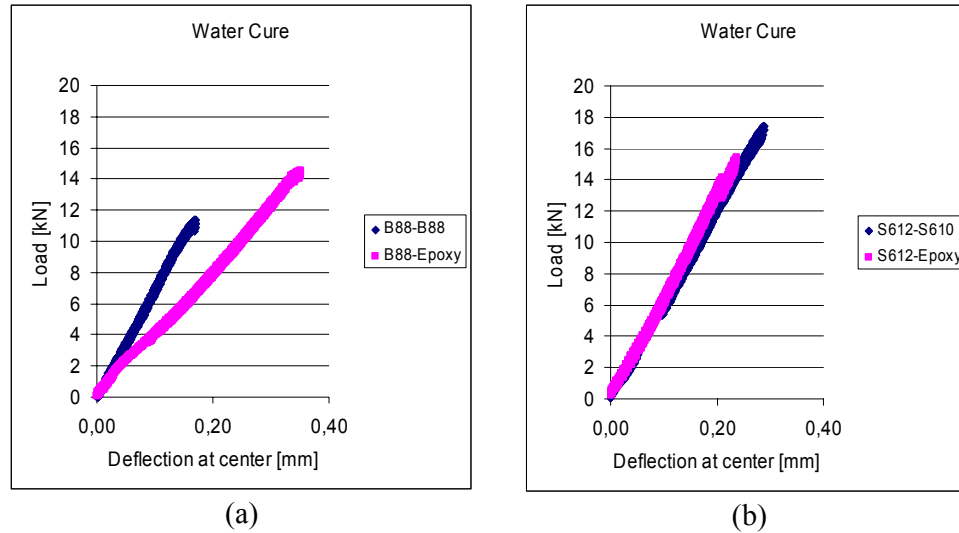
**Figure 6.13 : Load Deflection of B88 Composite Beam in Water Curing**

In addition, the corresponding load-deflection curves of these specimens in the flexure test are shown in the Figure 6.13 and Figure 6.14.

It can be observed that water curing improves the deflection ability and the load carrying capacity of the beam specimens. Specimens cured in air-dry condition have less flexural strength and less deflection at center.

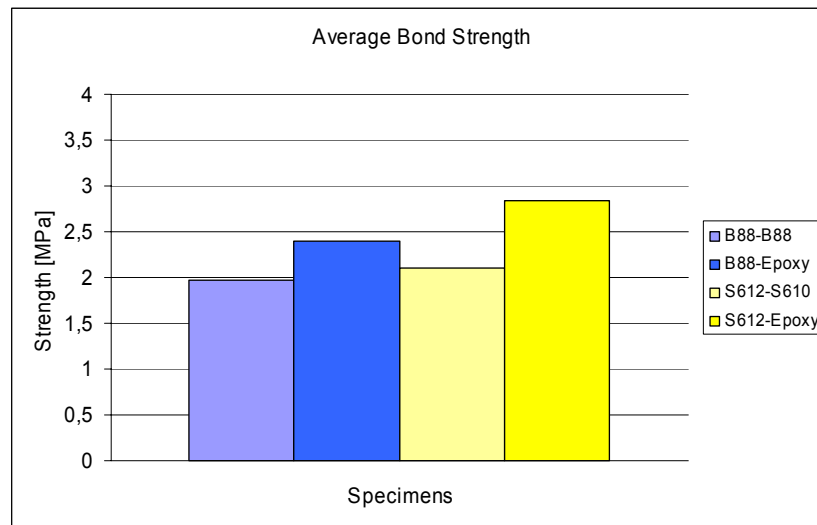
As shown in the Figure 6.15 the average bond strength results range between 2.0 to 2.5 MPa. The obtained average test results of S612 are higher than the test results of B88. Obviously, for both mortars, specimens prepared with epoxy primer provide better bonding strength.

**Figure 6.15 : Average Bond Strengths**

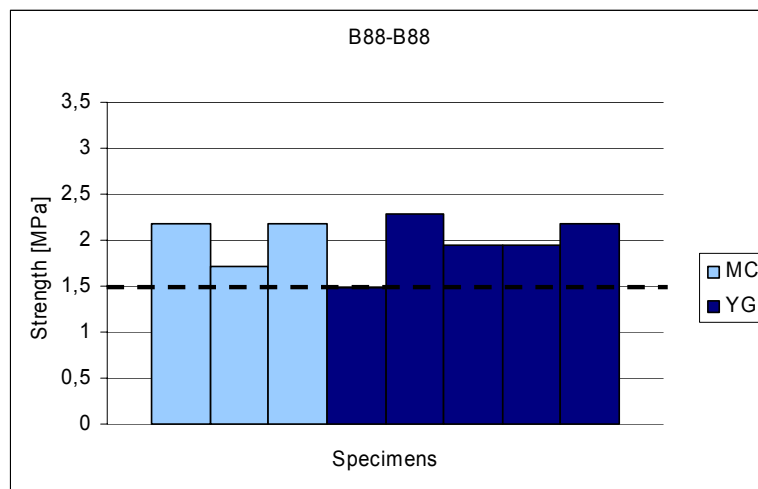
It can be observed from the Figure 6.16 that the pull-off strengths are not strongly affected by the workmanship if cementitious primer is used. But the application of the epoxy primer has resulted differences between two workers (Figure 6.17).

**Figure 6.16 : Effect of Workmanship on B88 Repair with Cementitious Primer**

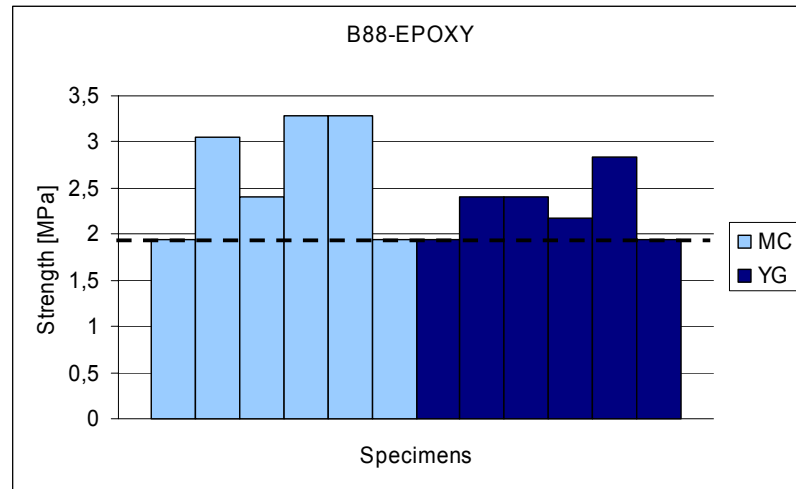
Though both workers are well trained and experienced at repair works, MC has higher results when using epoxy primer.

**Figure 6.17 :** Effect of Workmanship on B88 Repair with Epoxy Primer

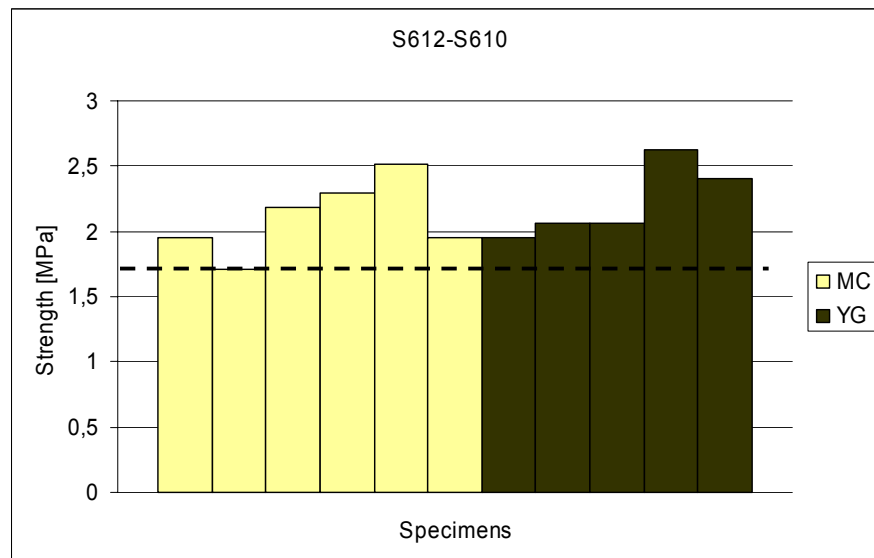
**Figure 6.18 :** Effect of Workmanship on S612 Repair with Cementitious Primer

On the Table 6.14, there are pull-off test results obtained from the S612 repairs prepared with both cementitious and epoxy primer. Obviously, specimens prepared with epoxy primer provide better bonding strength. It can be observed from the Figure 6.18 that the pull-off strengths are not strongly affected by the workmanship if cementitious primer is used. But application of the epoxy primer has resulted differences between two workers again as shown in the Figure 6.19.

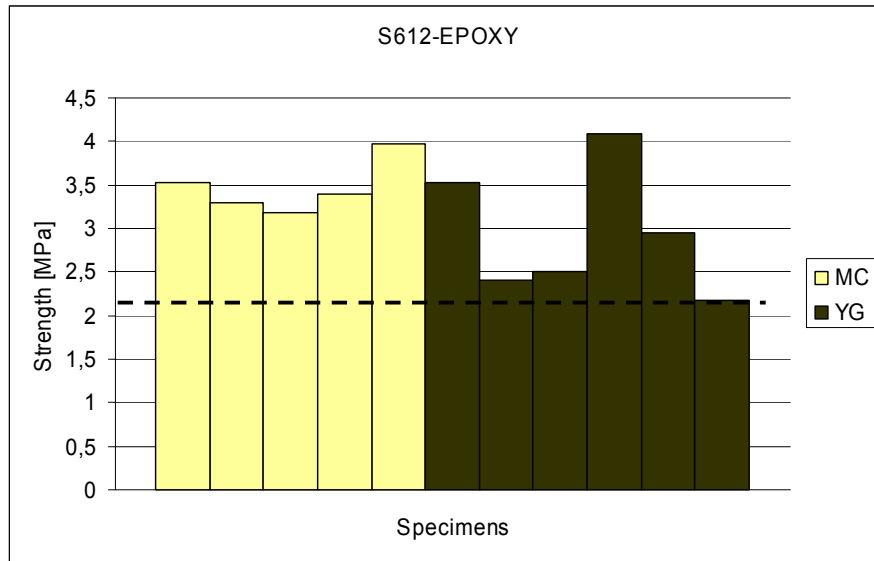
**Figure 6.19** : Effect of Workmanship on S612 Repair with Epoxy Primer

It can be observed that MC has a better result than the other worker again with an epoxy primer between concrete and substrate. The deviation of the results provided

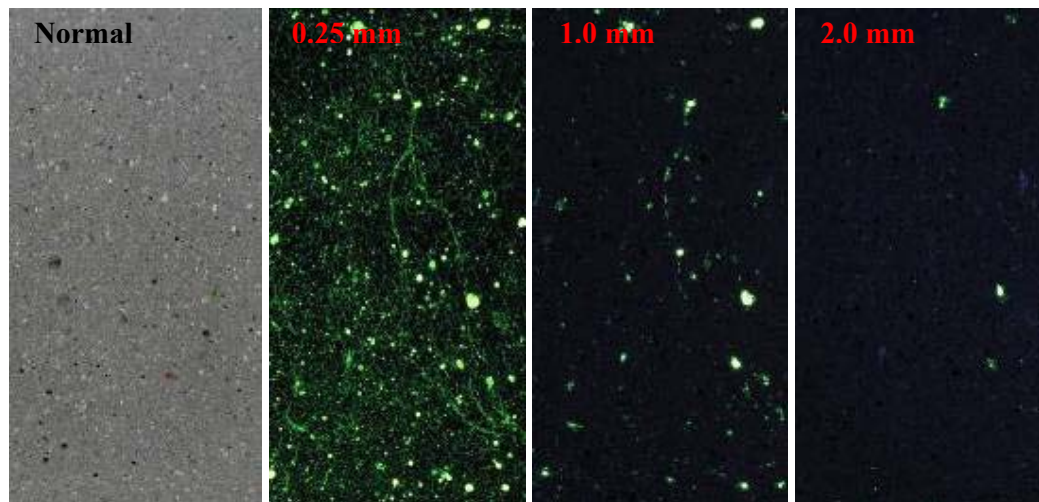
As shown in the Figure 7.1 the first image is taken under the normal light and the other images are taken under the UV-light. Fluorescent epoxy appears green under UV-light. Normally the stability of the specimens is evaluated on a finished 1.0 and 2.0 mm under the impregnated layer. In this research 0.25 mm sections are also evaluated. As seen in the image 0.25 mm, there is higher capillary porosity and some connected porous zones in paste areas. The maximum size of entrapped air voids is 5 mm and there are many air-filled pores with a diameter 2~5mm. Fine cracks are available through the section. Under 1.0 mm and under 2.0 mm sections the capillary porosity, air voids and cracks disappear, because they are unconnected.

**Figure 7.1 : Plane Section Pictures B88**

The Figure 7.1 and Figure 7.2 show the images of the fluorescent impregnated and polished 100x200 mm plane sections and Figure 7.3 and Figure 7.4 show the images of the fluorescent impregnated 35x45 mm thin sections from the cylindrical specimens of the repair materials B88 and S612 batched in the laboratory.

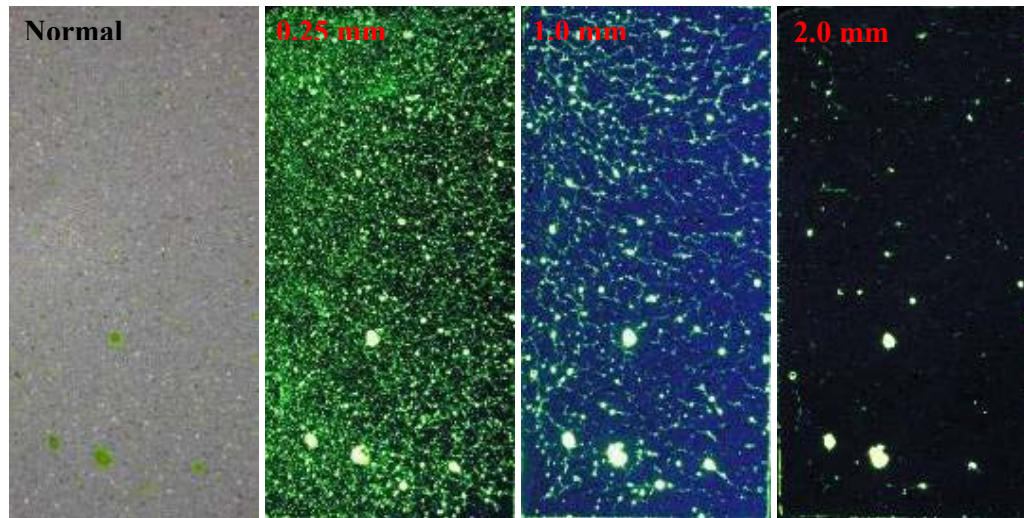
In the Figure 7.2 the first image is taken under the normal light and the other images are taken under the UV-light. As seen in the image 0.25 mm capillary porosity is greatly lacking in uniformity and there are many connected porous zones in paste areas. There are some air-filled pores with a diameter 5~8mm. Under 1.0 mm it is possible to see connected porous zones but under 2.0 mm sections the capillary porosity disappears. Between these two samples there is no significant difference in capillary porosity and there are also no visible cracks and connected voids. Specimens prepared in the laboratory show capillary characteristics under 2 mm impregnated plane sections.

**Figure 7.2 : Plane Section Pictures S612**

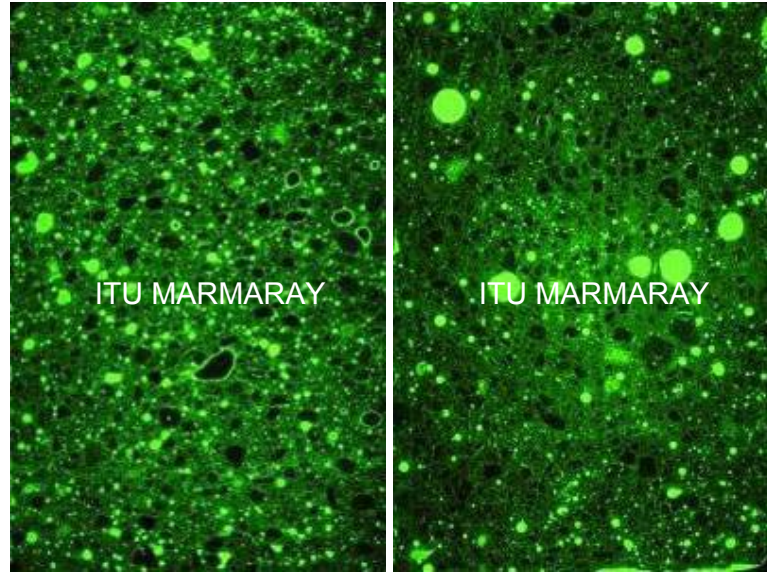
**Figure 7.3 :** B88 Thin Section (left), S612 Thin Section (right), 35x45 mm

Using a polarizing microscope with UV-Light and band stop filter, magnifying 50x, ten random fields across the thin sections are analyzed to document the quantity of microcracks in repair materials. Microcracks are categorized as paste cracks and bond cracks. The width of these cracks is <0.010 mm. Cracks with a width of 0.01-0.1 mm are defined as fine cracks and with a width of >0.1 mm are defined as large cracks. There are no fine cracks and macro cracks on both thin sections. The result of the microcrack analysis is shown in the Table 7.1.

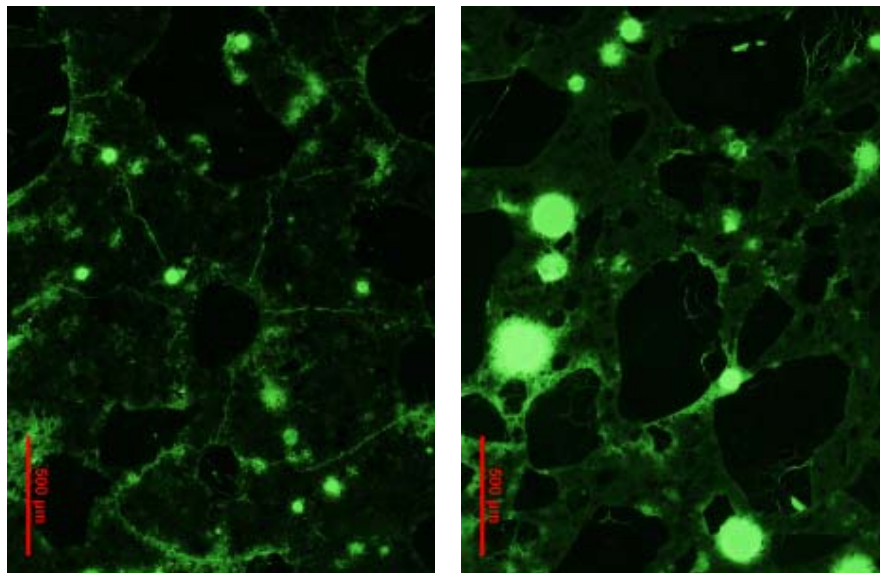
**Figure 7.4 :** Micro-cracking in the specimens

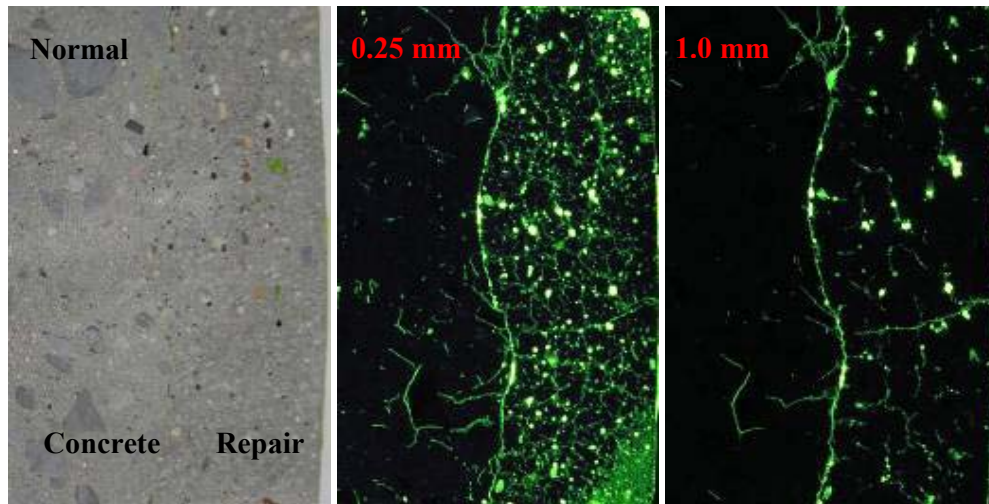
**Figure 7.5 :** Plane Section Pictures B88 with B88 Primer

The Figure 7.5 and Figure 7.6 shows plane sections with cementitious primer and Figure 7.7 and Figure 7.8 shows plane sections with epoxy primer. The repaired part is on the right side of the images. It is not possible to detect the cementitious primer

There are fine cracks in the substrate concrete parallel to the surface, due to mechanical preparations. Many entrapped air voids were located in the repair mortar along the interface due to insufficient compaction of the repair material. There are microcracks vertical to the surface, running through the thickness of the repair material, which may be the result of drying shrinkage.

Repairs made with cementitious material have a continuous interface filled with fluorescent epoxy, which looks like a crack. The interface of the specimens prepared with epoxy primer has uniform homogeneity and there is no sign of fluorescent epoxy in-between.

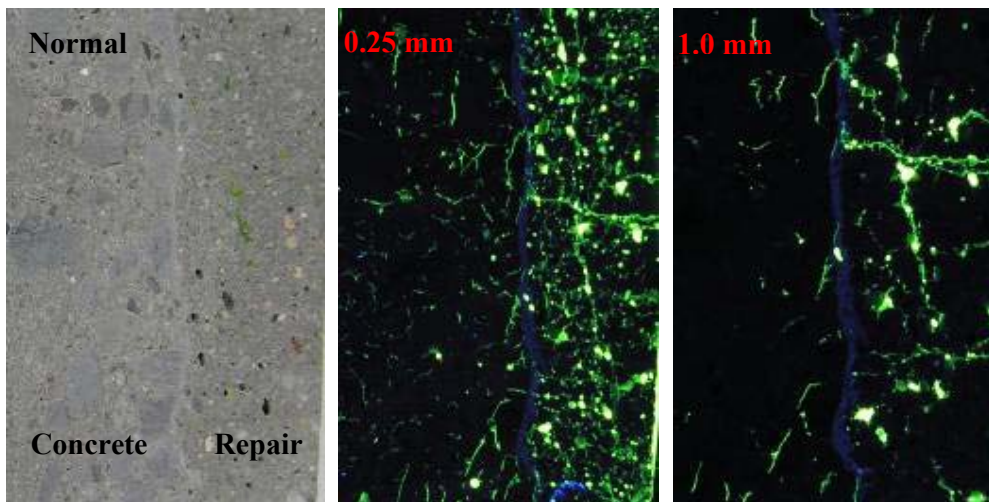
**Figure 7.6 :** Plane Section Pictures B88 with Epoxy Primer

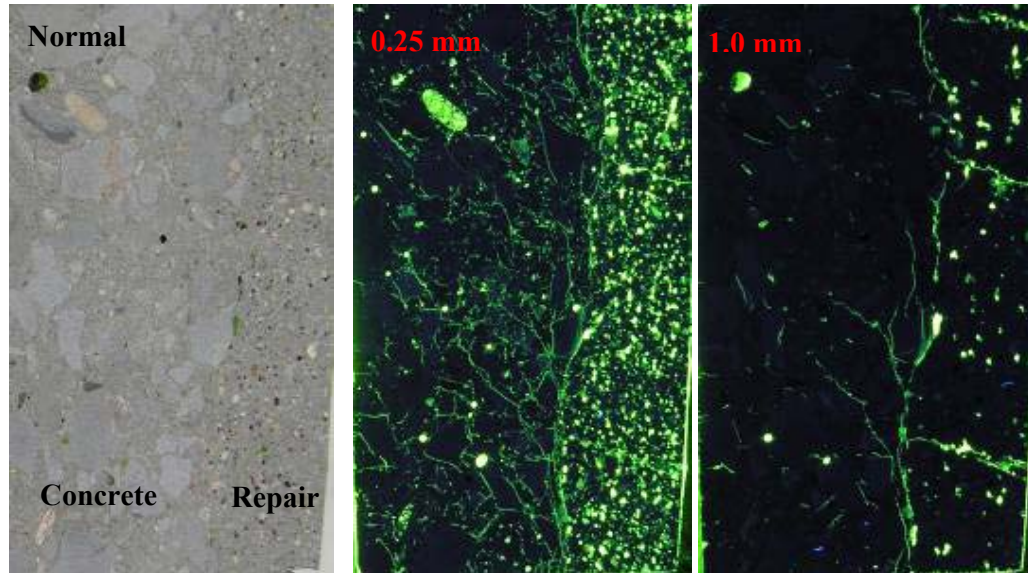
**Figure 7.7 :** Plane Section Pictures S612 with S610 Primer

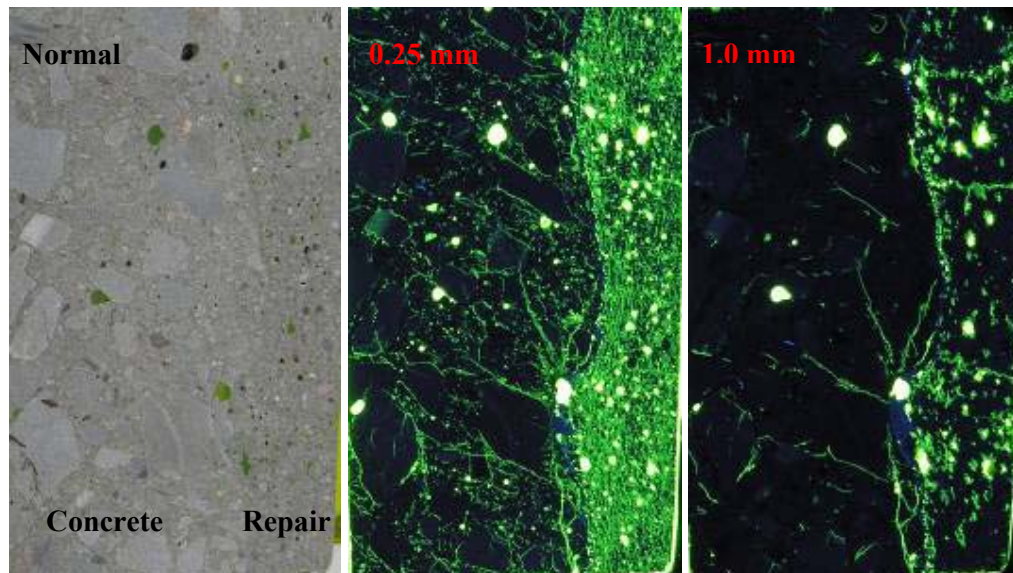
**Figure 7.8 :** Plane Section Pictures S612 with Epoxy Primer

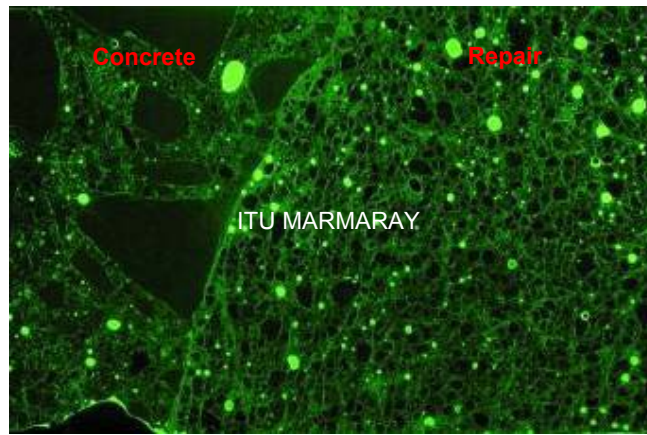
**Figure 7.9 :** B88 with B88 Primer Thin Section, 30x45 mm

From Figure 7.9 to Figure 7.12 displayed images belong to the thin sections prepared from repairs. The images were taken under UV-light. The repair part and the substrate concrete are shown in the images. It is not possible to differentiate the

The entrapped air voids in the repair mortar and along the interface mentioned above on the plane section images are more evident on the thin section images below. But there are no visible cracks in the repair mortar. Inhomogeneous entrapped air content in S612 is more than in B88.

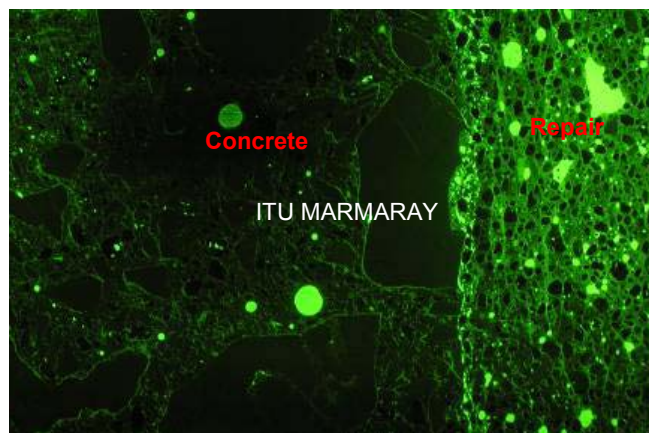
**Figure 7.10 :** B88 with Epoxy Primer Thin Section, 35x45 mm

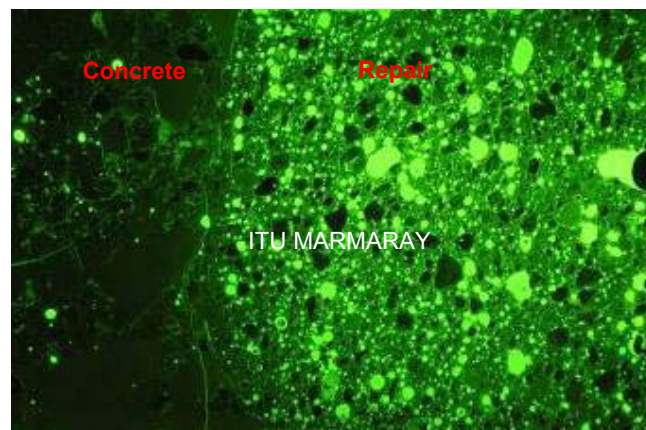
**Figure 7.11 :** S612 with S610 Primer Thin Section, 35x45 mm

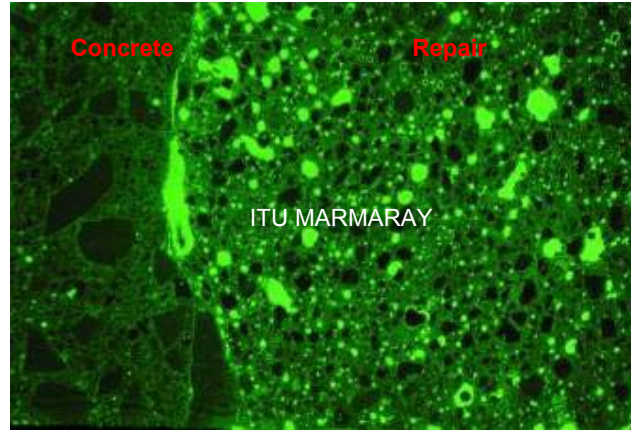
**Figure 7.12 :** S612 with Epoxy Primer Thin Section, 35x45 mm

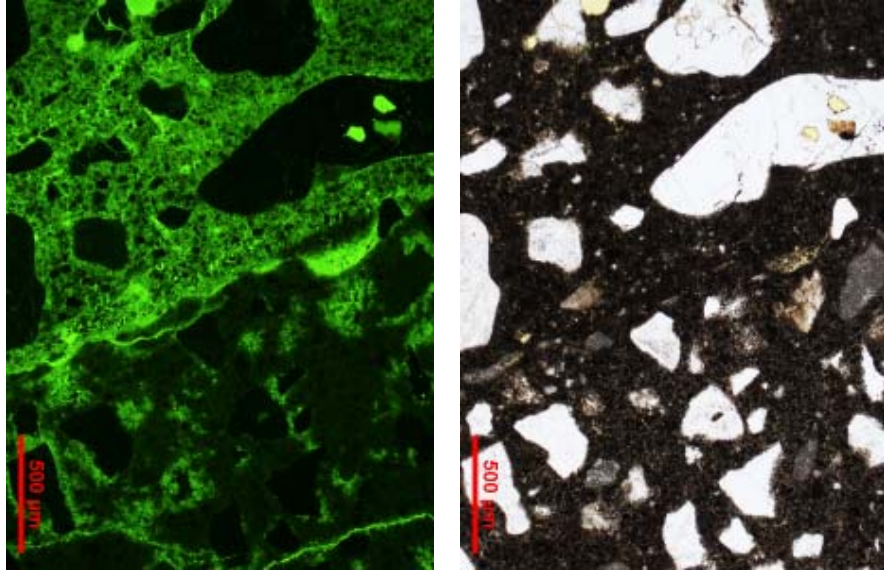
The interface between the repair mortar and the substrate concrete was investigated and the unbonded areas were determined. The unbonded areas were observed under polarized microscope with 100x magnification. Under UV-Light areas filled with fluorescent epoxy appear green and areas filled with primer appear dark.

**Figure 7.13 :** Interface of Repair B88 with B88 Primer

From Figure 7.13 to Figure 7.16 displayed images from the thin sections are taken under optical polarized microscope with 50x magnification. The images on the left are taken under UV-light and the images on the right are taken under normal light. The repair part is always on top, the interface appears in the middle section of the images and the bottom section is the substrate concrete.

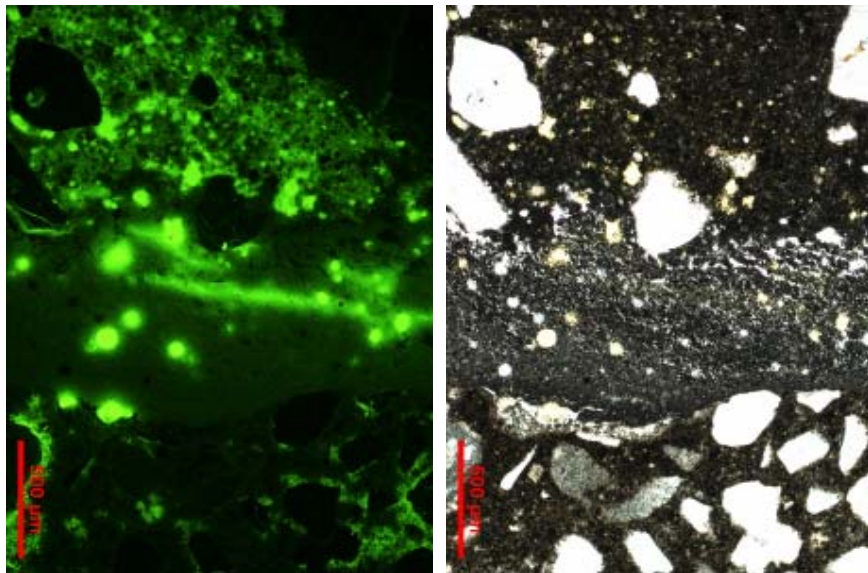
If there is dust or dirt on the surface of the interface, it also appears green. Areas filled with dust and dirt because of poor cleaning is calculated as unbonded areas.

**Figure 7.14 :** Interface of Repair B88 with Epoxy Primer

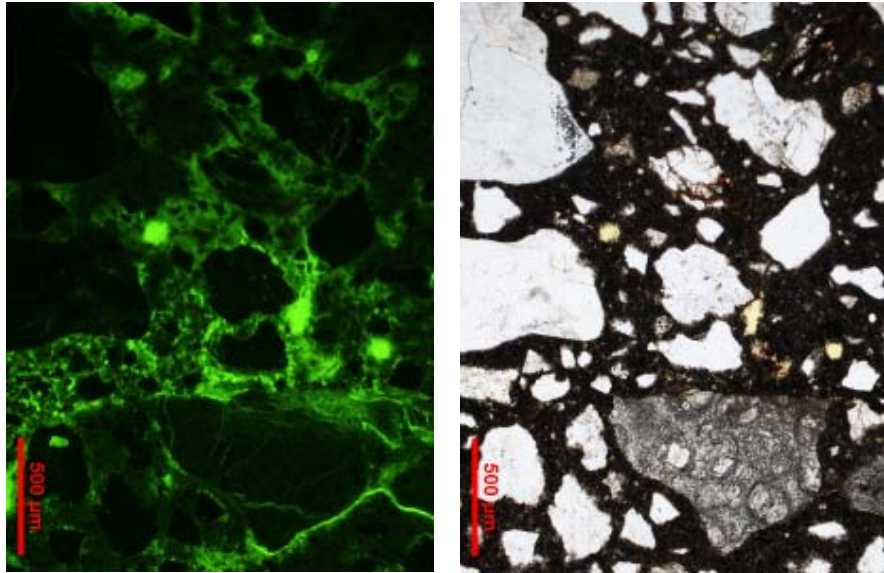
If air bubbles were located in the interface, thus indicating insufficient application of the primer, the interface appears green again. Increased number of air voids is the result of poor compaction.

**Figure 7.15 :** Interface of Repair S612 with S610 Primer

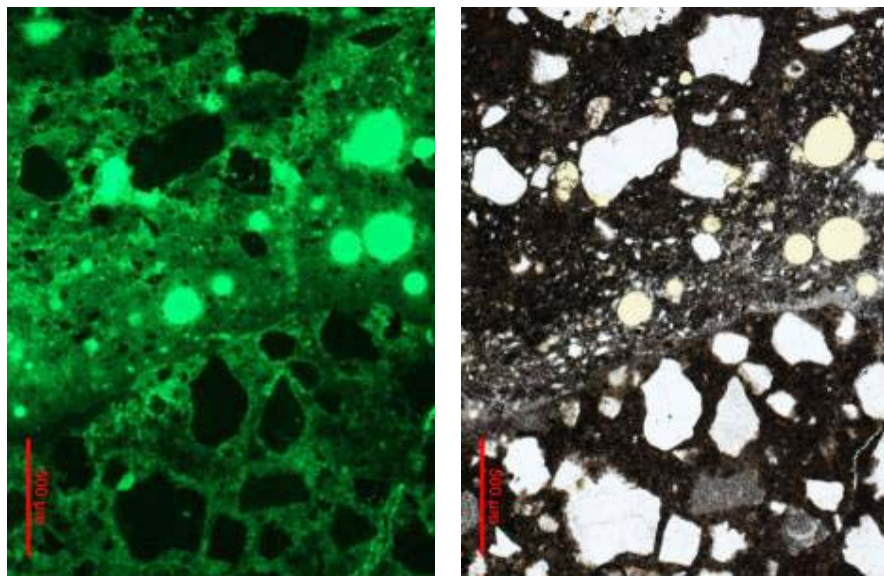
**Figure 7.16 :** Interface of Repair S612 with Epoxy Primer

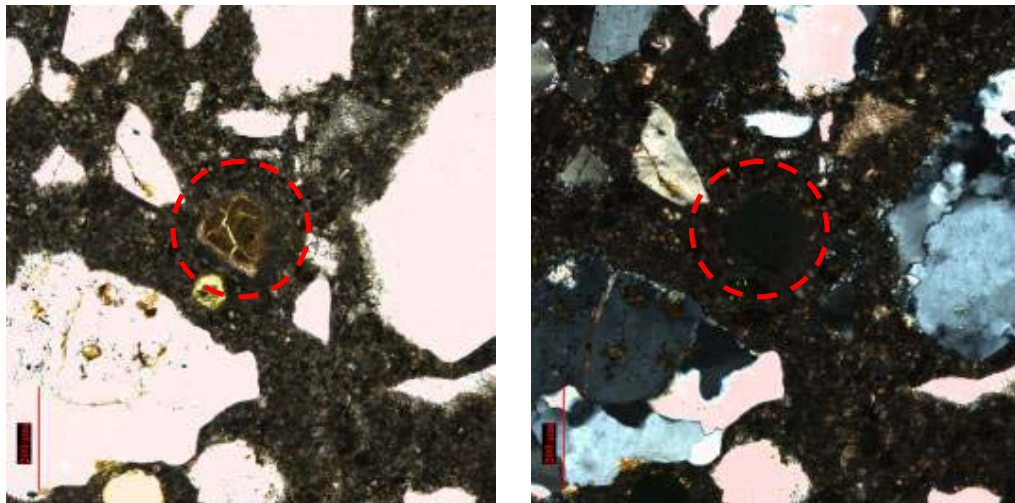
In Figure 7.17 there is a clump of silica-fume undispersed in the cement paste of the repair material designated in the dotted area. It can be identified at plain polarized light by its angular form, its brown color and most of the times there is a crack through the middle of the silica fume particle, filled with fluorescent epoxy. At the crossed polar it's opaque and appears dark as shown on the right image. Silica fume is a special product used in cementitious materials, but it is very hard to mix it. It is observed that all thin sections prepared from the repaired cores have nondispersed silica fume particles.

**Figure 7.17 : Undispersed Silica-Fume Particle**

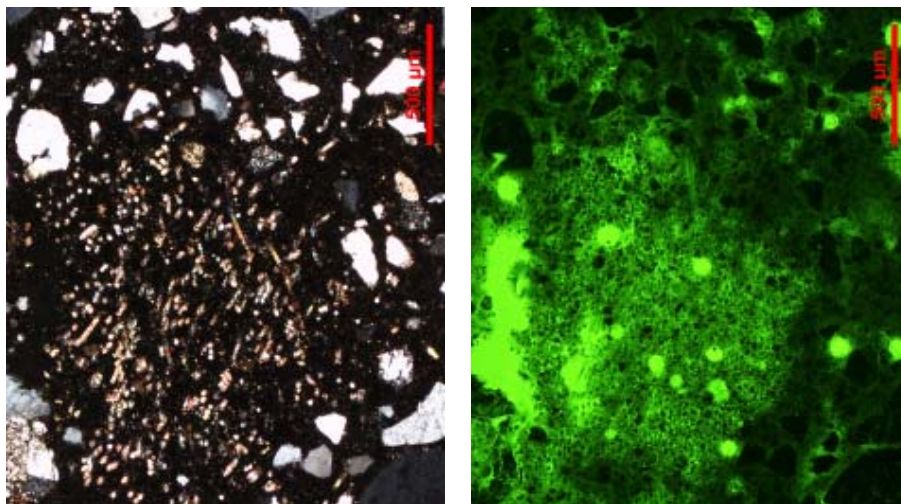
**Figure 7.18 : Clump of Fibers in the Matrix**

In the Figure 7.18 there is a clump of fiber in the cement paste. It is because of the poor mixing procedure and workmanship. Using fibers in repair materials improves its resistance against crack formation due to volume changes, but if it is not well dispersed, homogeneity lacks in uniformity shown in the Figure 7.18 right image.
