**REHABILITATION OF THE HISTORICAL FABRIC;
A PROPOSAL FOR EMEKYEMEZ (AZAP KAPI) NEIGHBORHOOD**

M.A. THESIS

Department of Architecture

Restoration M.A. Programme

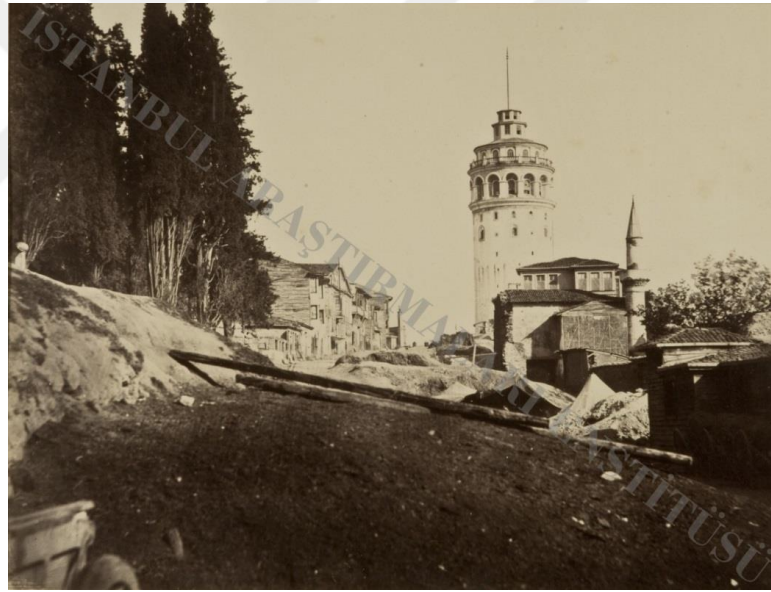
Figure 2.7 : A photo taken during the demolition of the walls (IRE, 1865).

The municipality intended to increase its revenues. One of these solutions was to demolish some areas of Galata city walls in 1863 and construct buildings there, and the fund came from those who were using these areas. Another decision was taken immediately after this, which mentioned that the destruction of the city walls could be made due to the fact that the land (blocks and the buildings of the parcels) was destroyed and the land was sold to the bidders, and this sale would increase the benefit of this destruction by obtaining significant funds from the city walls. Thus, the demolition of the Genoese Walls, which had survived until the end of the 19th century, had begun (Figure 2.7, Figure 2.8).

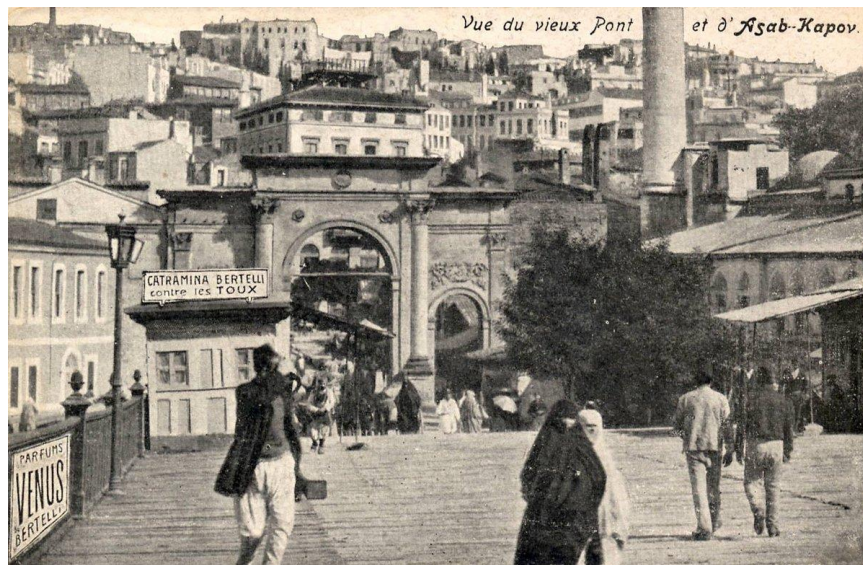
Figure 2.11 :Azap Gate (Salt archive, n.d.).

The Galata city walls in the Genoese period started from Tophane to the Golden Horn Shipyard (*Haliç*). The westernmost gates’ name embedded in the city wall was Porta di San Antonio or Porta San Antonio (Kömürçüyan, 1988). After the Ottoman conquest, some part of the city wall was destroyed but the gate preserved until the 19th century. It is possible to consider the “Azeb kapusu” as same as the one in the Genoese period (Porta San Antonio). Around Ataturk Bridge area, none of the gates survived; though the current entrance of the Golden Horn Shipyard follows the same path as there was of “Azeb Kapusu”. The entrance depicted an old photo shows is a single opening door, depressed arch, a triangular pediment and two pilasters on each side of it. There was an inscription on this pediment (Figure 2.11)

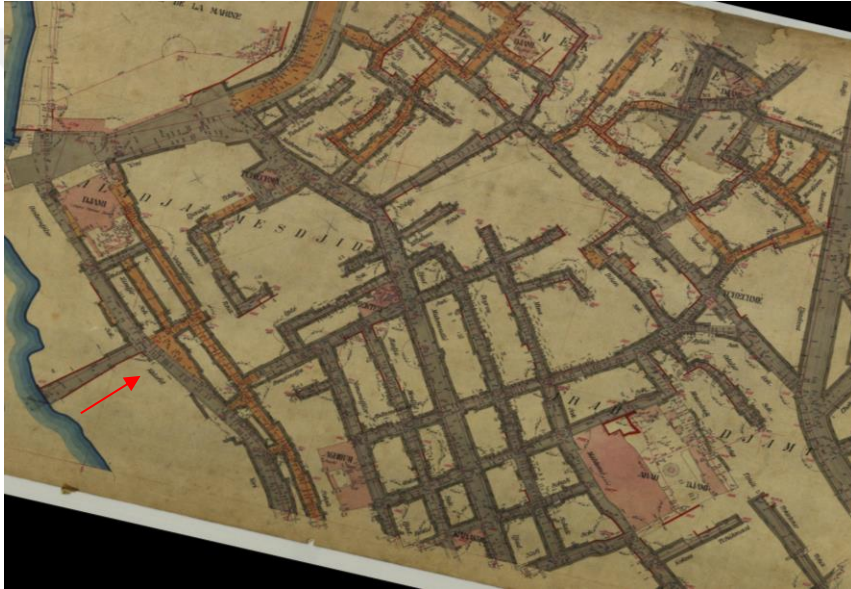
Figure 2.12 :Maps of "Azap Gate, IST HT 9/1 feuille" the Fountain of Saliha Sultan and its surroundings in 1913 (Dağdelen, 2007).

In the 17th century, there were a large number of ironmongers around the neighborhood who provided ironworks for ships at the shipyard, giving rise to the name of the road “Kalafatçılar” (Kömürçiyen, 1988) (Figure 2.12, Figure 2.13, Figure 2.14).

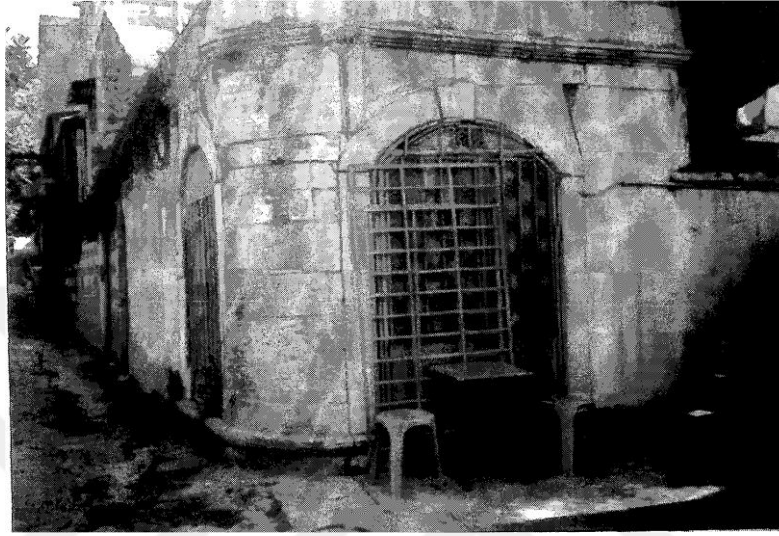
Figure 2.36 : Mustafa Pasha Fountain (Cesur, 2001).

It is a quadrangular-shaped fountain with rounded corners. It has architectural characteristics of the Tanzimat Period. Later restoration altered some of its original features (Figure 2.36).

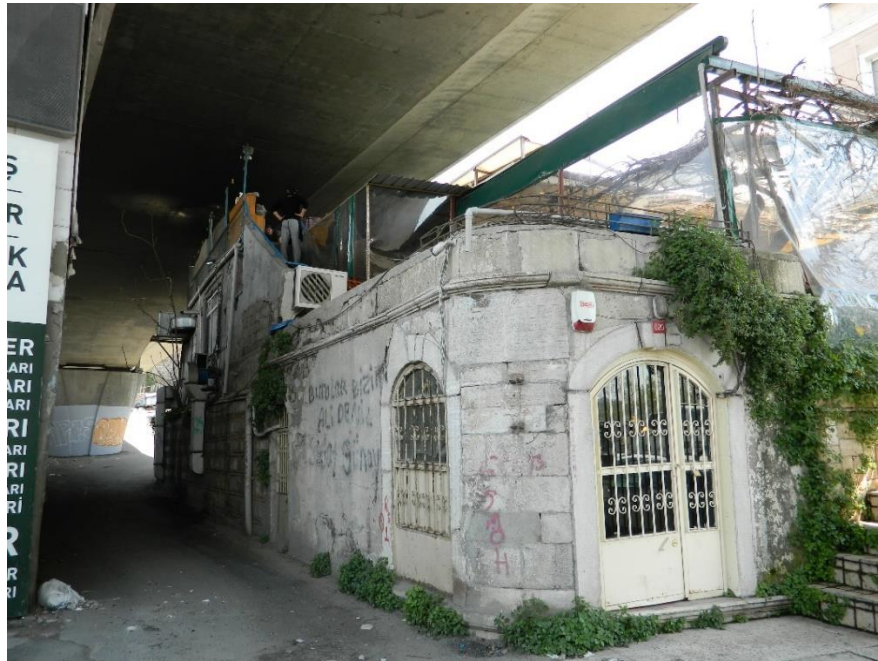
Figure 2.37 : Mustafa Pasha Fountain current situation (Beydaghdar, 2019).

Currently a store is on top of it and the first floor of the fountain is used as a coffee shop. There is cement mortar on the southeast side. The inscription on the fountain is:

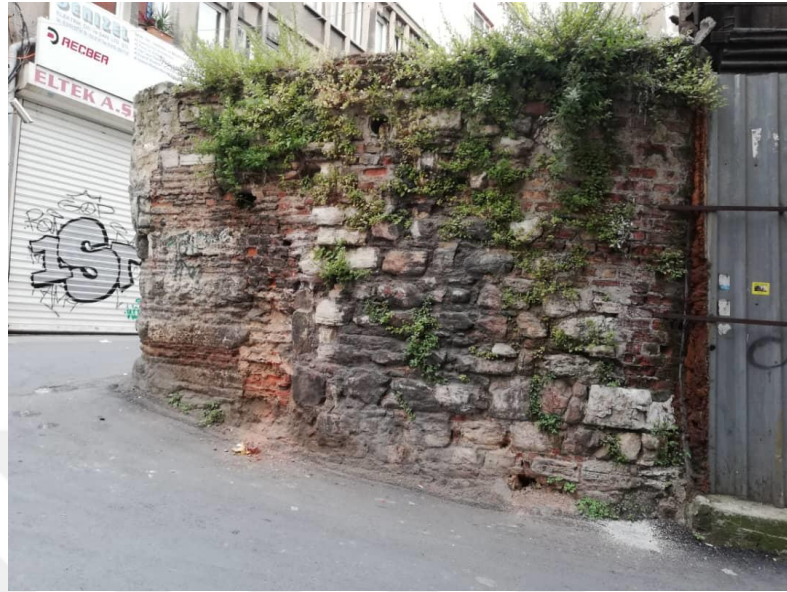
The two faces of the fountain are completely different from each other, the northern side contains the fountain and its inscription. The building materials of the other face are possibly from the Byzantine era (Figure 2.38).

Figure 2.39 : Sultan Selim Fountain west facade (Beydaghdar, 2019).

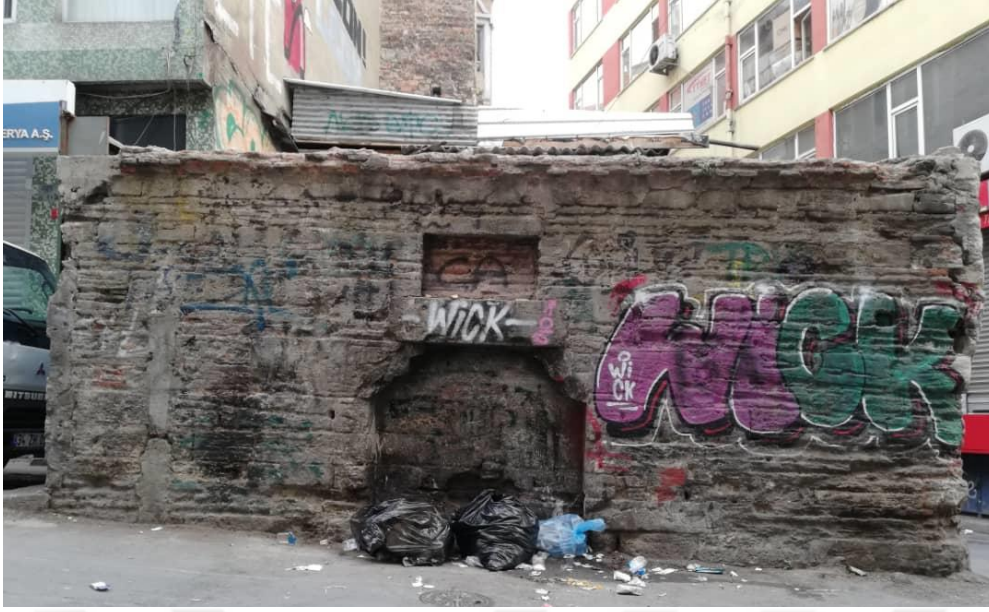
Some documents from the Ottoman era record its construction. Historical documents mention that this fountain was one of the most important fountains of its period. The current position is worrisome as half of the wall of the fountain is underground; its inscription was stolen and due to the lack of attention, it has lost its original characteristics. The newly built store is built over the store destroyed its cistern.

Figure 2.41 : The Sultan Selim fountain north facade (Beydaghdar, 2019).

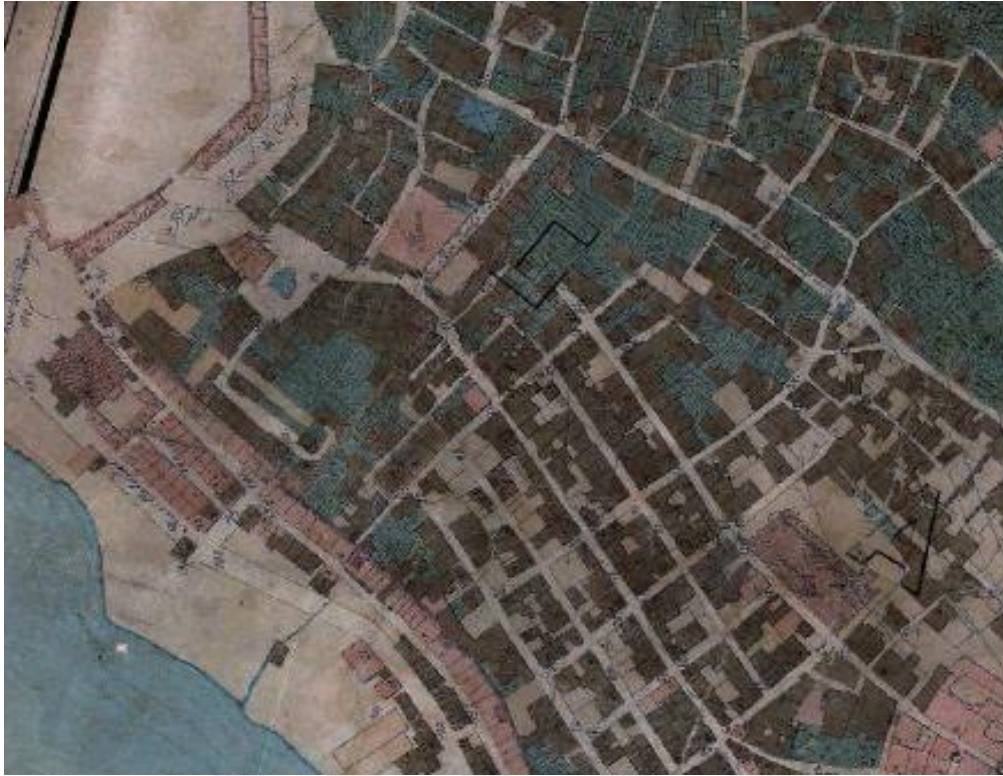
One of the oldest maps of this neighborhood is D'Ostoya Map that is dated to 1858-60. This map is showed the blocks and some lots of the neighborhood. Moreover, the streets and roads are clearly depicted as well. Arap Mosque, the cultural and historically valuable building is depicted in the map (Figure 3.2).

Figure 3.2 : The D'Ostoya Map (1858-60).

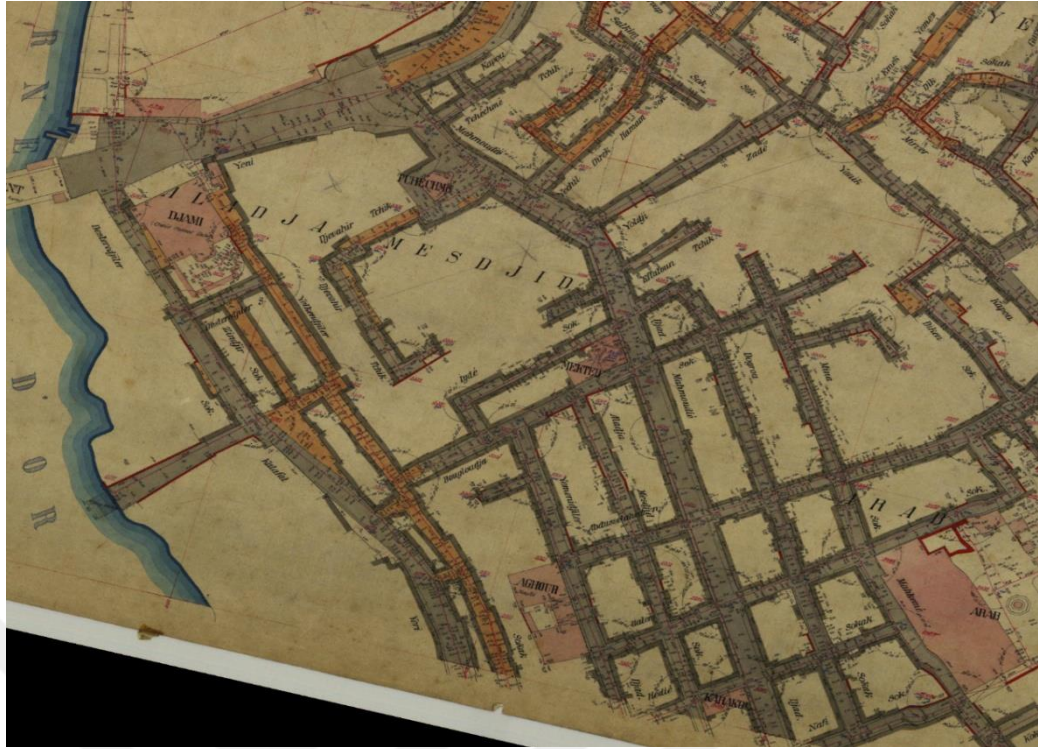
Figure 3.4 : Maps of the neighborhood and its surroundings in 1913 (Dağdelen, 2007).

In the Goad and German Blue (Alman Mavileri) Maps, Galata City Walls, lots and parcels were drawn in more detail (Figure 3.4, Figure 3.5).

It is necessary to mention the crucial significance of these maps. The lots and parcels in the Emekyemez Neighborhood did not change much and only the buildings were demolished or reconstructed over time.

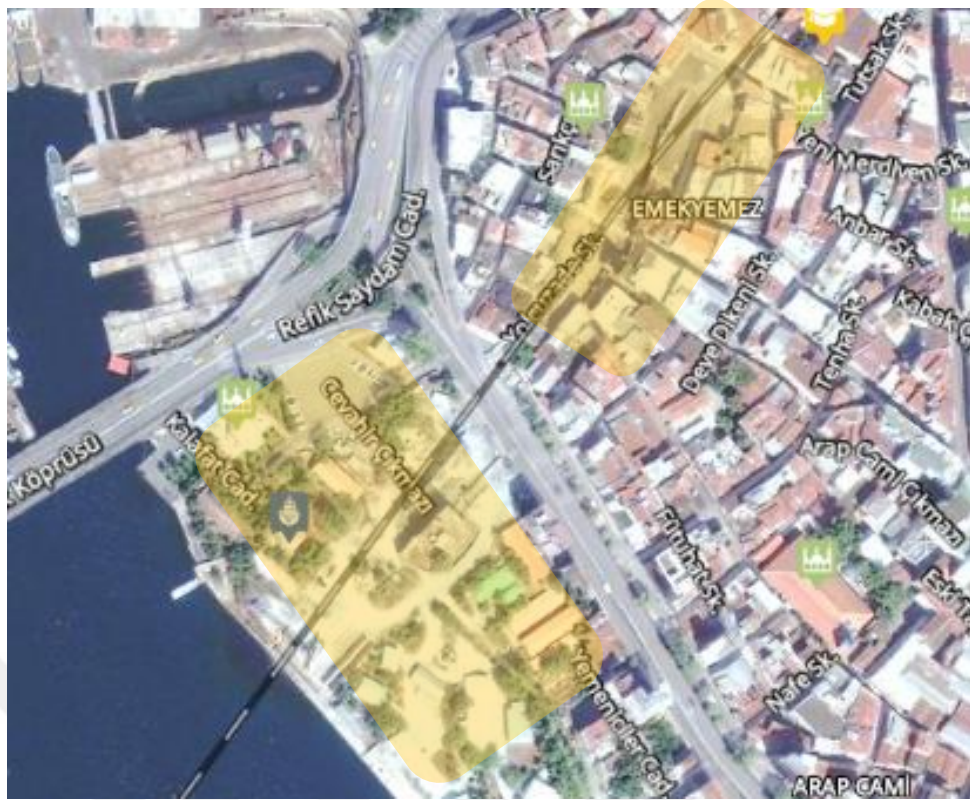
Figure 3.10 : Metro line during construction 2006 (Url-2).

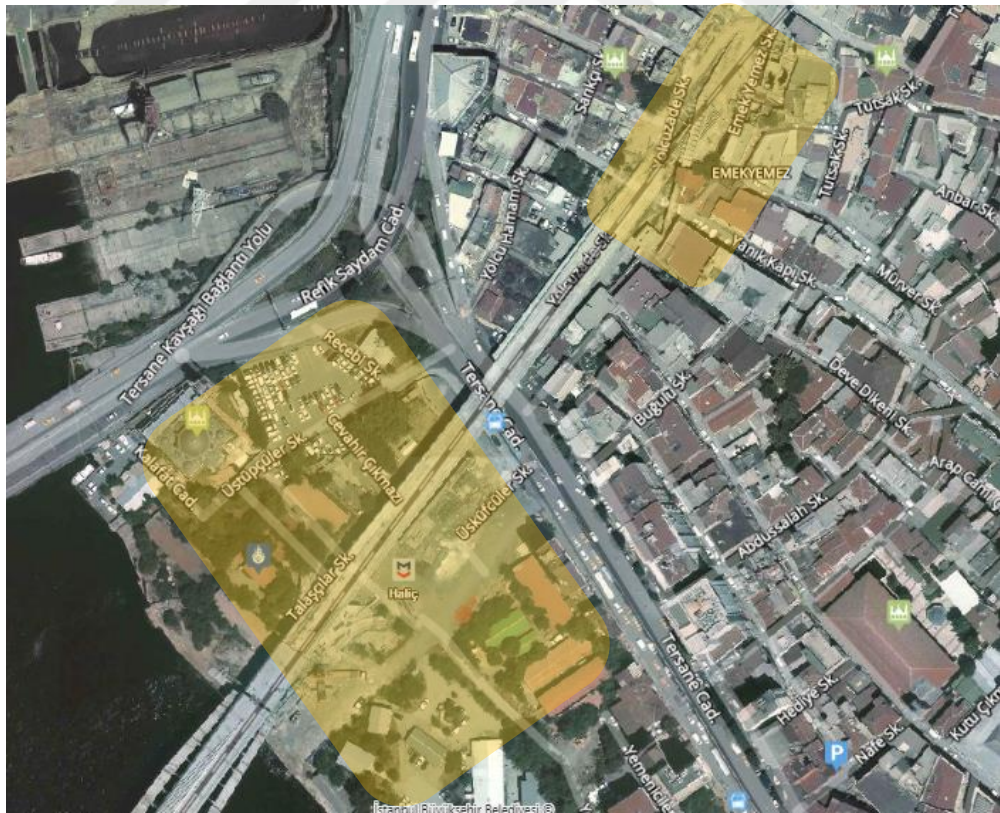
Figure 3.11 : Metro line during construction 2011 (Url-2).

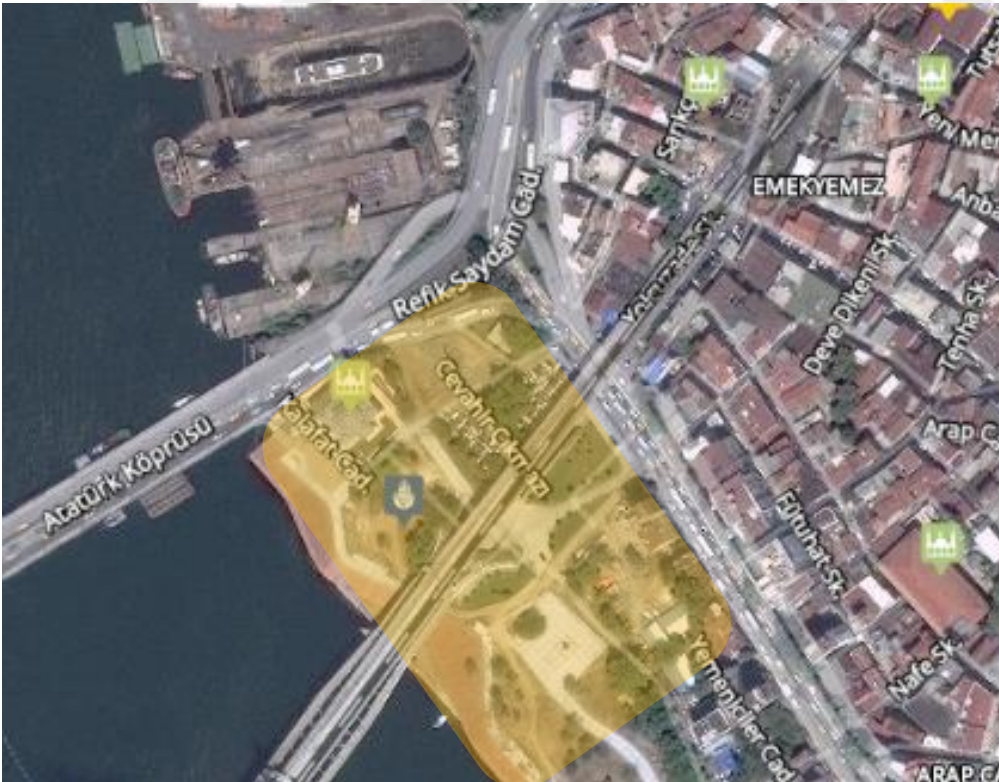
Figure 3.13 : Current situation of the Tersane Avenue and Metro line in the area 2014 (Url-2).

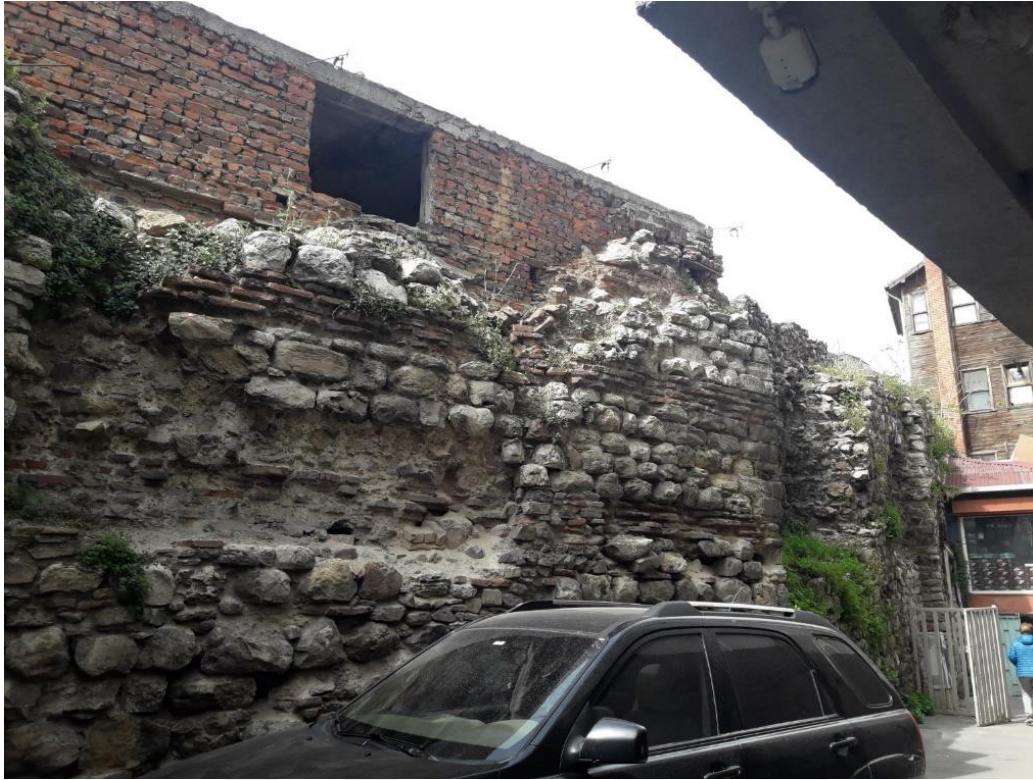
Figure 3.15 : Current situation of the Galata Walls (Beidaghdar, 2019).

The remained sections of the Galata Walls are depicted in grey, similarly, their structural condition is at risk as well (figure 3.15). On the south side of the site, in front of the east facade of the Sokullu Mehmet Pasha Mosque, there is a coat of the arm of Byzantine on a remained section of the Galata Walls.

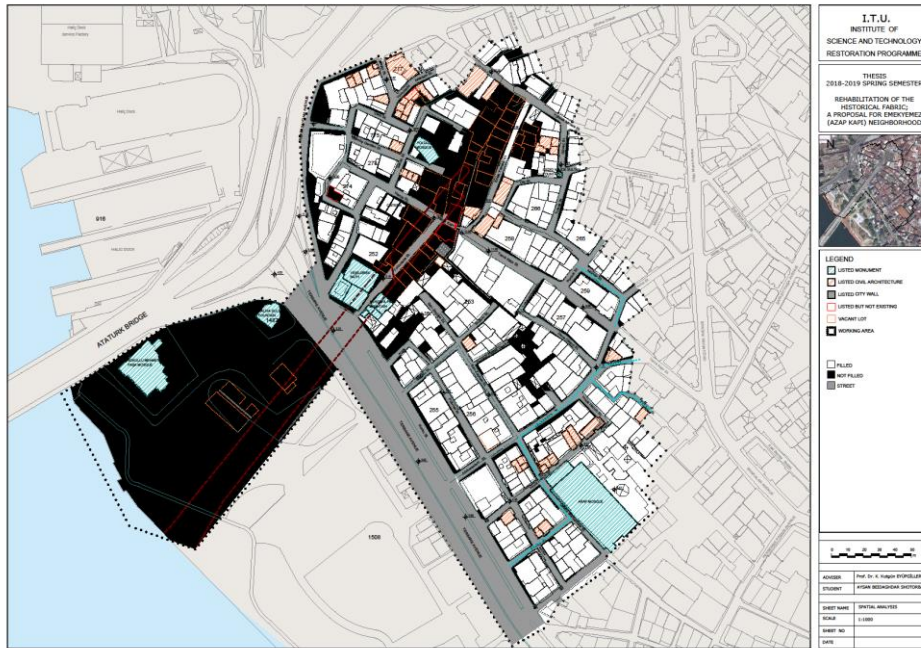
This is the analysis that represents the vacant or filled spaces of the site. As it is depicted in Figure 3.18, the black color shows the vacant lots and spaces and the grey color marks the roads. The filled blocks and lots are white. However, some buildings surround the metro bridge still stand, but they are abandoned.

Figure 3.18 : Spatial analysis of the site.

The south part of Tersane Avenue is the widest space that is vacant. Moreover, the blocks on the metro line route are vacant as well. The free space in the area of study is a wide area along the path of the metro where the tunnel enters the ground around the city walls which has no function. Less than 5% of the total area is not active.

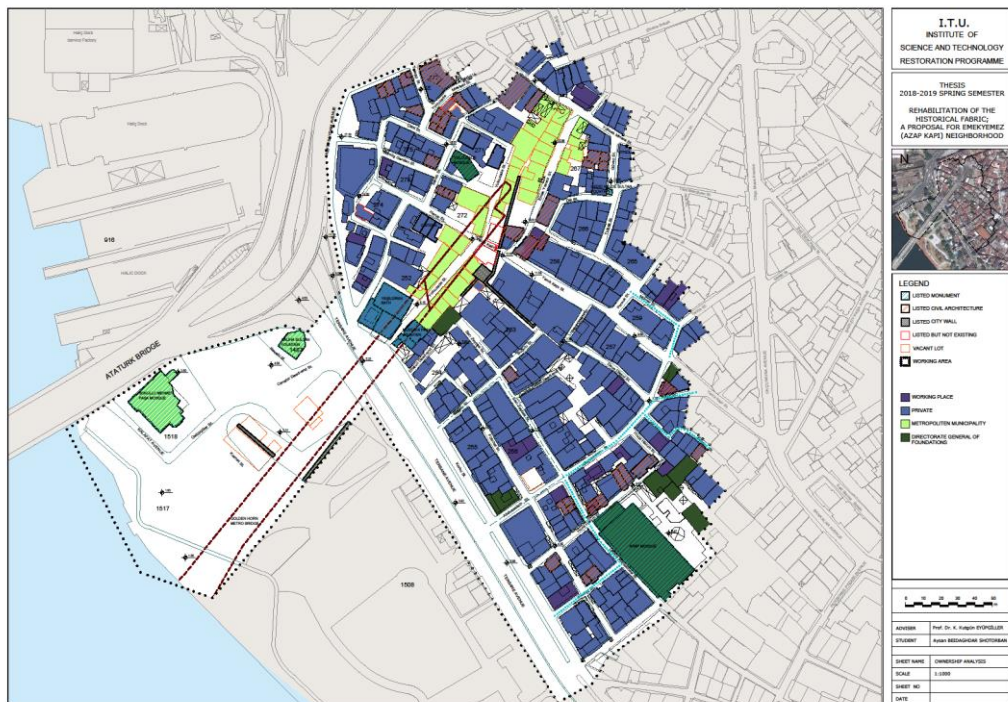
Figure 3.20 : Ownership status analysis.

In this analysis, the ownership status is categorized into three types: private, municipality and VGM (General Directorate for Foundations). In the first place, with the highest percentage in the pie charts private ownership. Most of the buildings in the working area have personal ownership or private foundations ownership status. This generality includes 83% of all buildings. Yesildirek Bath has a private ownership status, which causes serious conservation problems for cultural properties.

There are also shared possession like private & Directorate General of Foundations or private & Metropolitan Municipality that includes 5%. The vacant lots through the metro line are owned by the municipality. The last category is owned by VGM. Arap Mosque and some civil building structures are in this category.

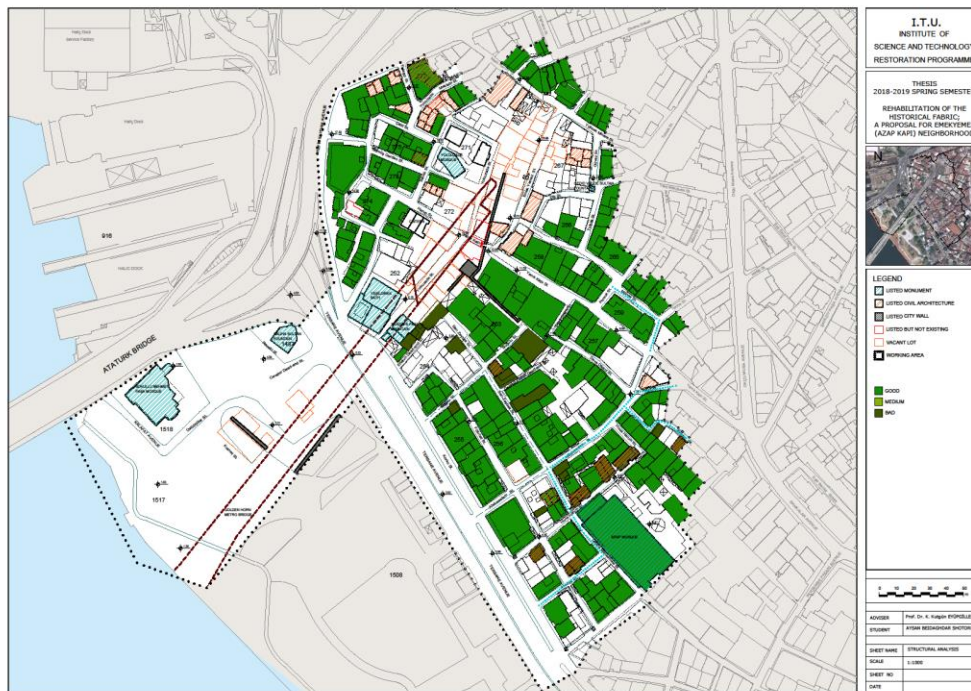
Figure 3.29 : Structural Condition Analysis.

Most of the buildings in the working area are in good condition and newly constructed structures characterized by the green color depicted in Figure 3.29. The masonry buildings are in risky condition and need to be protected. This category is the second

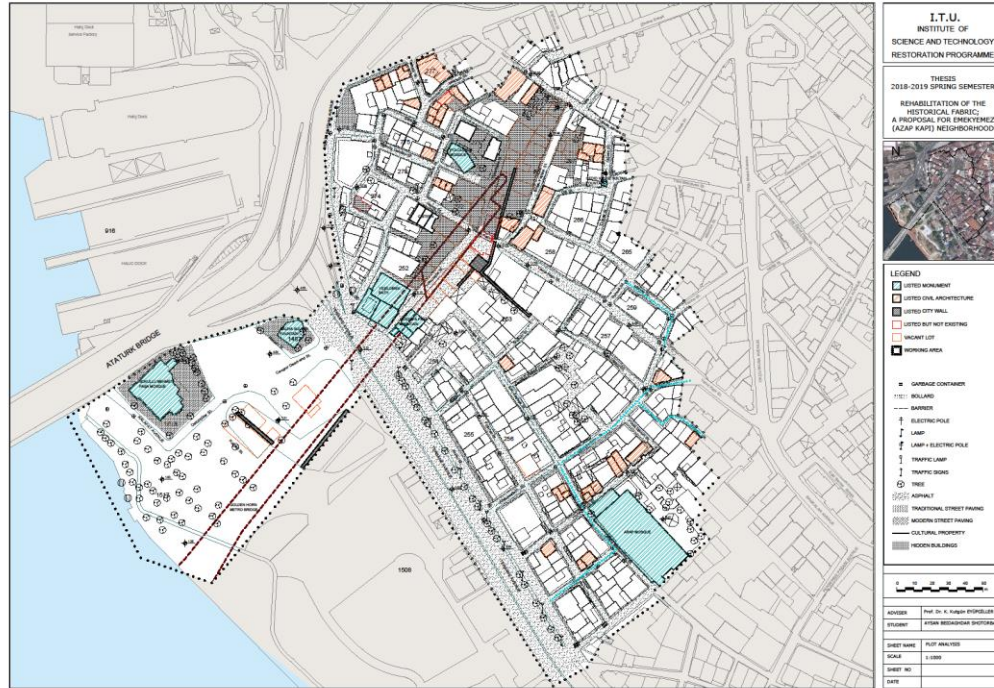
Figure 3.30 : Environmental analysis.

Most of the pavement is asphalt on the site. Only from Nazlı Hanım Street to Harup Street, which is located just above the metro line, it is colluvial soil without any paving. The only green spaces are on the southwest side of Sokullu Mehmet Pasha Mosque.

There are no green spaces in the central part of the neighborhood. The neighborhood lacks proper lighting and the only substantial lights are on the one side of Tersane Street. This makes the area unsafe at night. Moreover, due to the abundance of trash there are poor sanitary conditions in this area. For instance, the vacant spaces under the metro bridge has become rubbish dump.

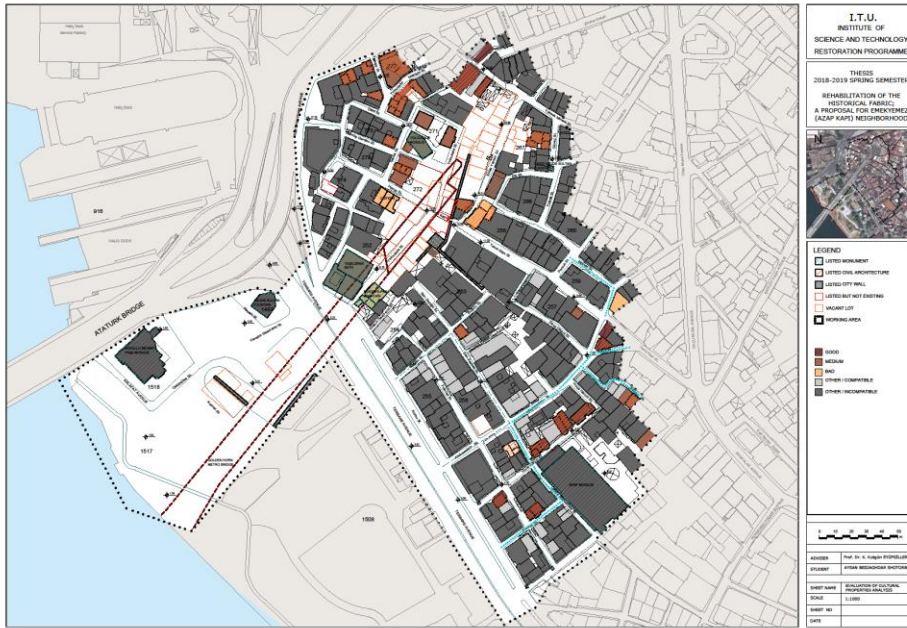
Figure 3.34 : Evaluation of cultural properties analysis.

A limited number of buildings is acceptable in the southeast and northwest. Most of the historical buildings are often bad or moderate shape and except for a few historic buildings that were restored, the most are not conserved or restored. The material of the buildings, facade details, the details of the windows and the number of the floors are the most important items to categorizing this analysis (Table 3.1). The buildings in good condition are that all those that are appropriate and listed buildings. The other categorized buildings are in medium and bad conditions. The newly built structure there are two categories of new buildings, compatible and incompatible, which are assessed according to their physical condition At least two items should be in the same category as the listed buildings. In the following pages, all types of structures will be represented (Figure 3.33).

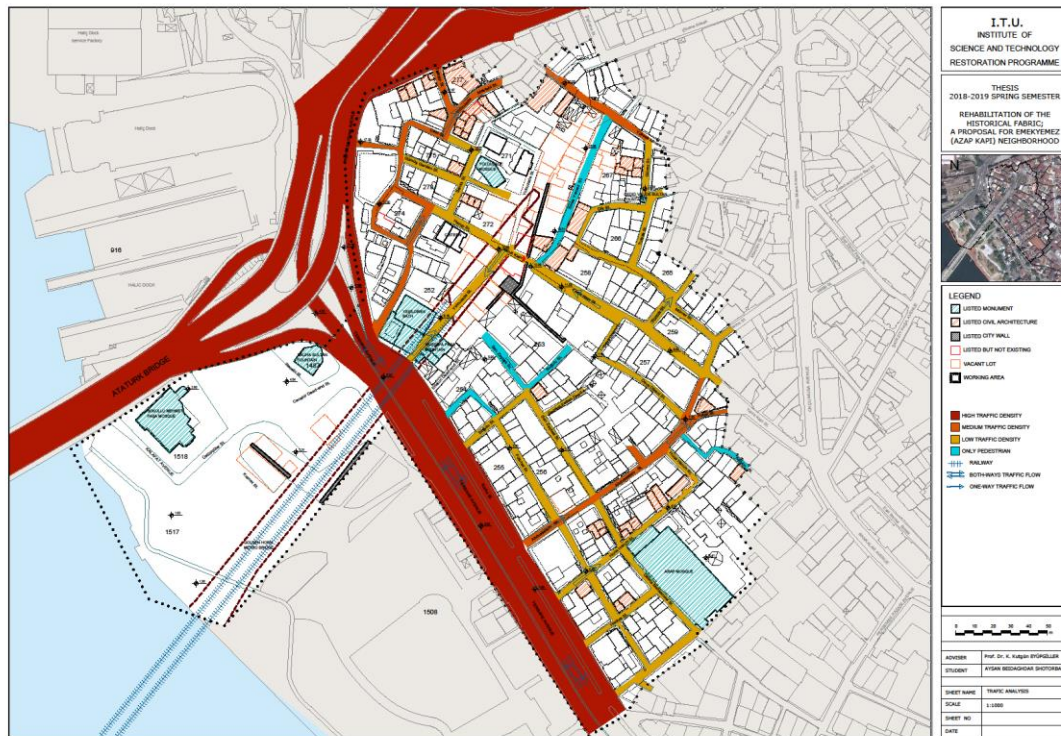
Figure 3.37 : Traffic Analysis.

In the study area, all of the transport in the area is connected to the main street, Tersane Avenue, which connects Kemaraltı Avenue to Refik Saydam Avenue. This main street (Tersane Avenue) links the commercial buildings via adjacent streets. Most of the inner streets of the area are in the northwest and south-east and are narrow; however, some of them are used as two-way streets, which causes traffic jams on the weekdays. Newly built structures also cause major problems, because the additions or improper expansion make the streets very narrow. The slope of the area increases from the southwest to the east and there are a few passes in this direction. The transit network in the central part was transformed by the construction of the subway to the pedestrian way. The adjacent pass has heavy traffic congestion, which is a part of this traffic load from the main streets.

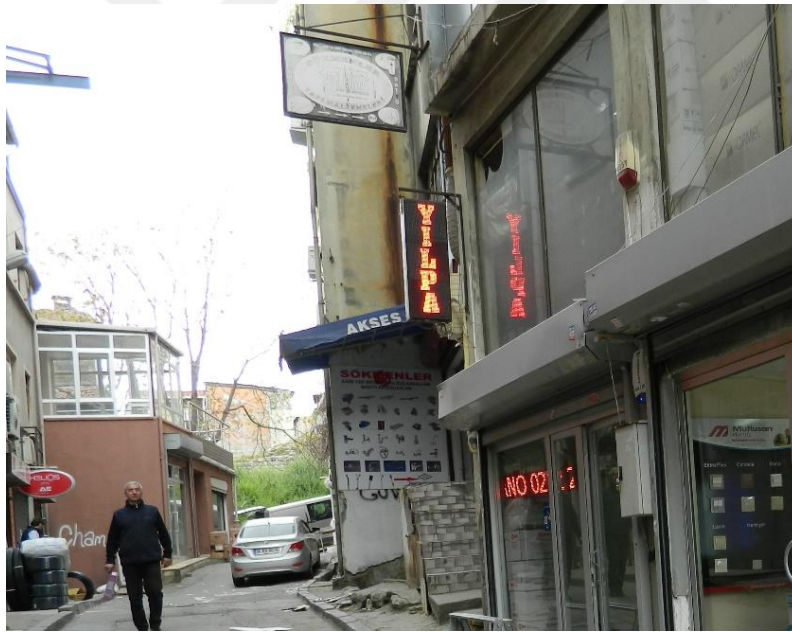
Figure 5.4 : View of the current unsuitable addition of the buildings in site (Beydaghdar, 2019).

One of the important decisions related to transportation is the expansion of streets. There are many streets where the improper of new buildings lots affects the width of the streets (Figure 5.4).

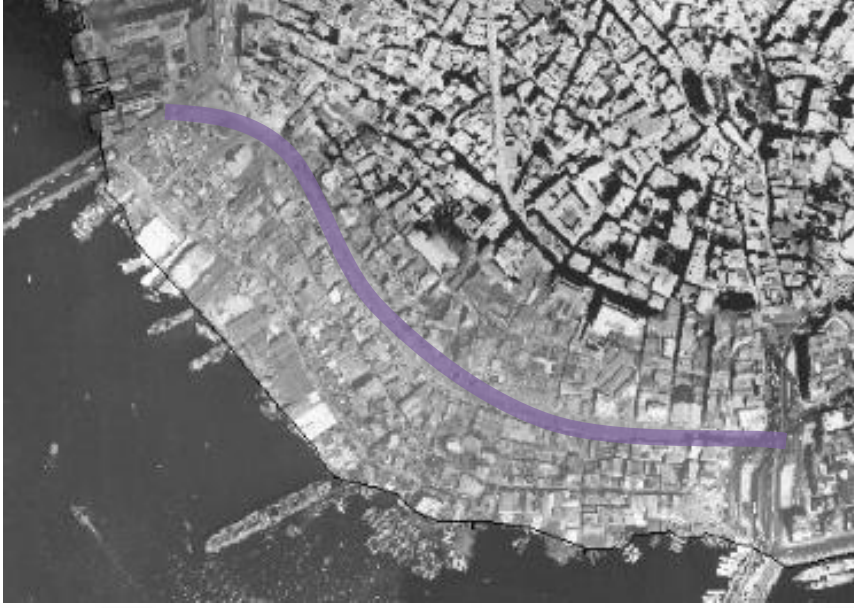
Figure 5.6 : Aerial photographs of Tersane Avenue in 1966 (Url-2).

First, the construction of Tersane Avenue in 1966 caused the destruction of many buildings and even some entire blocks. One of the reasons for this destruction was due to the construction of Tersane Avenue in 1966 (Figure 5.6).

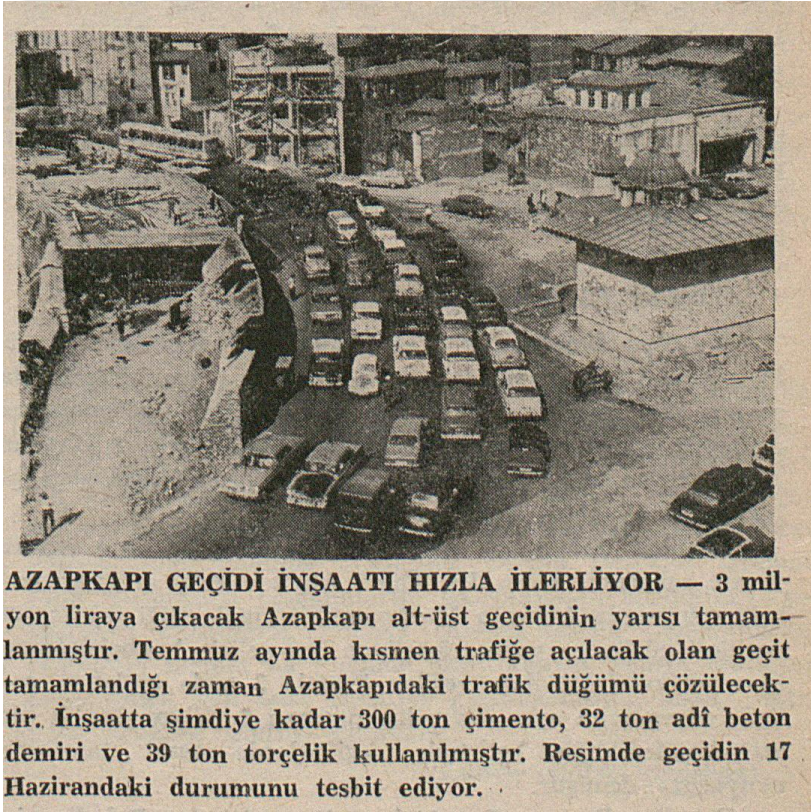
Figure 5.7 : The construction of Azapkapı Pass (Salt archive).

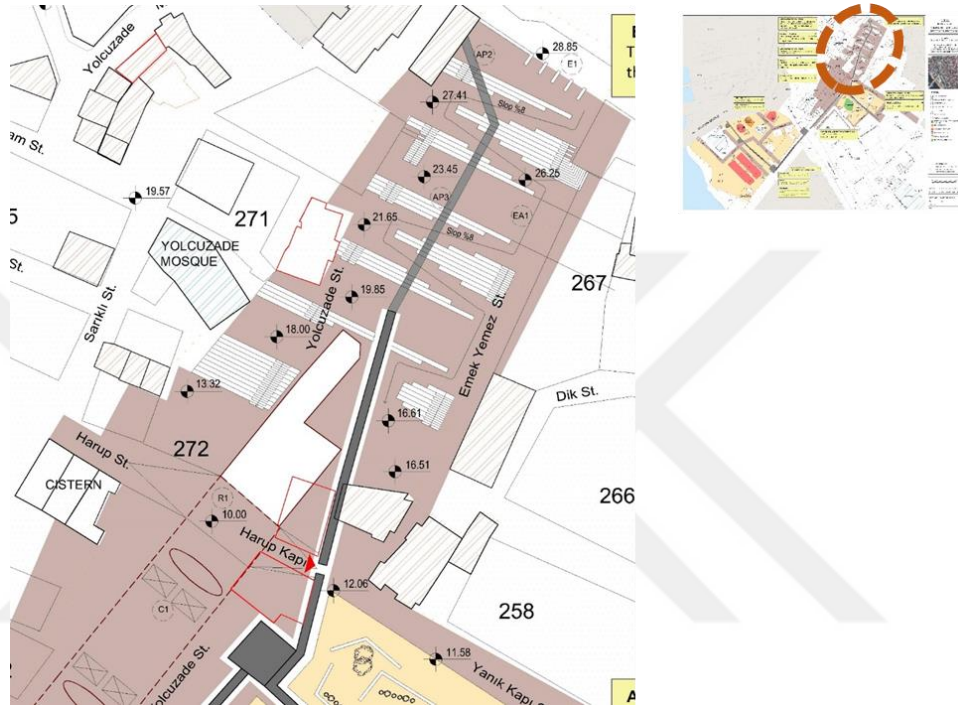
Figure 5.8 : Zone 1 master plan.

The proposed project for this area is designed with the help of the urban planning criteria. The area designated as Zone 1 will make the historical peninsula to be directly/clearly visible. In this direction, changes and vitalization were considered based on two main issues. First, principles on the protection of archaeological and cultural heritage will be implemented (Figure 5.8).

Behind the creation of this zone is to make the fragments of the Galata Walls more visible, in order to reflect the identity of the area. Since walls of Galata are no longer visible because of surrounding new buildings as well as additional floors added to older buildings on them over time, it is necessary to remove those annexes. The common pavement (that will be decided in the process of the restoration project) will be applied by creating a pedestrian space one-meter from the walls of buildings. The one-meter paving material beside the city walls is considered to be transparent, therefore it will be possible to see the relation of the walls to the floor and also the paving material will encourage visitors to be cautious as they go around the walls.

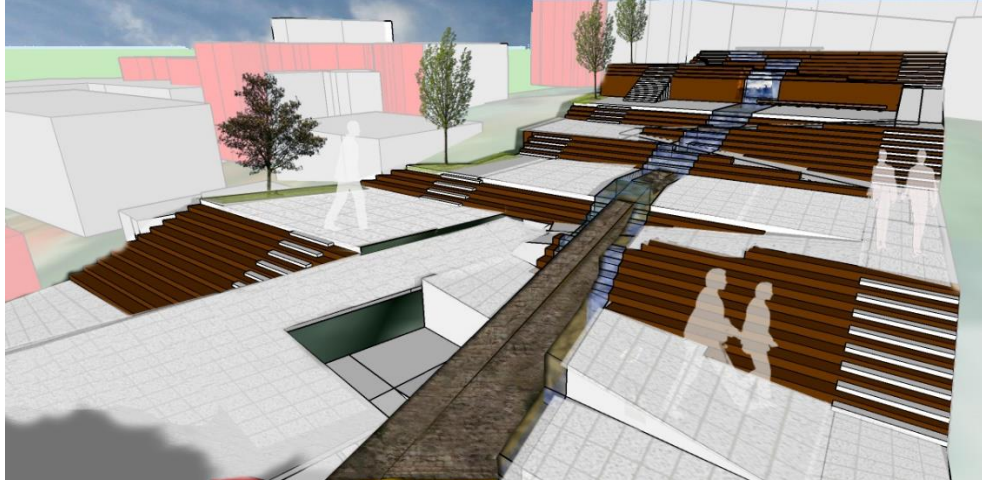
Figure 5.10 : View of Zone 1.

Since the metro line passes under this region, it is not possible to construct buildings over this ground. Therefore, the most appropriate usage can be provided by designing a public space where people can reach the traditional and antique accessorize and home stuffs that are usual in these open spaces. The level of the ground from Tersane Avenue to Nazlı Hanım Street reaches from +6.00 m. to +22.67 m. In this case, a path with stairs and ramps had been designed. Moreover, there is five platforms between the stairs allowing for people to sit on the benches and have a panoramic view of the Golden Horn.

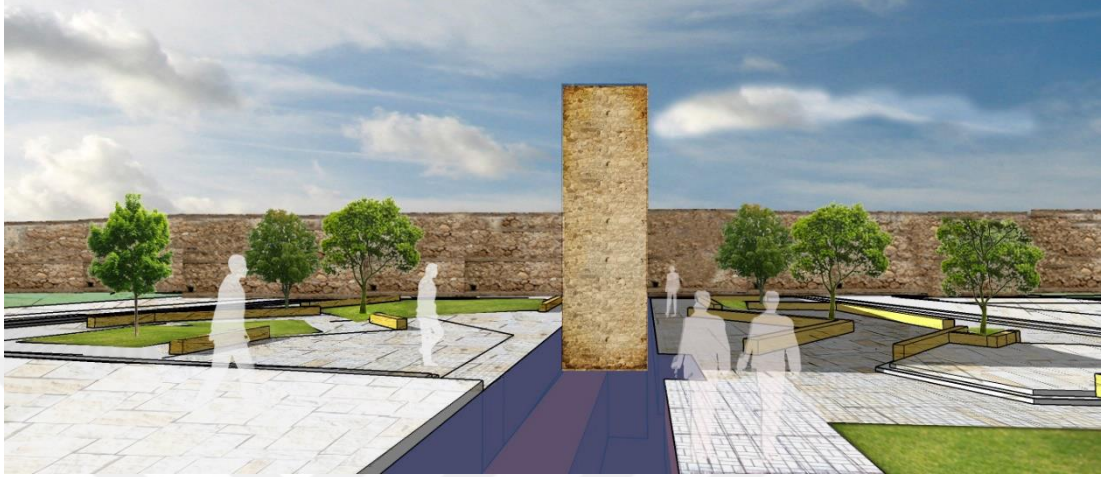
Figure 5.14 : View of Zone 2.

One of the most important decisions would be to develop the aforementioned large area into a green space to display the walls without any obstacles (Figure 5.14).

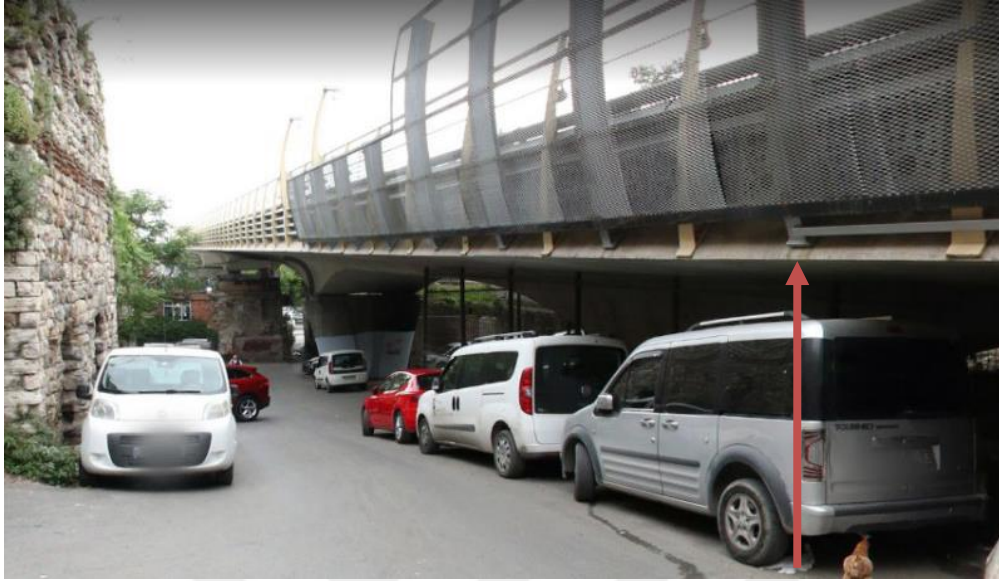
Figure 5.16 : View of the current situation of the subway and the streets (Url-1).

The current situation of the metro is close to the street level, as the height between the metro and the ground is not enough to for this road to be in a straight line. By decreasing the ground level about two meters in order to recreate Yanıkkapı Street, the

road and the height to the metro line will be increased to 3.15 meters. Moreover, forming the road as a ramp of 8% will be useful in reaching both sides of Harupkapı and YanıkKapı streets.

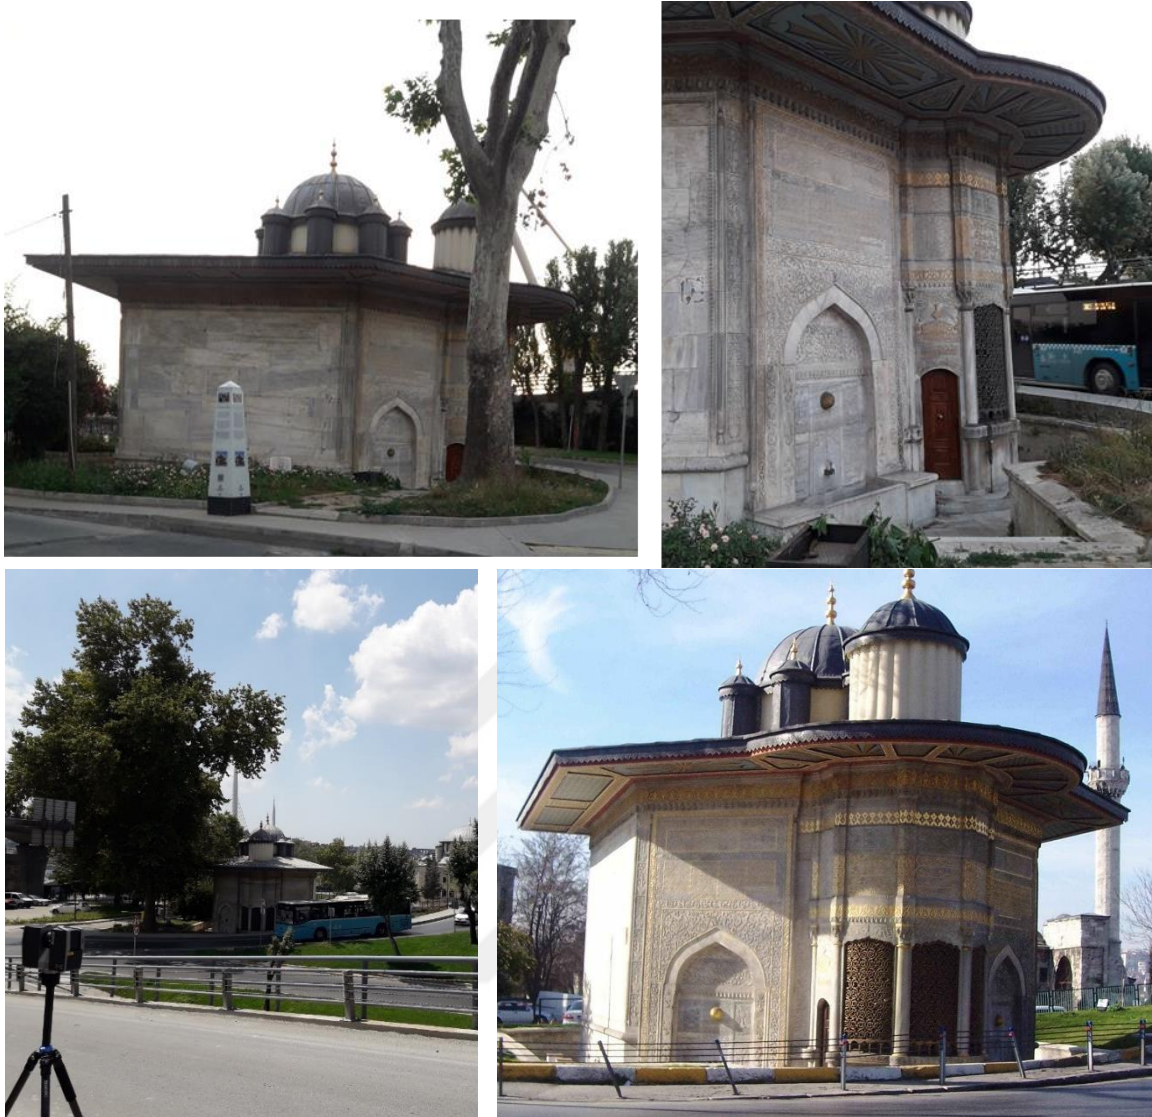
Figure 5.18 : Views of current situation of Saliha Sultan Fountain (Beidaghdar, 2019).

The fountain is one of the most magnificent and cultural significant fountains of its period. Currently, the state condition of the fountain is greatly endangered and this structure is at risk of total loss (Figure 5.18).

Due to issues with its current condition, it is advisable that the current location of the fountain could be changed, by removing it twenty-five meters backward (towards the sea) without altering its axis (Sheet). In addition, the method of moving the fountain can be done without any harming the structure based on the latest developed techniques.

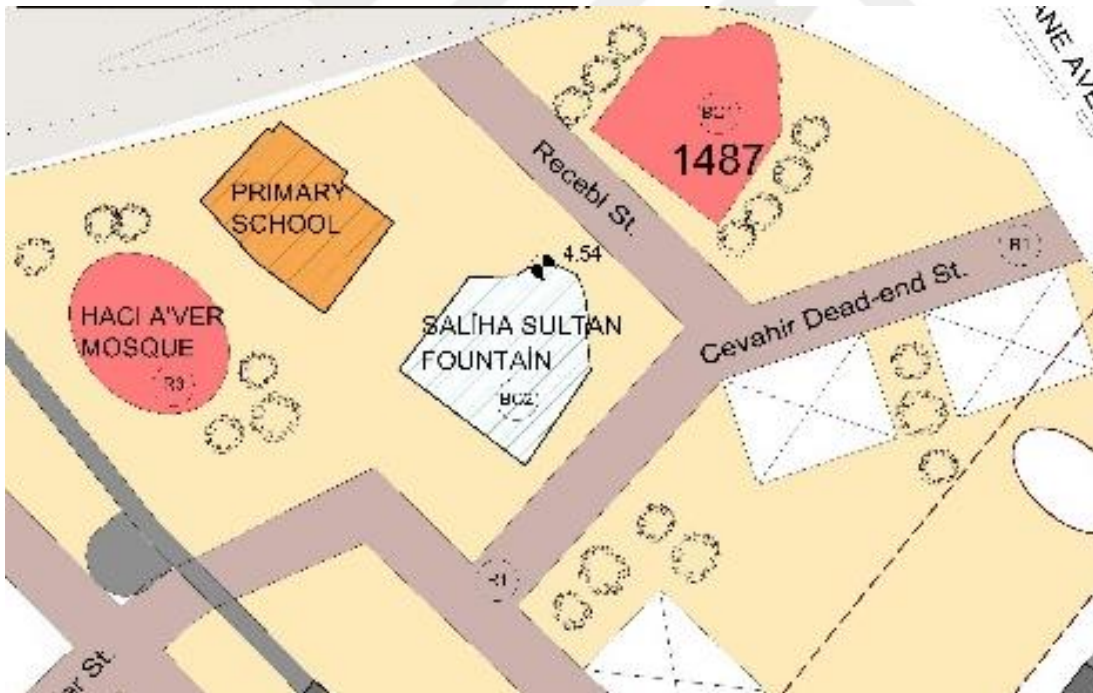
Figure 5.25 : Last situation of the fountain and school.
